FATAL PEDESTRIAN CRASH REPORT
CRASH REVIEWS

PORTLAND, 2017-2019

This report provides information relating to each of the 48 fatal pedestrian crashes in Portland, Oregon from 2017-2019.

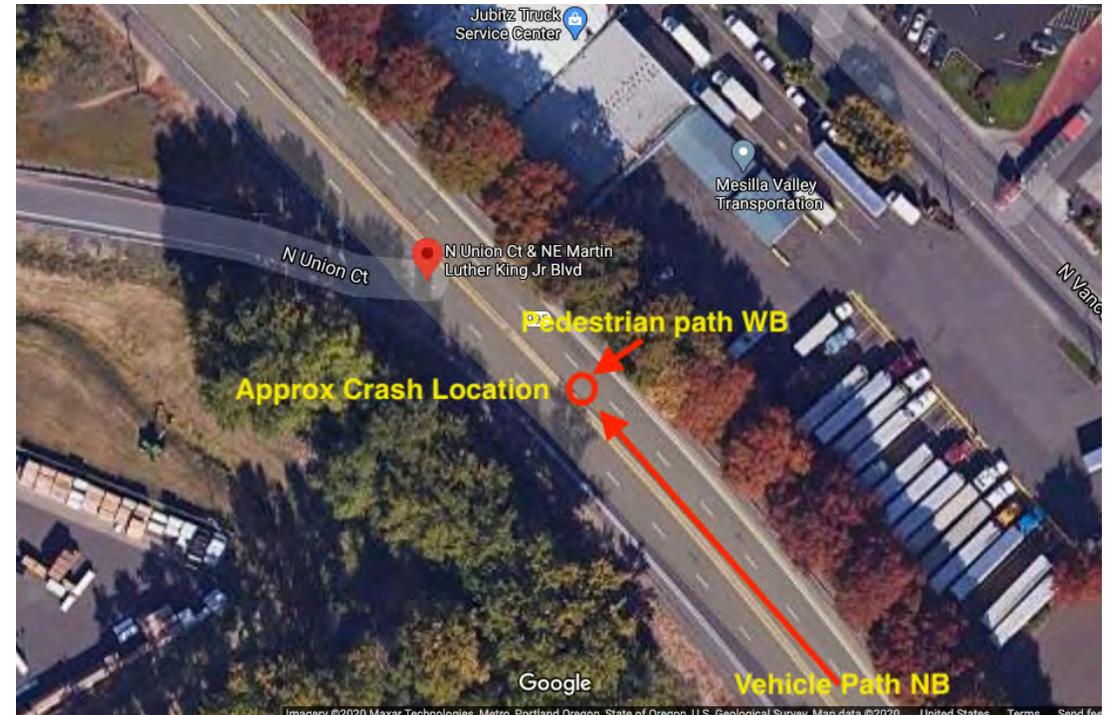
N MARTIN LUTHER KING JR BLVD AND N UNION CT 05/12/2017

The person driving was heading NB toward home after dropping off a friend. He had been awake for 16 hours as he had worked a night shift. "The minimum speed of [his] Dodge Durango when it began to skid was calculated to be 70.85 MPH (103.91 fps)" when he passed a slowing vehicle in the #2 lane.* He changed to the #1 lane when he saw a pedestrian closely ahead, attempted to brake hard, and failed to stop in time to avoid the collision.

The person walking was crossing WB just south of N Union Ct. pushing/pulling two strollers and a wagon filled with recyclables and other personal items. Responding officer notes indicate the person struck was experiencing homelessness, and state that he entered the road outside of a legal crosswalk. However, the only pedestrian crossings are 1.1 miles to the south and 0.9 miles to the north. The driver's speeding ticket resulted in a \$165 fine.

The curve at the crash location provided the person driving approx. 791 feet to see the person walking (7.6 seconds at 70 MPH; 9.8 seconds at 55 MPH). This would be considered sufficient based on AASHTO minimum recommended sight distances.

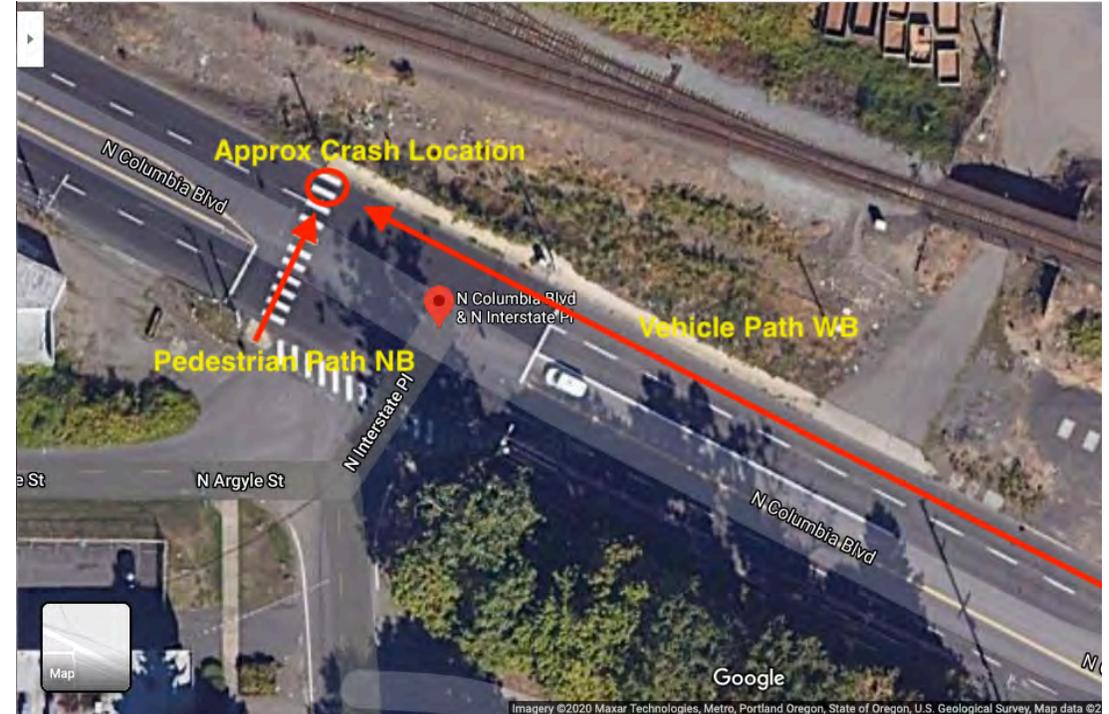
N COLUMBIA BLVD AND N INTERSTATE PL 09/25/2017

The person walking was on his way to work on a dark morning crossing Columbia Blvd NB in the west crosswalk on a “walk” signal. He was legally blind and was wearing a reflective vest and had a white and red reflective cane. The spouse of the person struck had petitioned the City to install the marked/signalized north/south crossing as this was his daily route to work.

The person driving was on his way to work after making a right onto Columbia Blvd. at the I-5 offramp 1750’ east of the crash location. He was travelling WB at or near the speed limit when he ran a red light and struck and killed the person walking within the crosswalk in the #2 outside lane.

There are no streetlights on north side of the crash intersection. A single streetlight is located at the intersection on SE corner (115' from the location in the west crosswalk where crash occurred). Nearest other streetlights on the north side of the road are 450' east and 120' to the west. PBOT Appendix K guidelines recommend 1.0 Average Maintained fc, 3 Uniformity Ratio.

There are well-worn "goat paths" on the north and south sides of Columbia showing regular pedestrian use despite lack of sidewalks. Paved sidewalks are needed to safely accommodate pedestrian access to nearby employers, other businesses and transit.

63' curb-to-curb. Recommend refuge island on the west side of the intersection at this location.

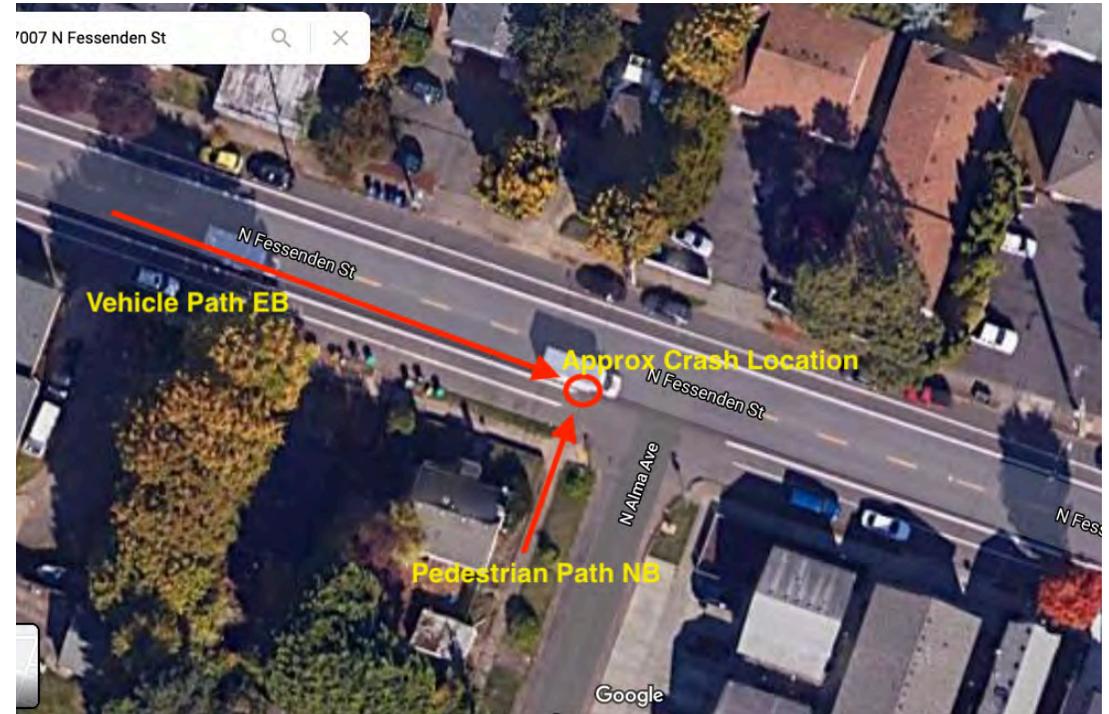
N FESSENDEN ST AND N ALMA AVE 11/26/2017

The person driving was travelling EB on Fessenden at an excessive speed (54-67 mph) when he hit the person walking. He did not stop, but proceeded EB. The case was an unsolved hit-and-run for two years until a person with knowledge came to police with a recorded confession by the person driving leading to his arrest. There was testimony that he was intoxicated the night of the cash.

Though there was a streetlight on the direct opposite side of the road from where Mr. Ramsey was hit and killed, there are no street lights along the entire south side of Fessenden on this stretch. PBOT literature states that streets over 48' should have lights on both sides. Fessenden is 54' from curb-to-curb at the crash location. Engineering review is needed to determine whether street lights should be added to the south side of the corridor. PBOT Appendix K guidelines recommend 1.2 Average Maintained fc, 3 Uniformity Ratio at the intersection of Fessenden St. and Alma Ave.

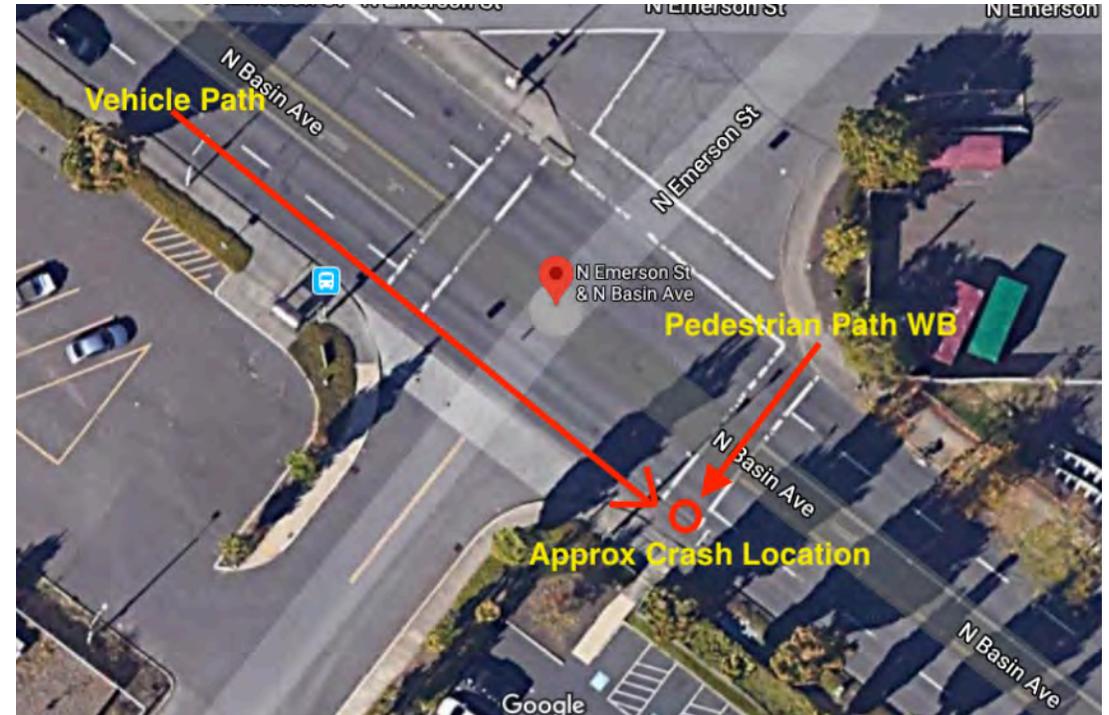
N BASIN AVE AND N EMERSON ST 03/23/2018

The person walking was working at a nearby business on the N corner as a security guard. He was crossing the street in the SE crosswalk to open a gate to a parking lot as part of his duties. The police report states he was wearing an all black work uniform with no reflectives and crossing on a “don’t walk” signal (unverified). The report does not evaluate whether street light location, white crosswalk striping, or other background colors should have enabled visibility.

The person driving was leaving work in the dark before sunrise, heading SE on Basin Ave. when he/she proceeded through a green signal (witness account) at Emerson St. and struck and killed the person walking within the crosswalk in the #2 lane. The person driving tested positive for THC Delta-9 Carboxy THC (7.7 ng/ml) and Delta-9 Carboxy THC (0.85 ng/ml) (report sic) but was determined not to be intoxicated. The person walking was in the crosswalk for approx. 12.6 seconds and in the driver’s view for approx.10.5 seconds before the impact.

The person walking was an Older Adult. Confirm that signal timing is long enough to accommodate slower walking pace of Older Adults and those with mobility issues. It is unknown whether the person walking failed to use the push button walk signal and crossed against the light, or whether he failed to make it all the way across the last lane before the light turned against him.

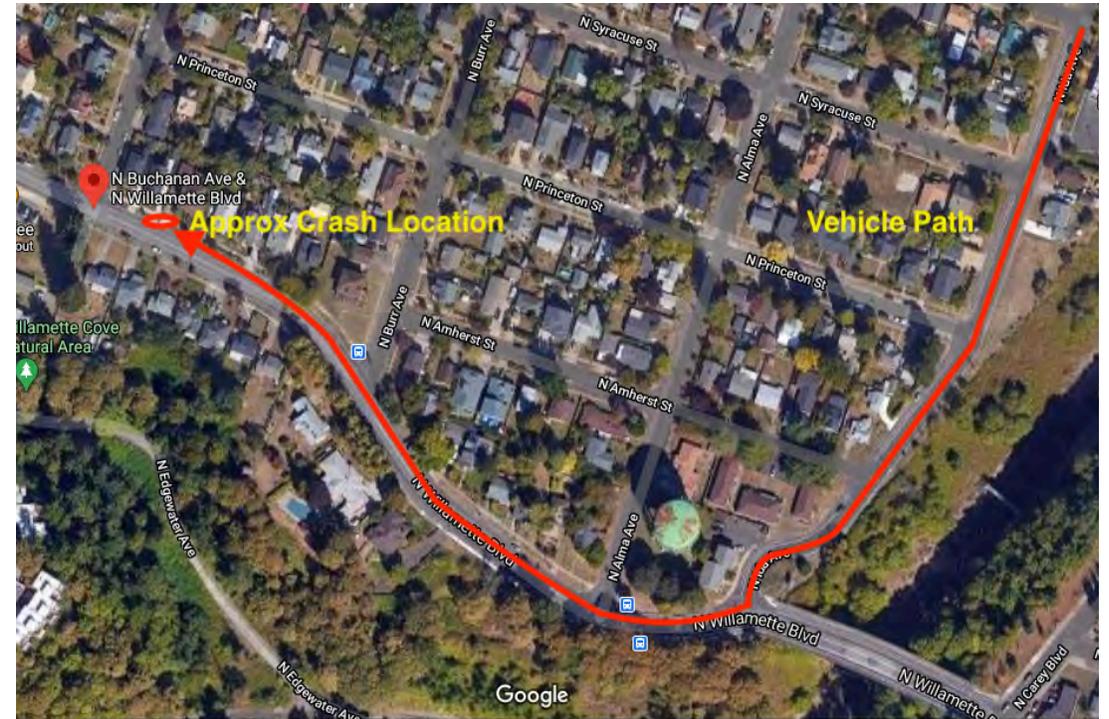
N WILLAMETTE BLVD AND N BUCHANAN AVE 11/15/2018

The person driving had left the food carts on N Lombard St. after drinking (BAC 0.18, which is more than twice the legal limit, and THC was present) and was driving home. He was rounding the left curving bend on N Willamette Blvd. speeding upwards of 53 mph when he lost control of his vehicle, hit another parked vehicle and struck and killed the person walking on the sidewalk before coming to a stop.

Willamette Blvd is a Major Collector, with many people on bicycles, and walking, running and rolling. (This is reflected in in the police report as well.) There is a long unimpeded 1.4 mile stretch from N. Portsmouth Ave. in the south to N Richmond Ave. in the north with no traffic signals, stop signs or traffic calming infrastructure to reduce vehicle speed. Extreme speed is a daily occurrence with approximately 12 drivers daily exceeding 45 MPH. Recommend installing speed bumps along N. Willamette Blvd.

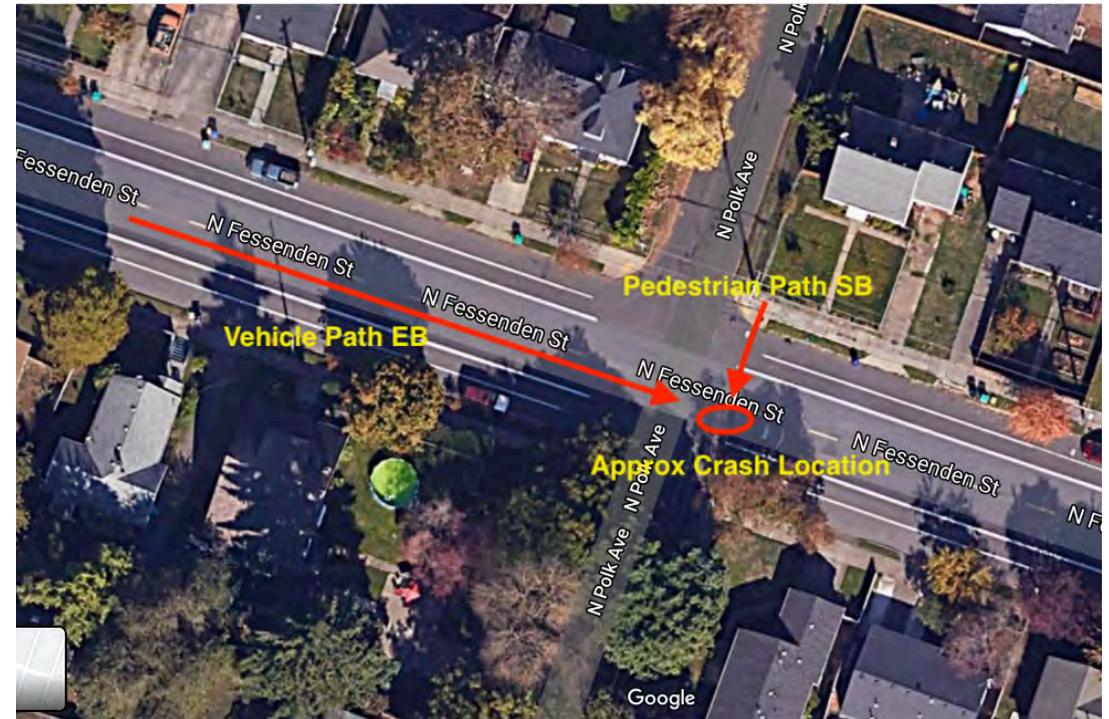
N FESSENDEN ST AND N POLK AVE 04/10/2019

The person driving was heading EB on Fessenden and said he was going 35-40 mph (no witness accounts). He hit the person walking, killing her, and proceeded. Police found the abandoned vehicle and forensic investigation helped them to track down the person driving. He admitted to the hit-and-run and was arrested. He said that he had drank 2 Bud Lights shortly before the crash.

This crash is remarkably similar to the 11/26/2017 crash noted above in which an (also eastbound) driver killed a person walking (also at an unmarked crossing—because they are all unmarked) just six blocks to the east of this location.

There no street lights along the entire south side of Fessenden on this stretch. PBOT literature states that streets over 48' should have lights on both sides. Fessenden is 54' from curb-to-curb at the crash location. Street lights should be added to the south side of the corridor. PBOT Appendix K guidelines recommend .8 Average Maintained fc, 4 Uniformity Ratio at the intersection of Fessenden St. and Polk Ave.

Multiple, similar pedestrian fatalities should be sufficient (and not necessary) for PBOT to comply with the speed-setting ordinance by posting N Fessenden at 20 MPH, and providing the calming and other safety improvements that needed to achieve that as the observed speed.

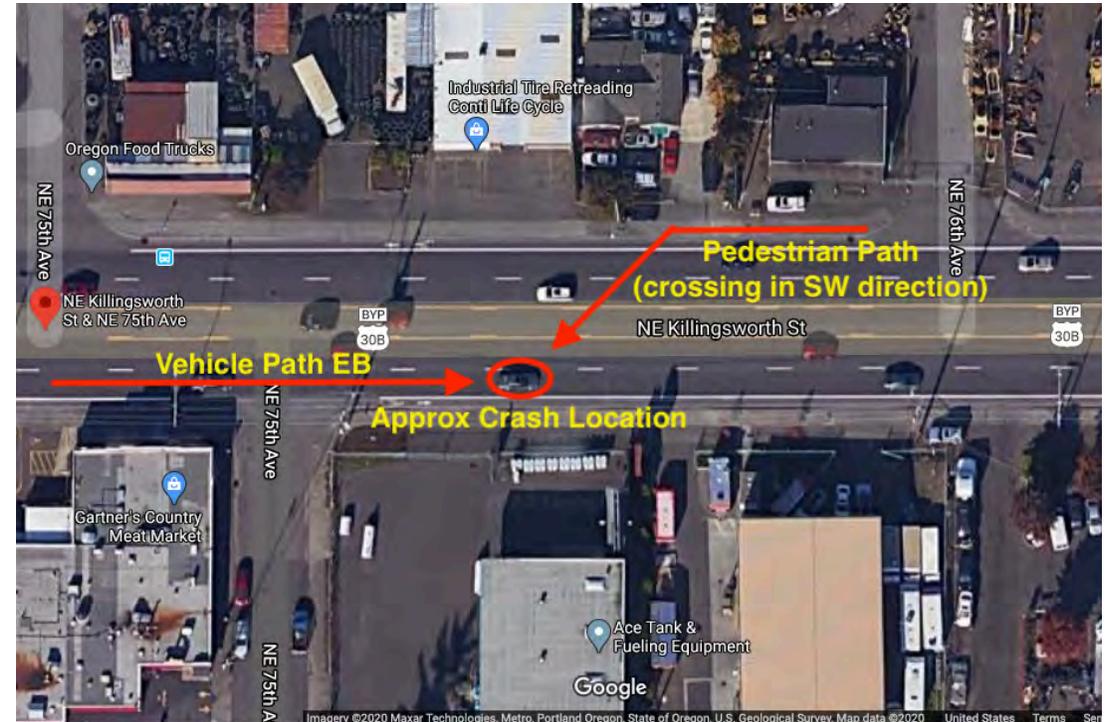
NE KILLINGSWORTH ST AND NE 75th AVE 04/30/2017

The person walking was crossing in the roadway for approx. 18 seconds and was visible to the person driving for this entire duration. Police noted that driver “A-pillar” sightline obstruction was a possible factor in this crash. High vehicle Hood Leading Edge Height (vehicle was an SUV design) was also noted by police to have been a factor in this fatality.

Streetlamps are spaced 350' apart. Recommend review for possible additional lighting according to current PBOT Appendix K guidelines. 1.2 Average Maintained fc, 3 Uniformity Ratio.

73' curb-to-curb. Enhanced crosswalks with refuge islands recommended (if the multi-lane cross-section is preserved).

NE Killingsworth is currently posted at 35 mph. As an Arterial in a Business District, the street has a 20 mph statutory speed. Rescission of the Speed Zone Order setting a faster-than-statutory speed is recommended.

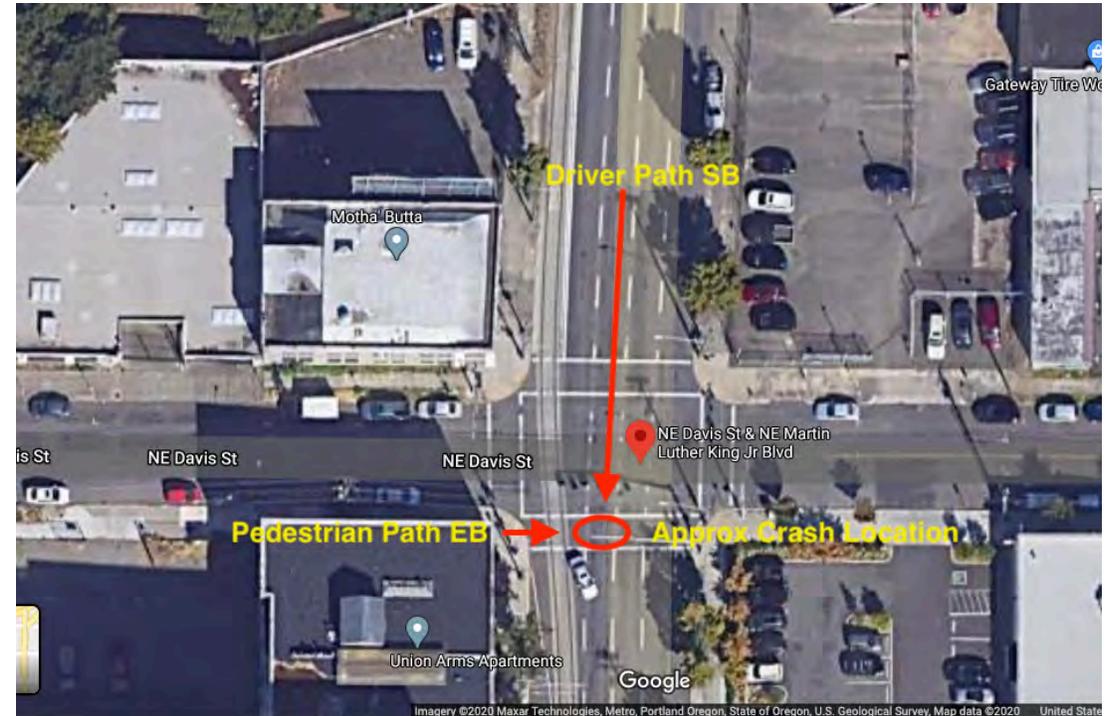
NE MARTIN LUTHER KING JR BLVD AND NE DAVIS ST 09/23/2017

The person driving was proceeding SB in lane #3 approximately at the speed limit when she saw a stopped vehicle with their hazards on. This vehicle turned off their hazards and made a lane change to the #4 lane. The person driving proceeded through the green light in lane #3 and hit and killed the person walking on the south side of the intersection in the crosswalk.

The walk signal changed before the person walking could cross the entire 57' road presumably due to a mobility disability and/or slow walking pace (Older Adult). Recommend increasing signal time, reducing the crossing distance, and/or reducing the number of lanes that must be crossed to accommodate pedestrians who walk at a slower pace and nearby residents with possible mobility issues.

LED street lights are located on the SE and SW corner of the intersection as well as vintage style high pressure sodium types on all corners, but a witness to the crash who was on the road at the time of the collision said that it was "dark, and difficult to see [the person walking] even with the street lights." Recommend review for compliance with PBOT Appendix K Guidelines 1.0 Average Maintained fc, 3 Uniformity Ratio.

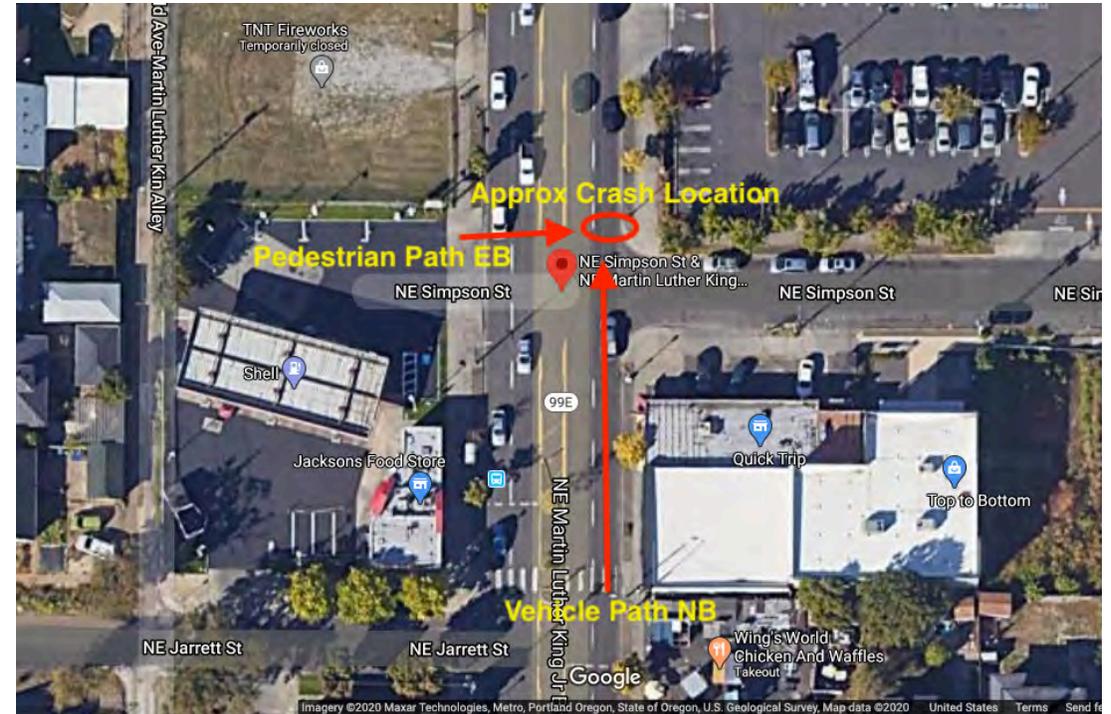
NE MARTIN LUTHER KING JR BLVD AND NE SIMPSON ST 10/27/2017

The person driving was an Older Adult travelling NB at a slow speed (approx. 10-15 mph) driving a heavy truck with a refrigerator in the bed (curb weight over 5000 lbs.) when when he struck and killed the person walking the #2 outside lane. Police describe driver A-pillar sightline obstruction and pedestrian intoxication as factors in this crash.

NE Martin Luther King Jr. Blvd. is a high ADTV (13865) City Walkway and Major City Bikeway (TSP classifications). The crash location is in a Business District on a Principal Arterial (federal classification) and subject to statutory 20 mph. Rescission of SZO is recommended.

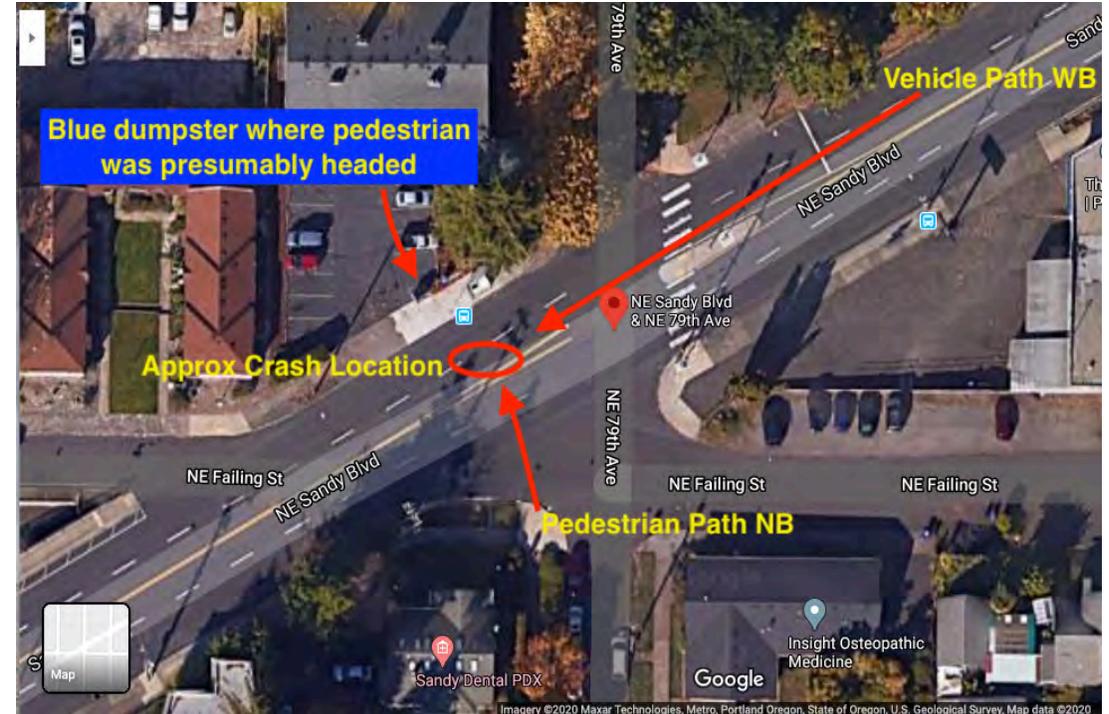
NE SANDY BLVD AND NE 79th AVE 12/20/2017

The person driving was heading WB after turning onto Sandy Blvd from 82nd Ave when she hit and killed the person walking in the #1 inside lane.

This crash also what traffic engineers know but rarely design for: just as drivers will rarely follow the speed limit if it “feels safe” to go faster, people walking will rarely go very far out of direction in order to cross a street. This is commonly observed where a driver finds a mid-block parking spot, and then crosses to a destination directly across the street without going to the corner (and back).

Appropriate designs will accommodate known human behaviors, and even human errors, so that they do not result in death. NE Sandy Blvd is a high crash corridor because PBOT fails to apply this principle, despite the needs and welfare of the people who live on and around the street. Only the interests of people who drive on it, and want to do so at potentially deadly speeds, are protected.

Due to the length and dangerous nature of crossing 79th Ave on the south side of the intersection where it meets Failing St., crossing improvements are needed from the east side of the intersection of NE Sandy Blvd. and NE 79th Ave. parallel to the one existing on the west side.

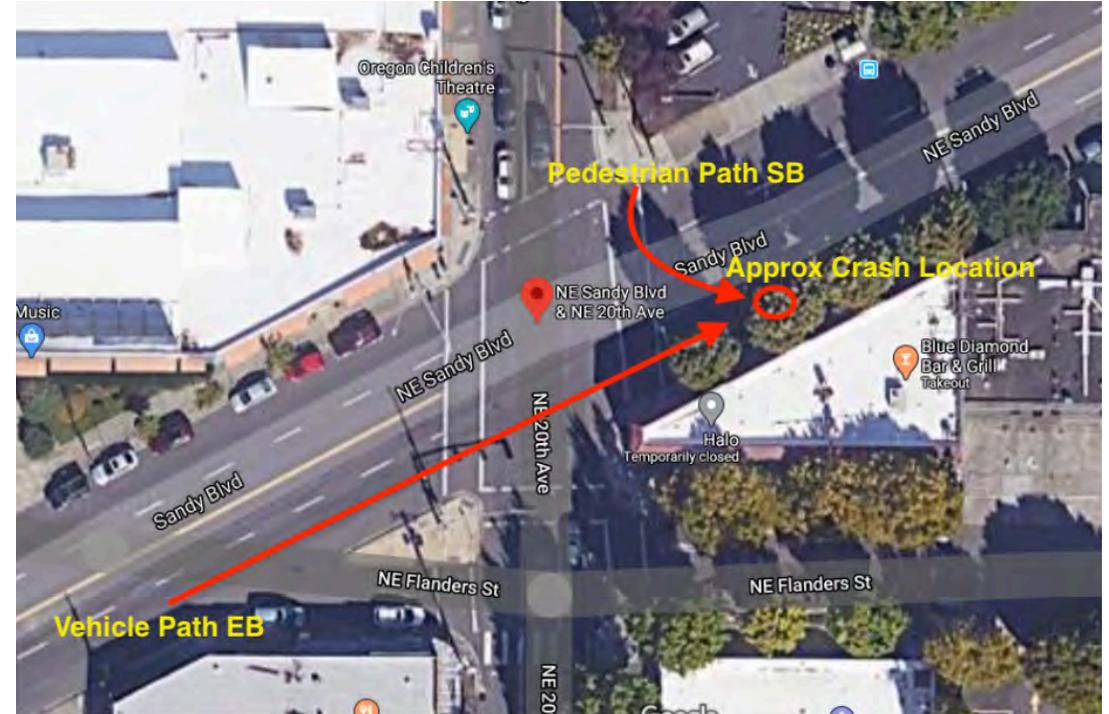
NE SANDY BLVD AND NE 20th AVE 08/25/2018

The person driving (unknown identity) was travelling an estimated 55-65 mph (possibly racing another vehicle) through the intersection heading NEB when they hit and killed the person walking in the #2 lane (unknown exact POI). At typical walking speeds, the person walking would have been in the driver's view for an estimated 12 to 15 seconds before the driver struck him.

Sandy Blvd. at this location is currently posted at 30 mph. This is Principal Arterial (Federal) and a TSP Major City Bikeway and Major City Walkway in a Business District and subject to statutory 20 mph. Rescission of SZO recommended.

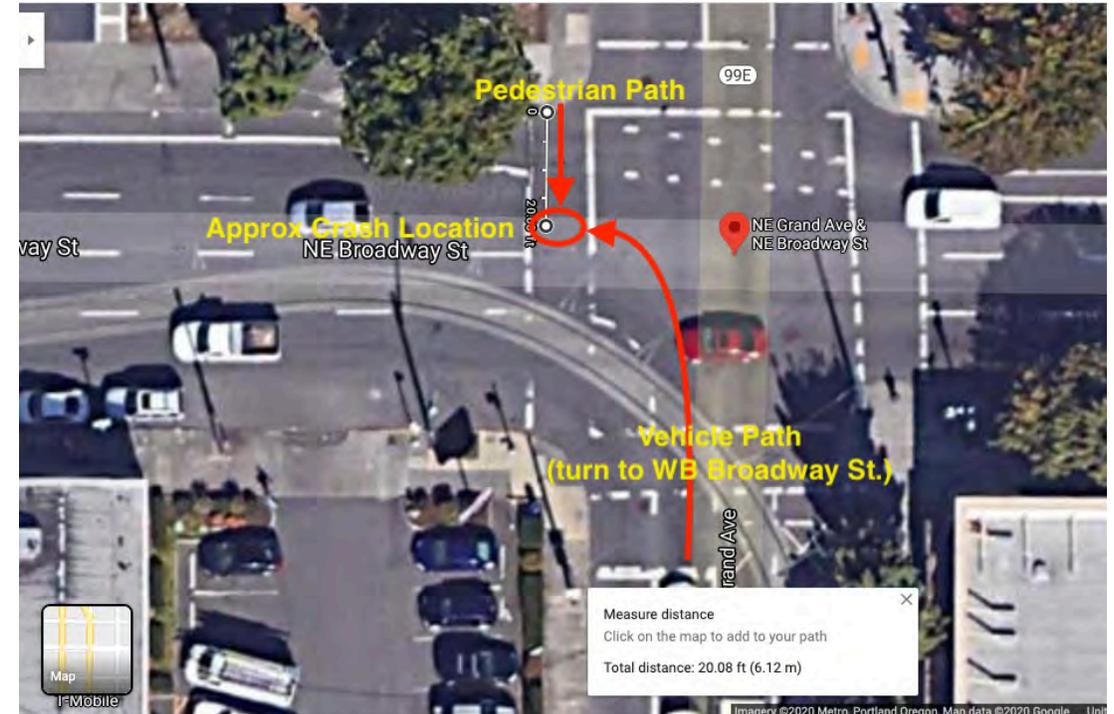
NE BROADWAY AND NE GRAND AVE 04/19/2019

The person driving was making a left turn from the #2 middle lane of NE Grand Ave. from the south side of the intersection to the #2 WB lane on Broadway St. The person walking was struck and killed in the crosswalk approx. 20 ft. from the NW corner in the #2 lane of Broadway. The vehicle was a large semi-truck and police opined that the A-pillar sightline obstruction was a crash factor. At the time of the crash, the “walk” signal conflicted with the green light for the vehicle’s left turn (see issues and recommendations). That is, the walk signal was “walk” as the same time as NB drivers had green.

“Changes were made to the intersection infrastructure after the crash. Investigator David H. Enz states On May 8, 2019, at approximately 10:00 AM, I again returned to the scene and observed several changes to the intersection (NE Grand Ave/ NE Broadway St.). I observed new signage attached to the signal post located on the NW corner of the intersection. The pedestrian control display box is also attached to this pole. The new signage alerts (NB) drivers on NE Grand Avenue that pedestrians may be crossing the intersection and for drivers to stop for pedestrians. This sign also has a direction indicator drawing the reader's attention to the crosswalk. I observed new white candle sticks atop the painted white line marking the bicycle lane along the north shoulder of NE Broadway Street (along the angled portion of this lane from the crosswalk to toward the north sidewalk). I observed the TCD light cycles and noted that the timing, or sequence had been changed in the days following this collision.

Speed at this location is currently at 30 mph. This is a Business District on a Principal Arterial and subject to statutory 20 mph. Rescission of SZO recommended.

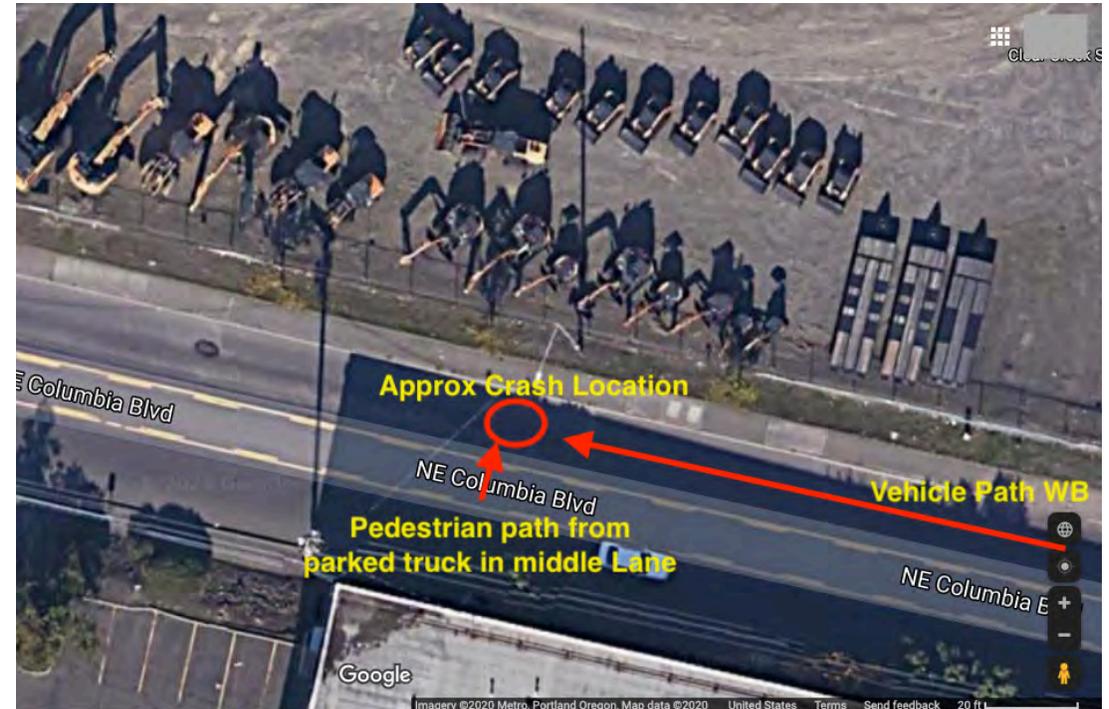
NE COLUMBIA BLVD NEAR NE 63rd AVE 04/25/2019

The person driving was a Lyft worker transporting a customer from PDX Airport to home. He was heading WB on NE Columbia Blvd. Oncoming headlight glare of the semi-truck parked facing in his direction (EB) reportedly made it harder for the person driving to see the person walking as he exited the truck. It is unknown the extent to which the driver slowed approaching the stopped truck and the area of reduced visibility.

The current speed at this location is 40 mph. As a Business District on a Principal Arterial the road at this location and subject to statutory 20 mph. Although dominated by car-oriented businesses, the number of pedestrian crossings, and crashes, on NE Columbia speaks to the grave need for PBOT to reduce speeds and operate the street in a way that is consistent with safety for all users. Rescission of SZO recommended.

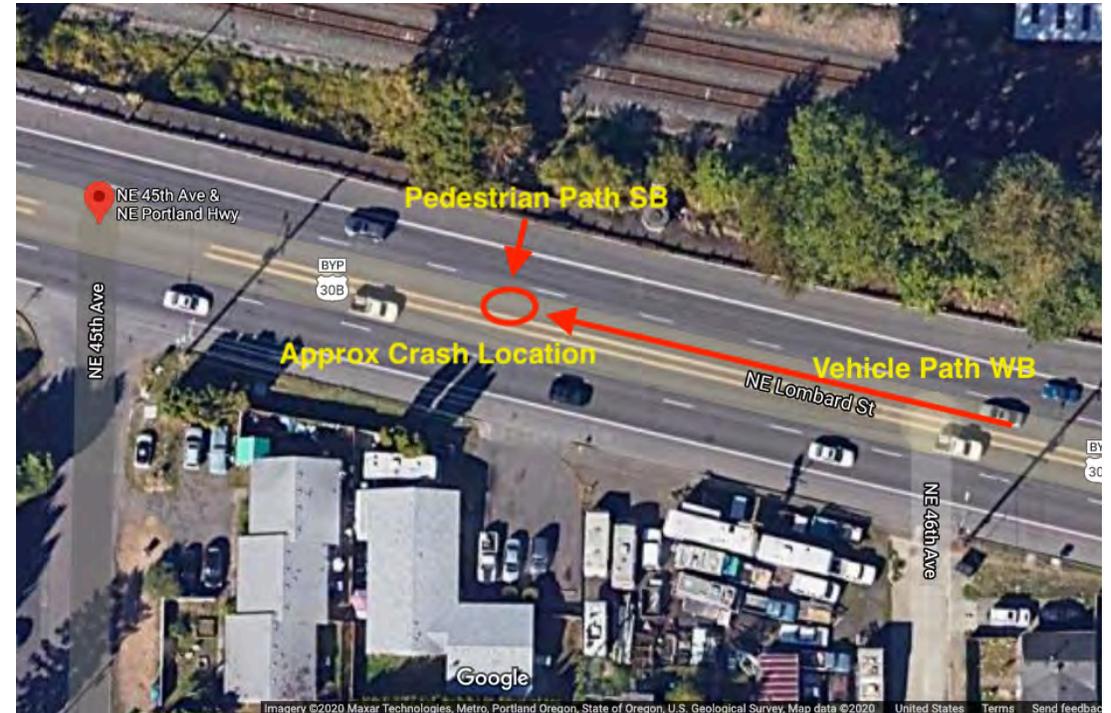
NE PORTLAND HWY NEAR NE 45th AVE 09/15/2019

This was a hit-and-run. The person driving (identity unknown) was heading WB in the #1 inside lane of the NE Portland Hwy where they hit and killed the person, and continued WB.

Police and a witness described how dark it is on the road where the person walking was hit. There are lights only on the south side. The person walking was hit on the north side. PBOT guidelines recommend 1.0 Average Maintained fc, 3 Uniformity Ratio.

This location is part of the PBOT Columbia-Lombard Corridor plan scheduled to be adopted summer of 2020. The entire corridor from MLK Jr. Blvd to I-205 is supposed to receive infrastructure upgrades to more safely accommodate pedestrian and vehicle. PedPDX, adopted in June 2019, identifies Lombard (Portland Hwy) as a priority for sidewalk gap completion and addressing crossing deficiencies. NE Lombard between NE 42nd Avenue and NE 60th Avenue is identified as a Tier 2 priority where crossing deficiencies will be addressed. North side lighting upgrades are not shown to be part of the existing upgrade plans. Speed reductions and reallocation of the multiple travel lanes are uncertain.

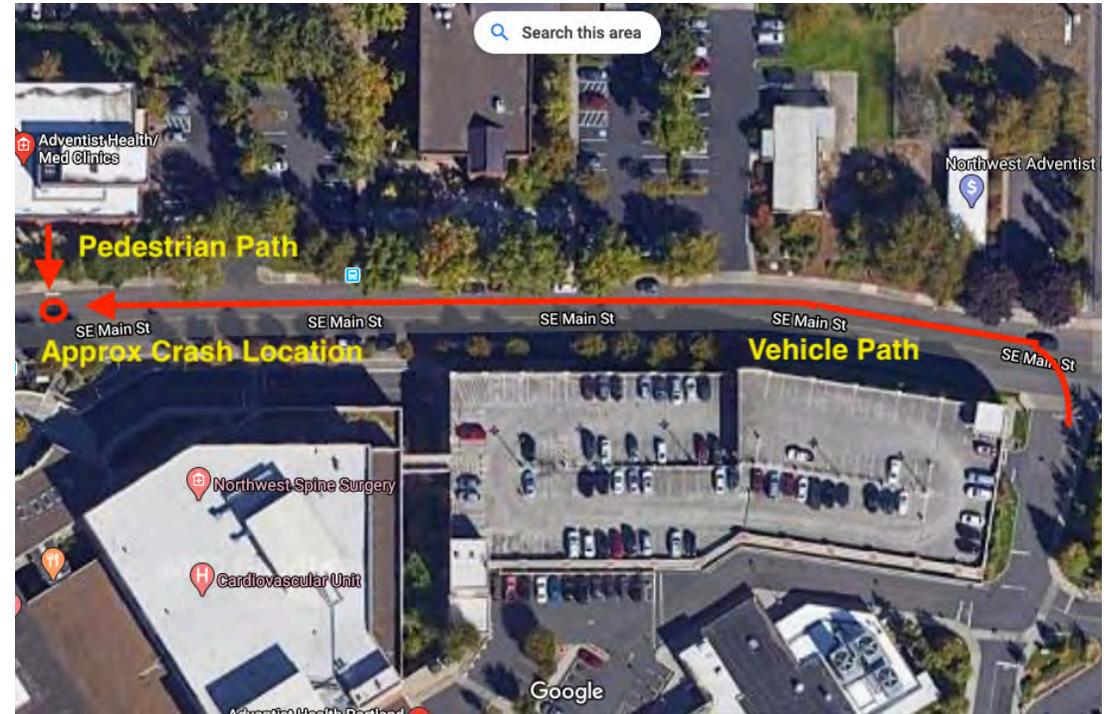
10100 SE MAIN ST
01/04/2017

The person driving left the parking lot to the east of the crash location and proceeded WB on Main St. travelling at approximately the posted speed limit. The person driving hit and killed the person walking in the marked crosswalk.

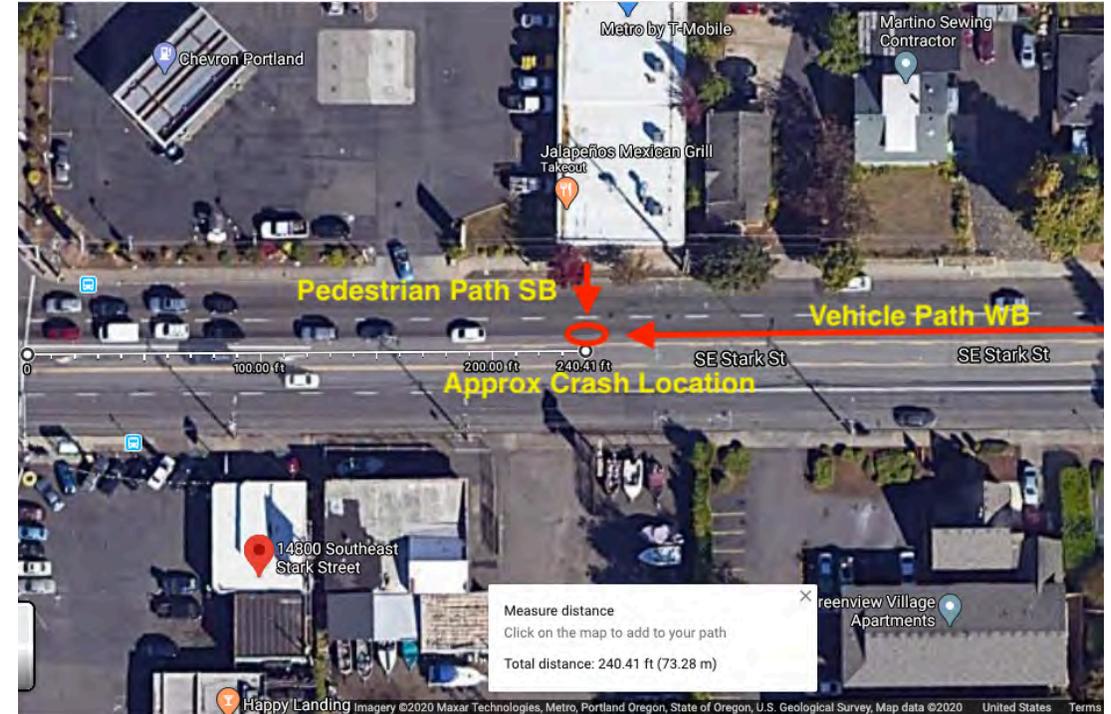
SE STARK ST NEAR SE 148th AVE 03/09/2017

The person driving was going 59 mph at the time of impact (75 mph shortly before) and was unlicensed. He hit and killed the person walking in the WB #1 inside lane and fled the scene, turning himself in to police 4.5 hours later.

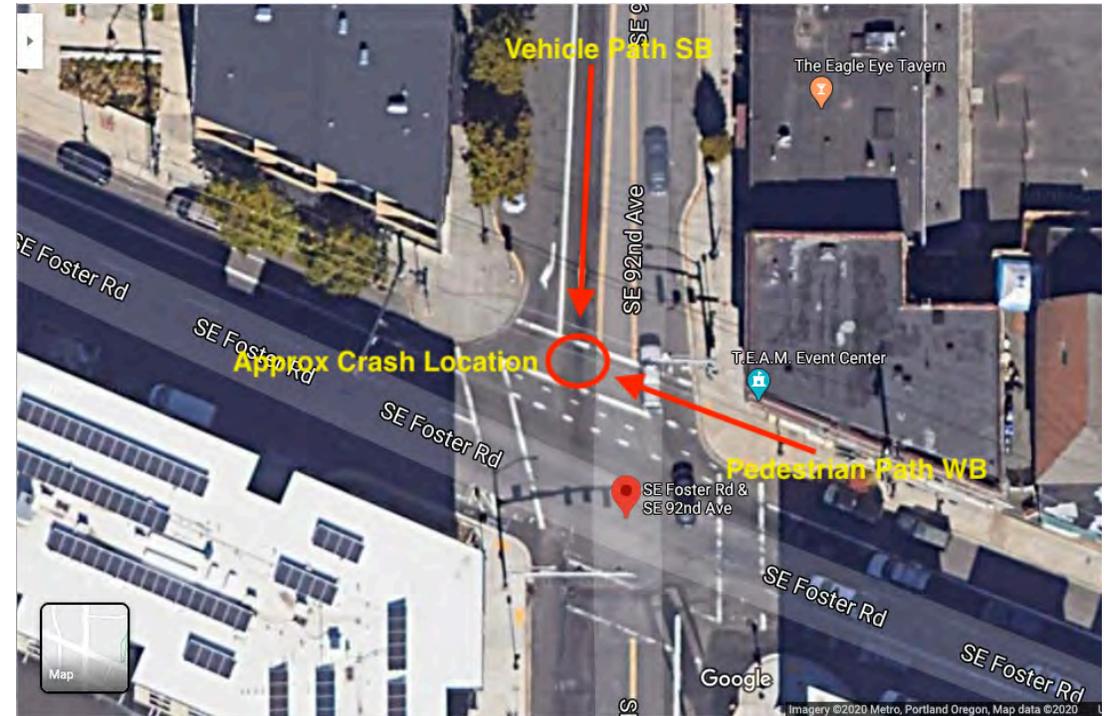
SE 92nd AVE AND SE FOSTER RD 04/26/2017

The person driving stated he was on his way to work travelling SB in the #1 inside lane when he heard and felt an impact, stopped south of the intersection and realized he had hit the person walking in the marked north crosswalk. The traffic signal status is unverified though one witness said it was green. The person driving was reportedly travelling at or near the speed limit. The person walking was in the crosswalk and likely in view of the person driving for approx. 7 to 8 seconds before impact.

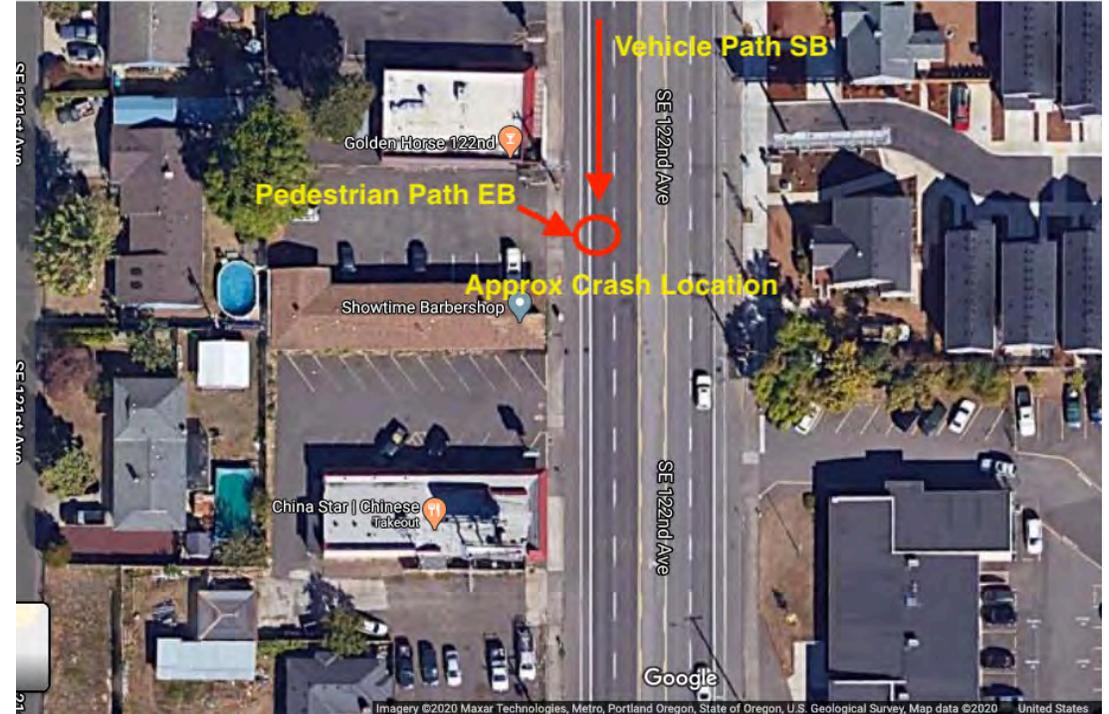
SE 122nd AVE NEAR SE WOODWARD PL 07/03/2017

The person driving was heading SB in the #2 outside lane at or near the speed limit when he hit and killed the person walking. The person driving was tested and found to be driving under the influence of alcohol (0.112 BAC which is over the current “legal limit” of 0.08).

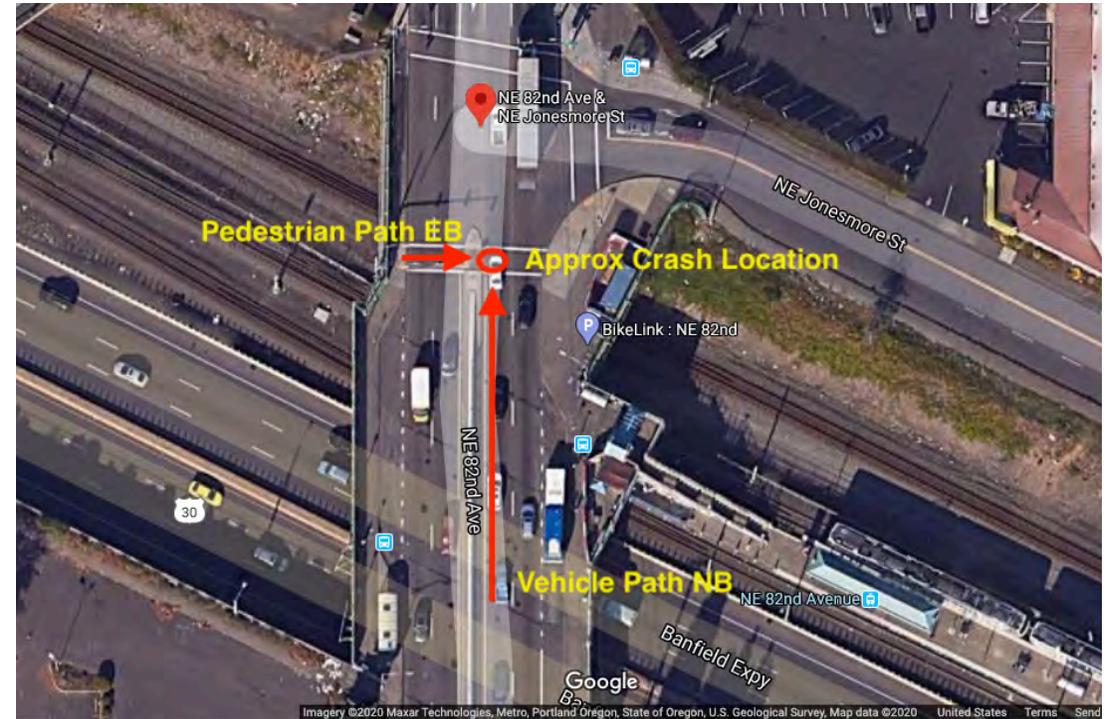
NE 82nd AVE AND NE JONESMORE ST 10/07/2017

The person driving was heading NB in the #1 inside lane along the dividing wall where she hit and killed the person walking in the marked crosswalk as he emerged from behind the wall and walked into the lane. It is not known if the traffic signal was green or red. Sightline obstruction by the wall (for both pedestrian and driver) was a factor in this crash.

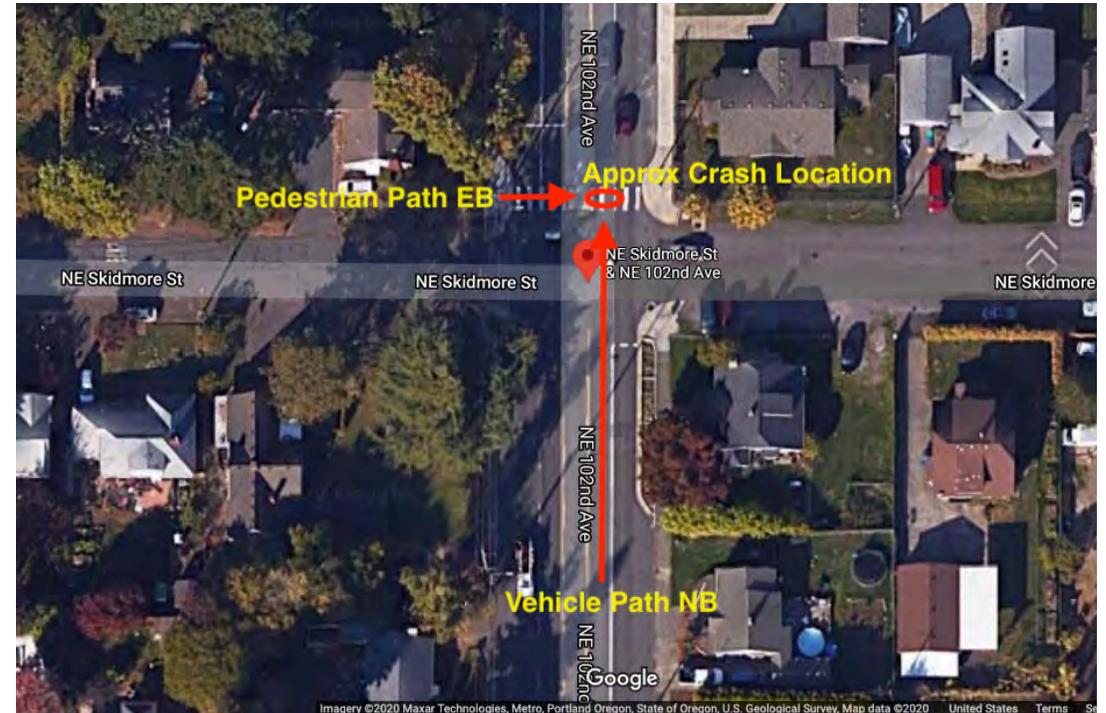
NE 102nd AVE AND NE SKIDMORE ST 11/30/2017

The person driving was travelling NB on 102nd Ave. He tried to swerve to the left when the person walking advanced from the refuge island but was prevented by the raised island. The person driving hit and killed the person walking within the marked crosswalk in the #1 inside lane.

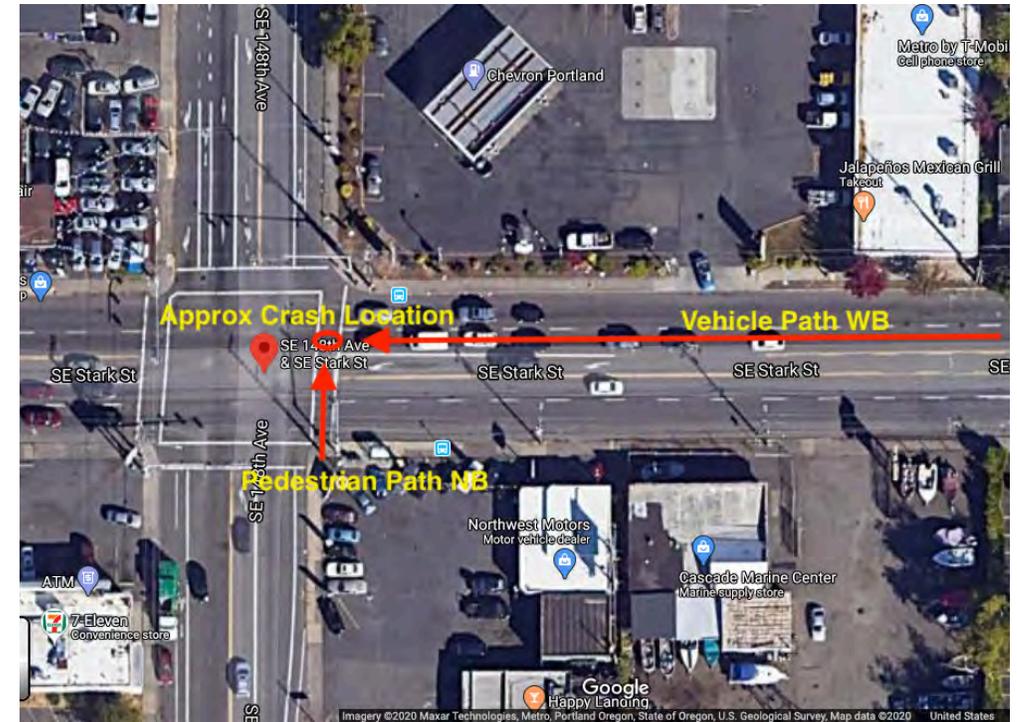
SE STARK ST AND SE 148th AVE

This was a hit-and-run. The person driving (unidentified) was travelling in the #1 inside lane of SE Stark St. at 60-100 mph and hit and killed the person walking within the east crosswalk. The person driving then sped away heading WB. This crash occurred just 250’ from another fatal crash on 03/09/2017 that involved similar excessive driver speed.

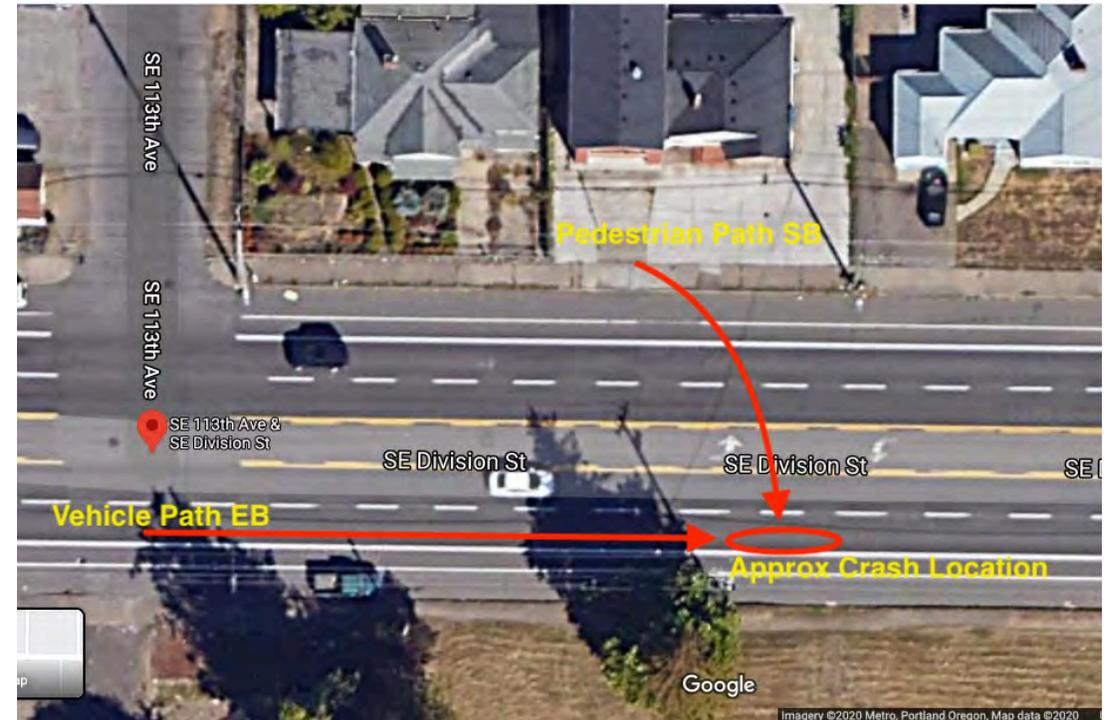
SE DIVISION ST NEAR SE 113th AVE 03/11/2018

The person driving was heading EB in the #2 outside lane where he hit and killed the person walking. Due to a slow walking pace, police determined that the person walking was in the roadway and within view of the person driving for approx. 25 seconds before the collision.
