FATAL PEDESTRIAN CRASH REPORT
CRASH REVIEWS

PORTLAND, 2017-2019

This report provides information relating to each of the 48 fatal pedestrian crashes in Portland, Oregon from 2017-2019.

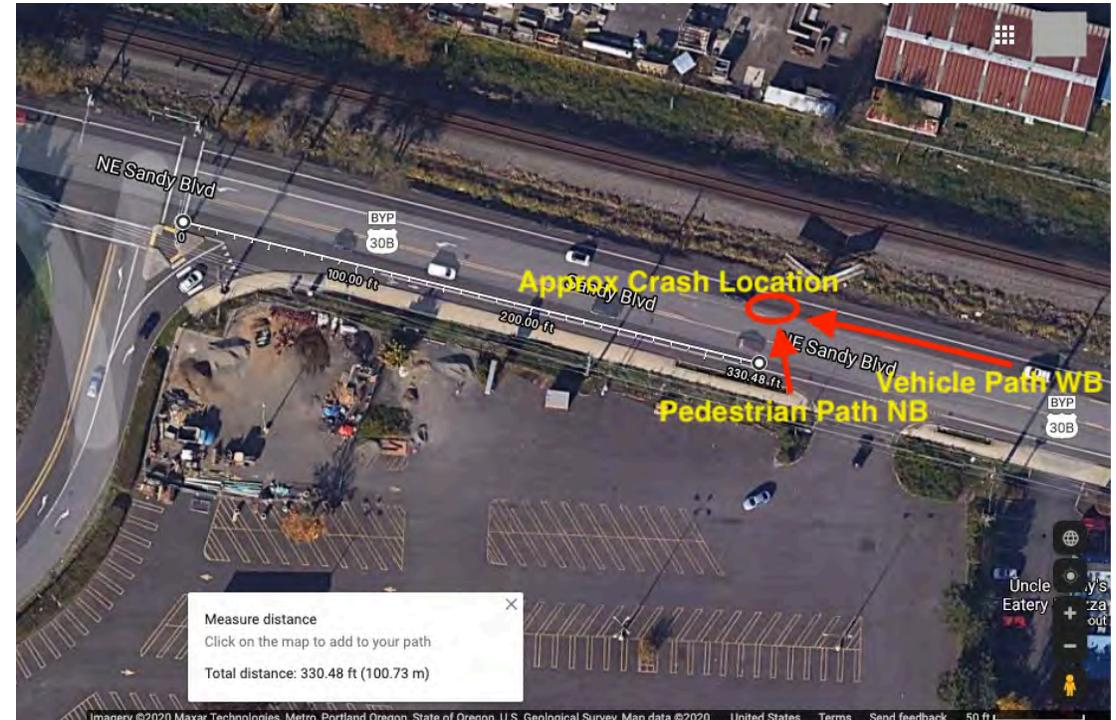
NE SANDY BLVD NEAR NE 122nd AVE 03/21/2018

The person driving was heading WB when he hit and killed the person walking in the northern most lane. Investigators did not believe he was speeding, impaired or distracted. Not accounting for bad weather and lighting conditions, the person walking was in the roadway and in the person driving's view for approx. 9.5 seconds.

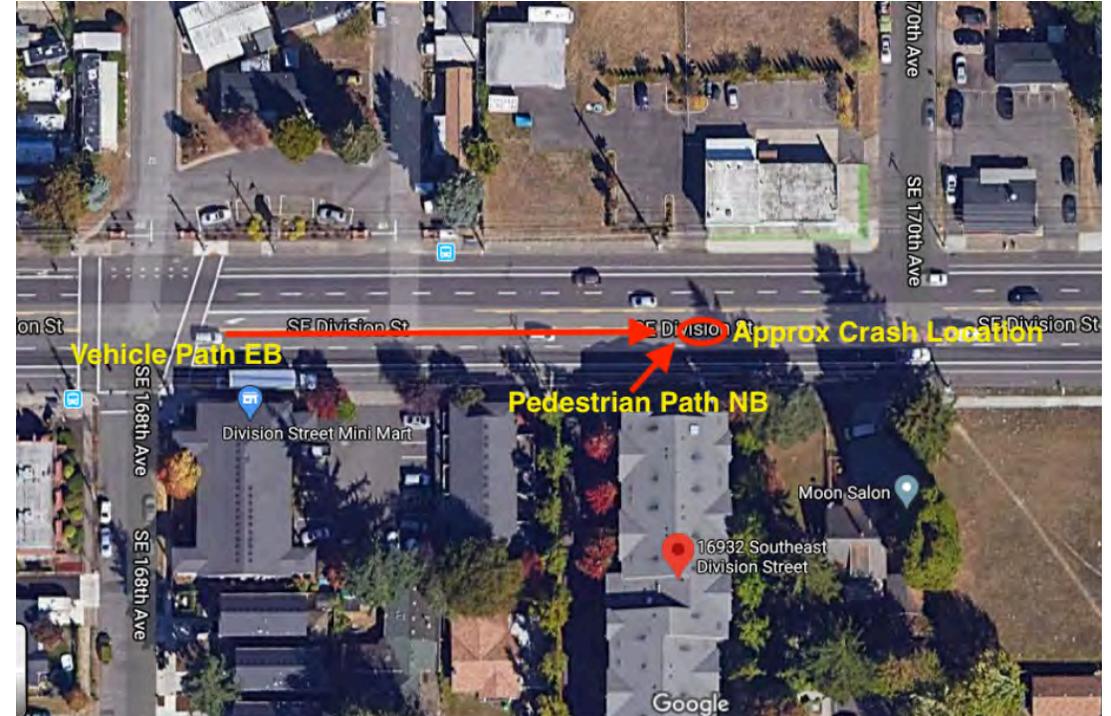
SE DIVISION ST NEAR SE 169th AVE 05/08/2018

The person driving was heading EB on Division and hit and killed the person walking in the #1 inside lane. The person walking was in the roadway and within view of the person driving for approx. 13 seconds prior to the collision.

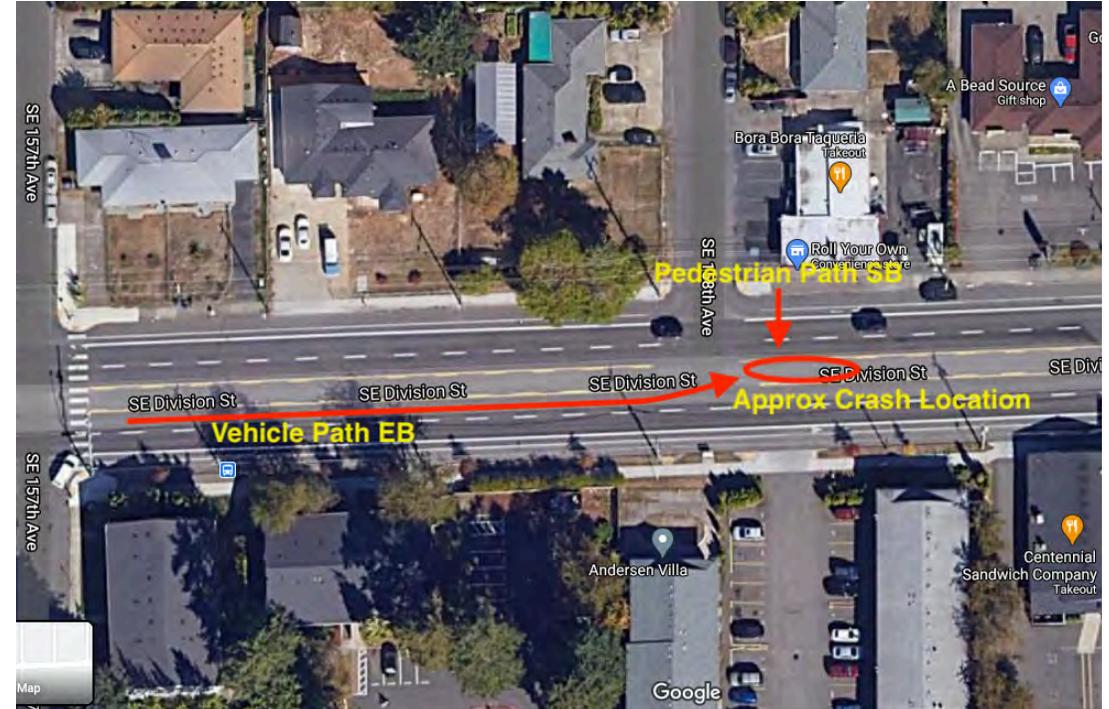
SE DIVISION ST AND SE 158th AVE 07/23/2018

The person driving was heading EB on Division in the #1 inside lane. He said that he smelled diesel from the vehicle in front of him and veered left into the center turn median to leave Division St. when he hit the person walking with the driver side of his vehicle.

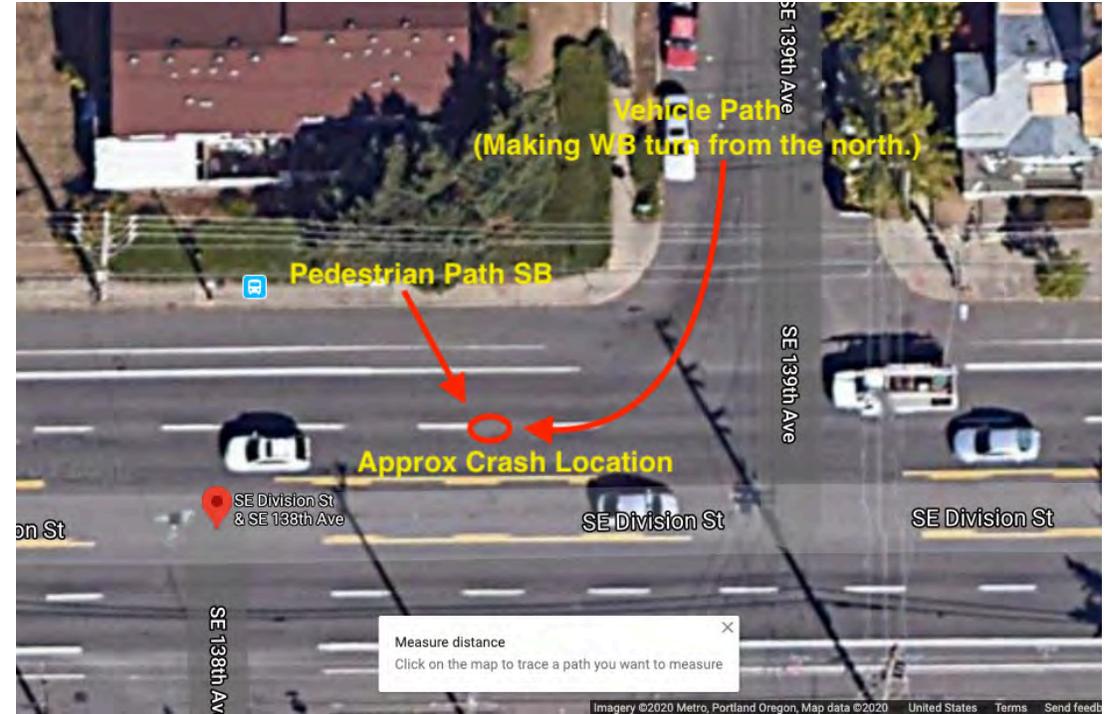
SE DIVISION ST AND SE 139th AVE 10/10/2018

This was hit-and-run. The person driving (unidentified) was coming from the north intersection making a right hand WB turn onto Division St. when they struck and killed the person walking near the dividing line of lanes #1 and #2. The person driving stopped after the crash, spoke to witnesses and others who had stopped, but left the scene before police arrived. It is not known whether the person driving stopped at the stop sign on 139th Ave. before making the right turn.

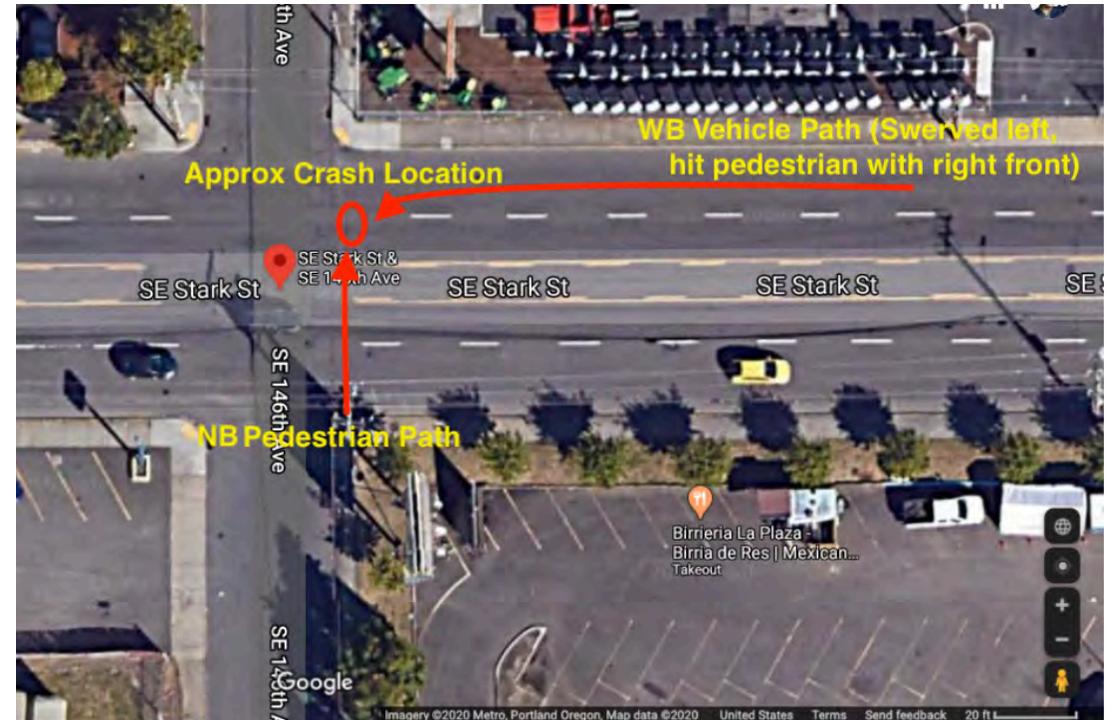
SE STARK ST AND SE 146th AVE 10/26/2018

The person driving was heading WB in the #2 outside lane. He swerved left toward the #1 inside lane in an effort to avoid the person walking but hit and killed him in the crosswalk. The person driving was legally intoxicated (alcohol .10 BAC, hydrocodone, and marijuana). Police determined Driver A-pillar sightline obstruction was also a possible factor along with lighting glare from a large business sign on the NE corner of the intersection.

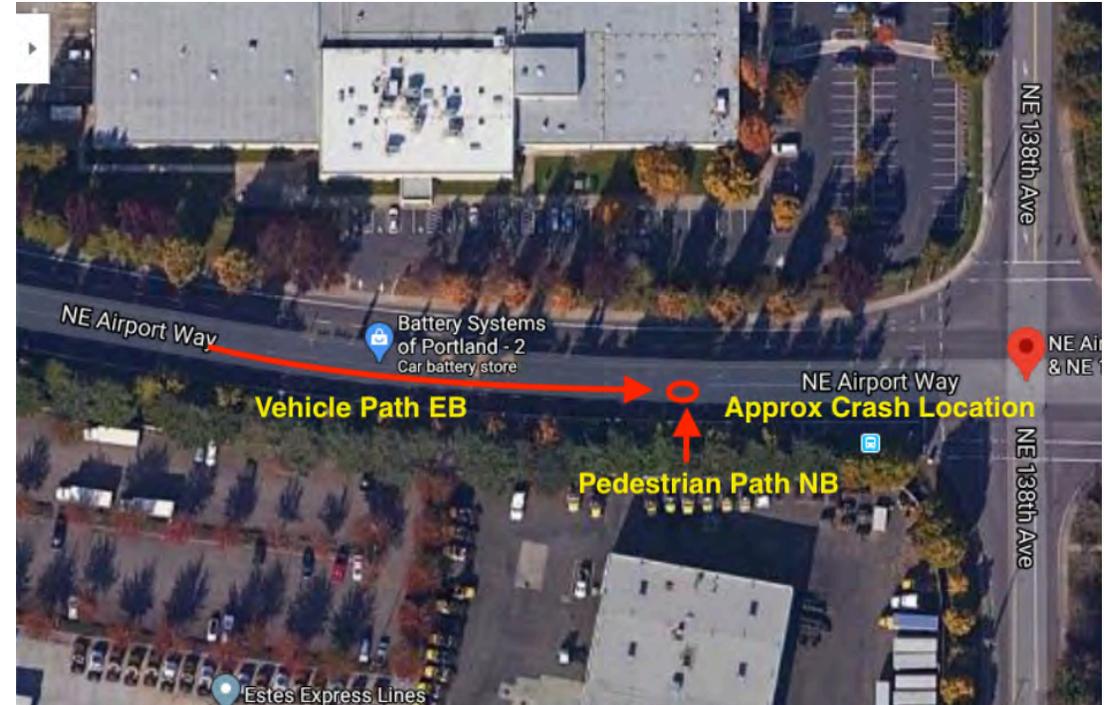
NE AIRPORT WAY NEAR NE 138th AVE 11/13/2018

The person driving was travelling EB from a stop at the signal approx. 3446' to the west at 122nd Ave. The person driving hit and killed the person walking in the #1 inside lane without braking. Distraction, speeding and intoxicants were not a factor. The person walking was in the roadway in view of the person driving for approx. 5.5 seconds before impact and he had adequate stopping distance (145') and time to see the the person walking and stop.

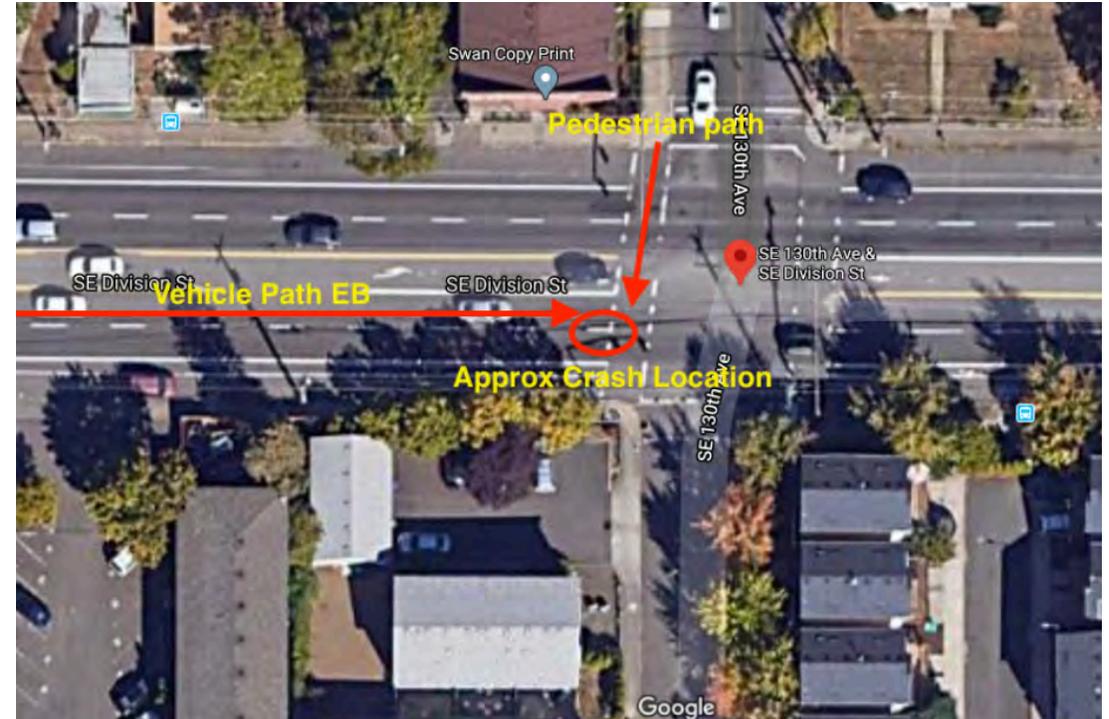
SE DIVISION ST AND SE 130th AVE 02/02/2019

This was a hit-and-run. The person driving (unidentified) was travelling EB in the #1 inside lane at 35-40 mph (witness account) where they hit and killed the person walking within the marked crosswalk, ran a red light and continued EB.

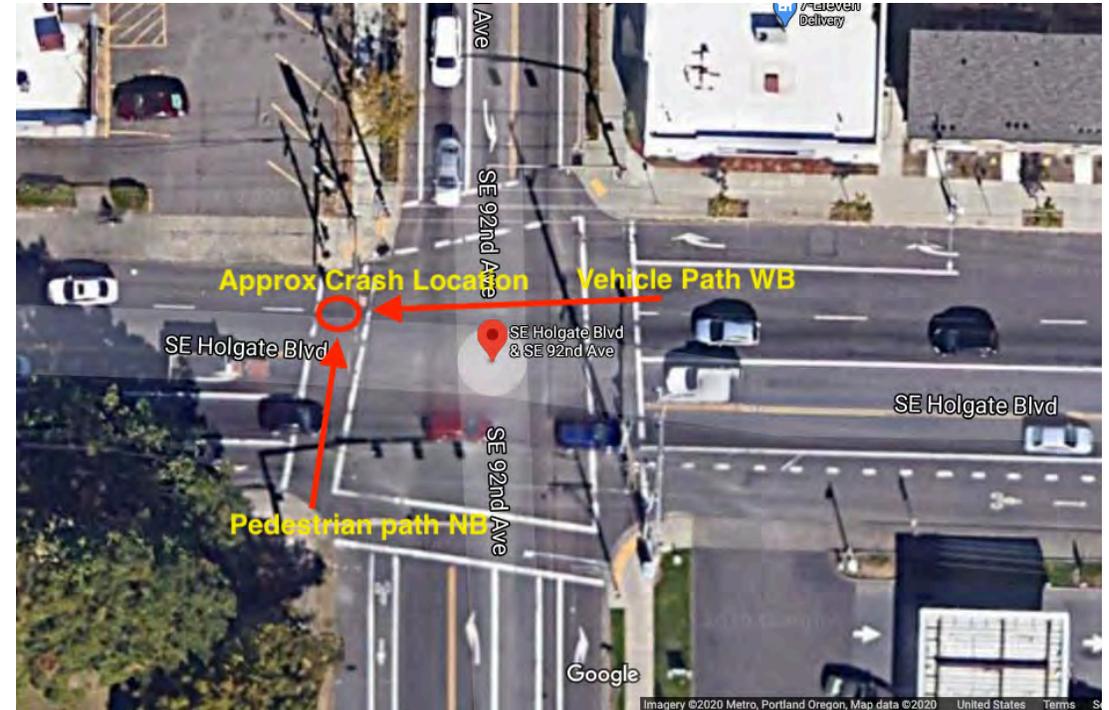
SE HOLGATE BLVD AND SE 92ND AVE 03/01/2019

The person driving was travelling WB in the #2 outside lane and drove through the green light a 36.7 mph and hit and killed the person walking in the crosswalk near the dividing for the #1 and #2 WB lanes on the west side of the intersection. Conditional sightline obstruction due to stopped traffic and a large garbage truck in the turn lane was a factor for both pedestrian and driver. Police noted that “driver error” was also a factor as a driver should not proceed through an intersection with stopped traffic and sightline obstruction at such a high speed.

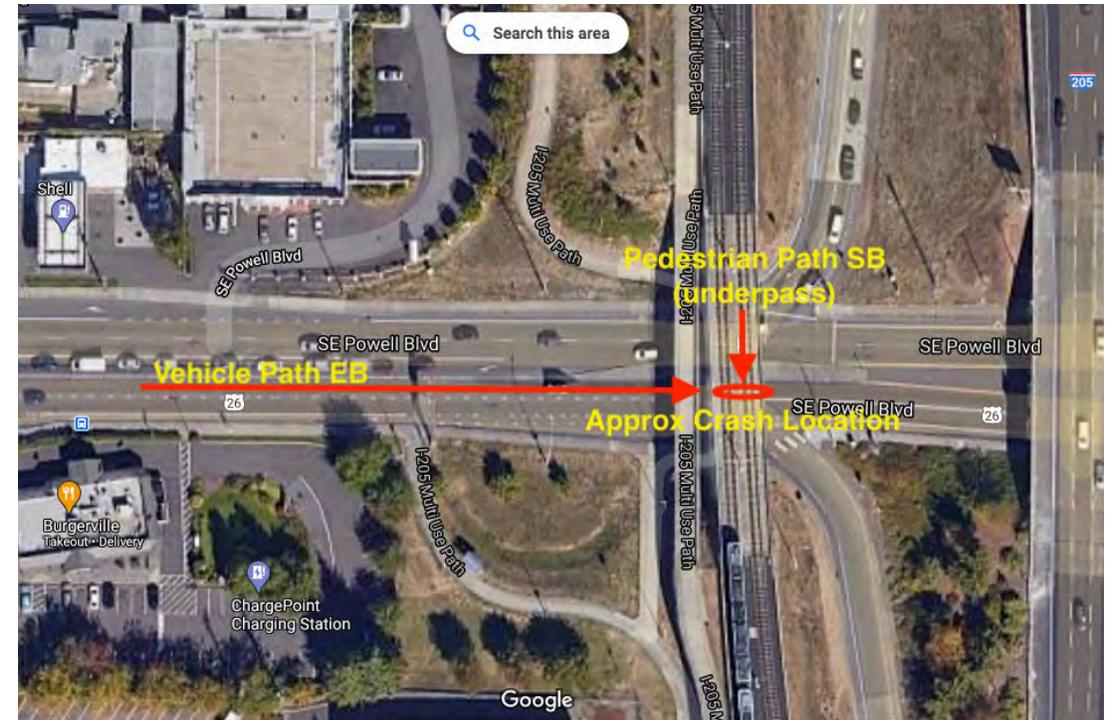
SE POWELL BLVD AT I205 04/07/2019

The person driving was travelling EB in the #1 inside lane. He said that he was travelling below the speed limit (unverified) when he hit the person walking in the #1 lane.

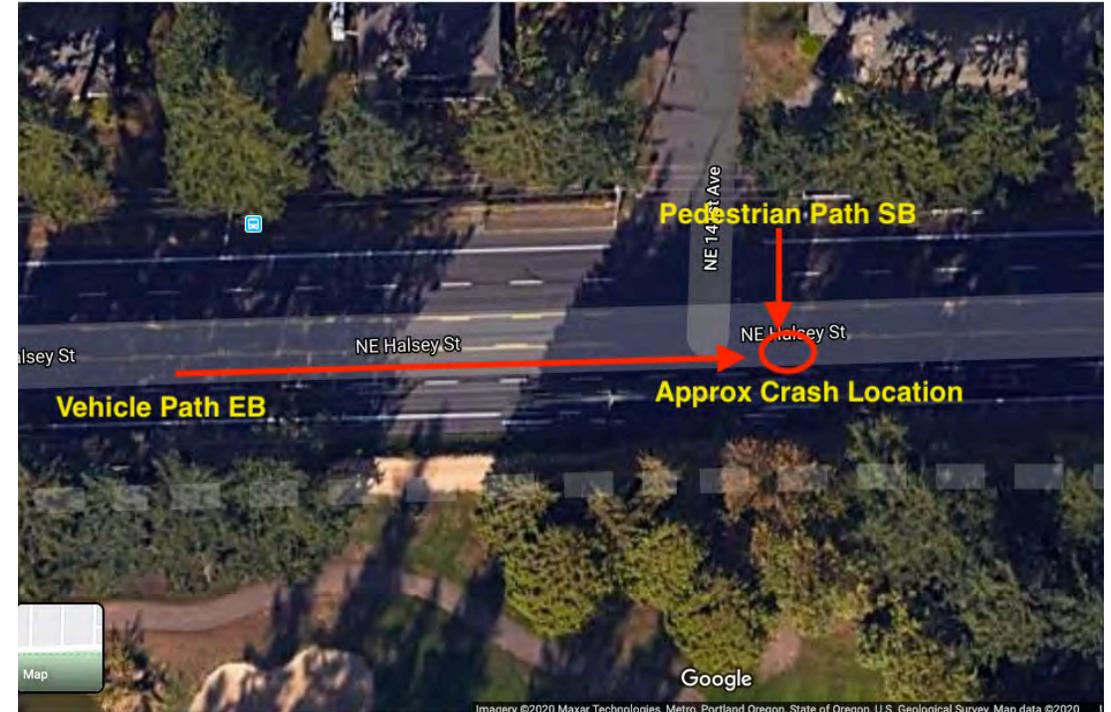
NE HALSEY ST AND NE 141st AVE 07/24/2019

The person driving was travelling home in the #1 inside lane of Halsey St. when he hit the person walking as she entered the lane. He was going 50 mph at the time of impact with the person walking according to the vehicle EDR. The person driving was found not to be legally intoxicated, but had a BAC of .06% and the presence of THC in his blood according to the toxicology report.

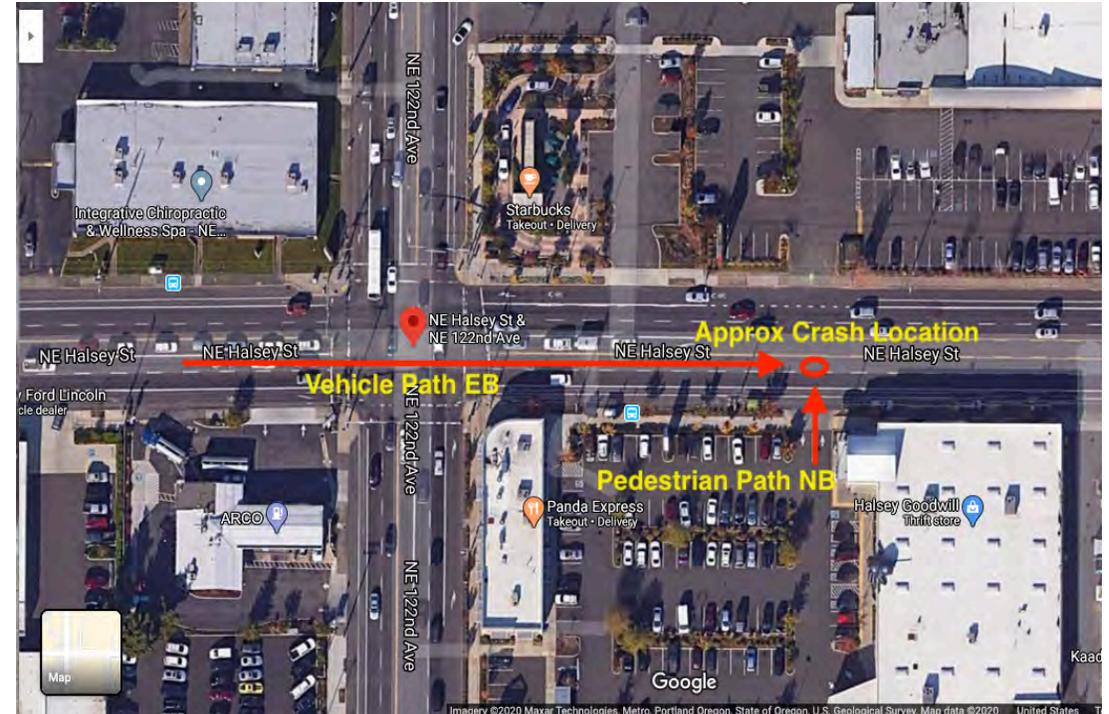
NE HALSEY ST NEAR NE 122nd AVE 12/27/2019

The person driving was proceeding through the green light at 122nd Ave. heading EB in the #1 inside lane when she struck and killed the person walking in the #1 lane.
