FATAL PEDESTRIAN CRASH REPORT
CRASH REVIEWS

PORTLAND, 2017-2019

This report provides information relating to each of the 48 fatal pedestrian crashes in Portland, Oregon from 2017-2019.

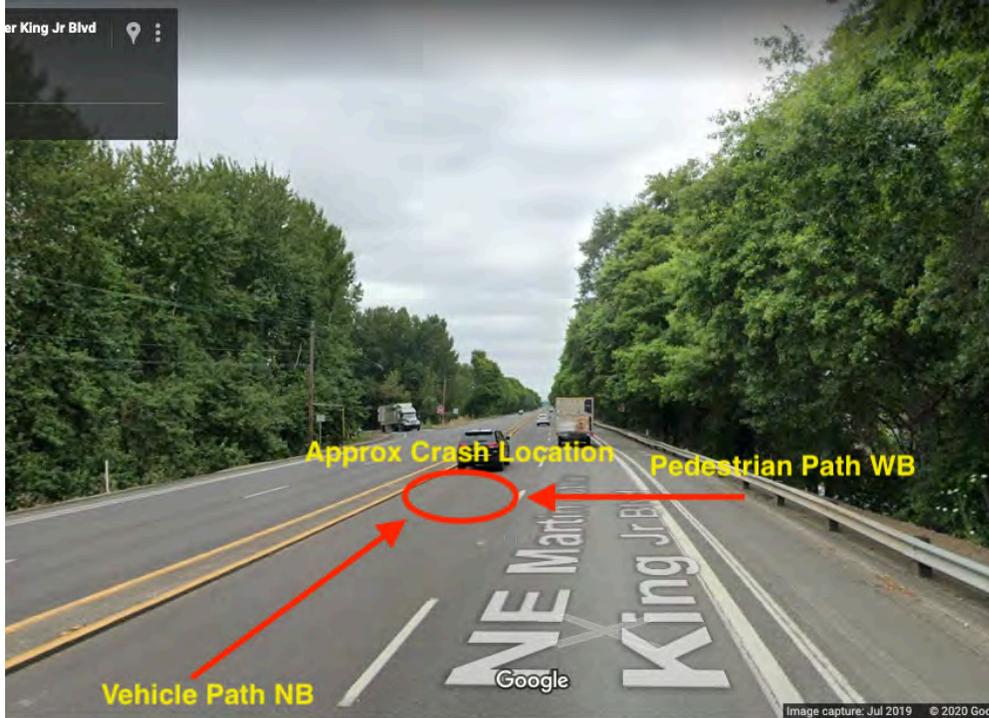
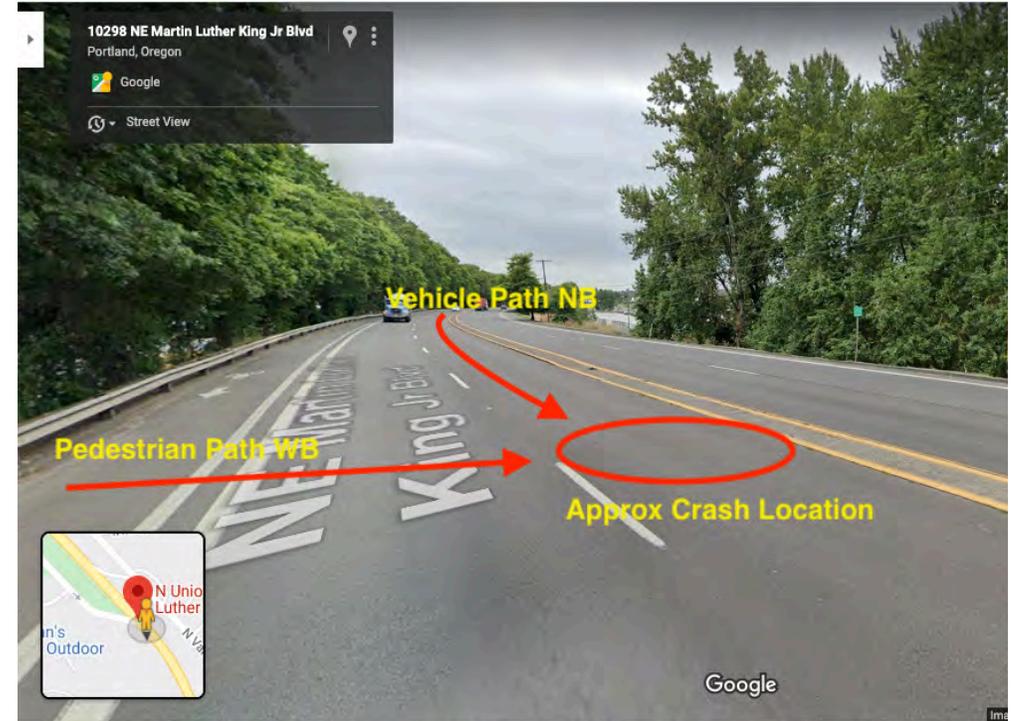
N MARTIN LUTHER KING JR BLVD AND N UNION CT 05/12/2017

The curve at the crash location provided the person driving approx. 791 feet to see the person walking (7.6 seconds at 70 MPH; 9.8 seconds at 55 MPH). This would be considered sufficient based on AASHTO minimum recommended sight distances.

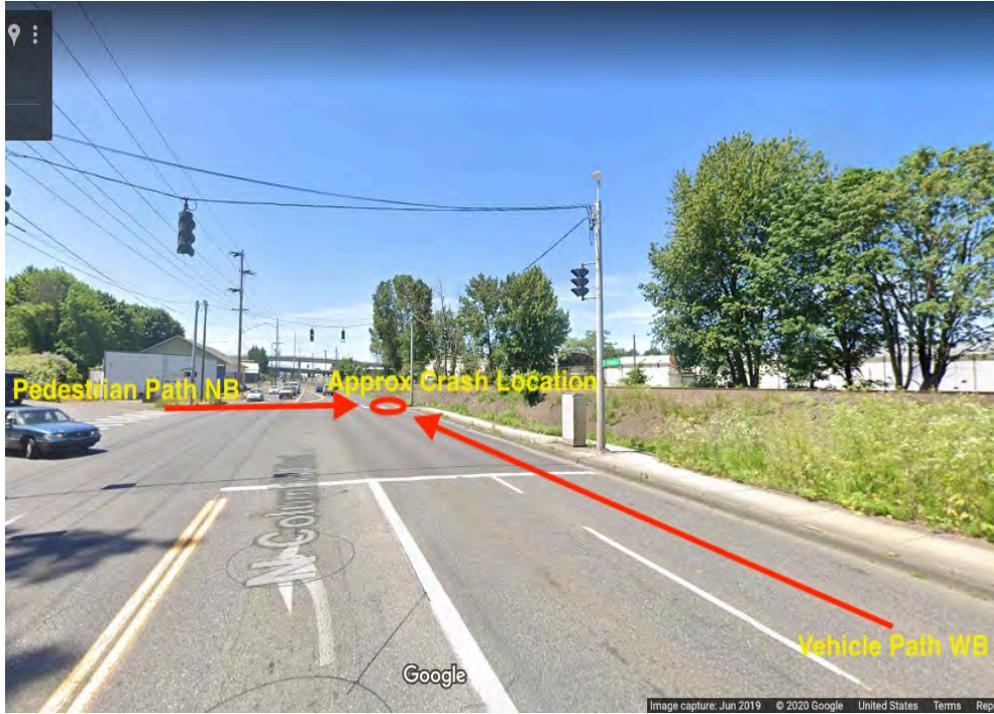
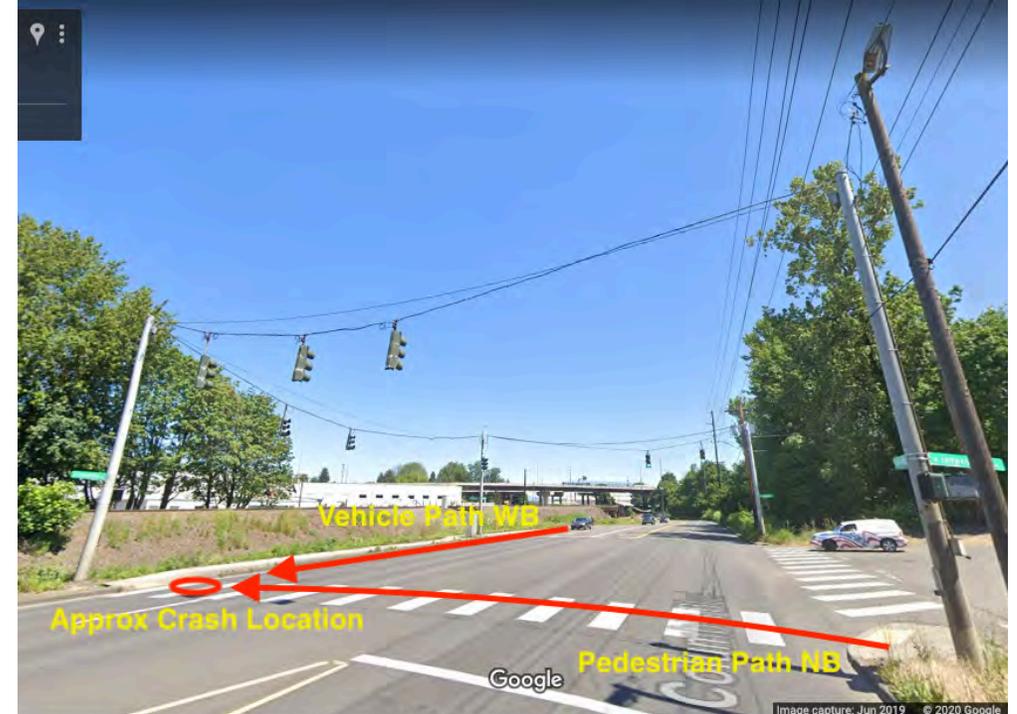
N COLUMBIA BLVD AND N INTERSTATE PL 09/25/2017

Possible Inadequate Lighting

There are no streetlights on north side of the crash intersection. A single streetlight is located at the intersection on SE corner (115' from the location in the west crosswalk where crash occurred). Nearest other streetlights on the north side of the road are 450' east and 120' to the west. PBOT Appendix K guidelines recommend 1.0 Average Maintained fc, 3 Uniformity Ratio.

There are well-worn "goat paths" on the north and south sides of Columbia showing regular pedestrian use despite lack of sidewalks. Paved sidewalks are needed to safely accommodate pedestrian access to nearby employers, other businesses and transit.

63' curb-to-curb. Recommend refuge island on the west side of the intersection at this location.

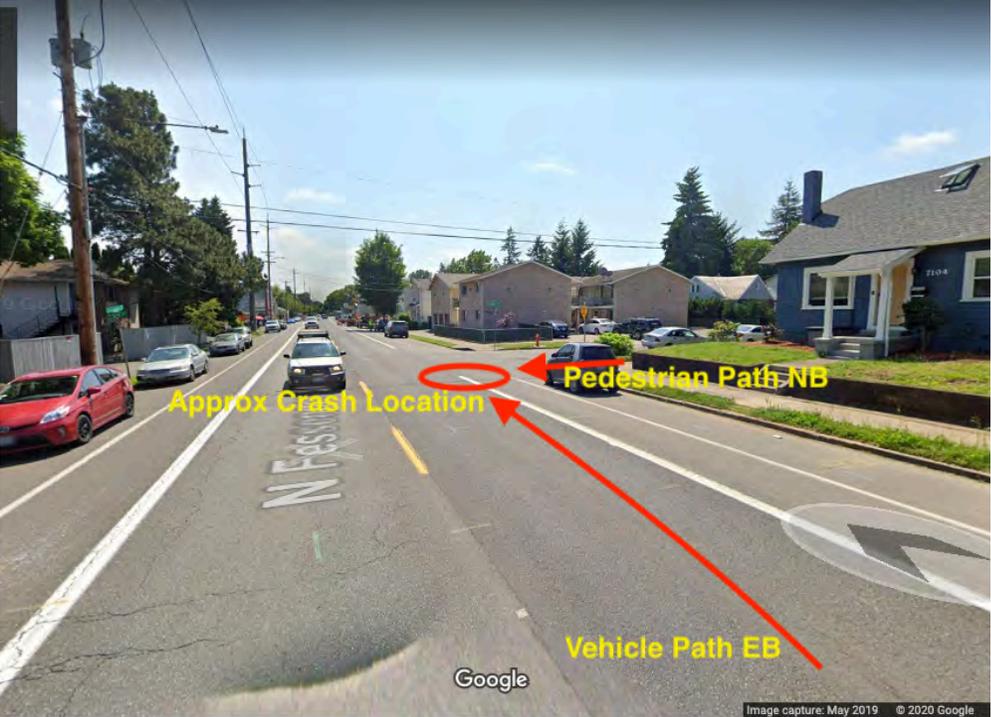
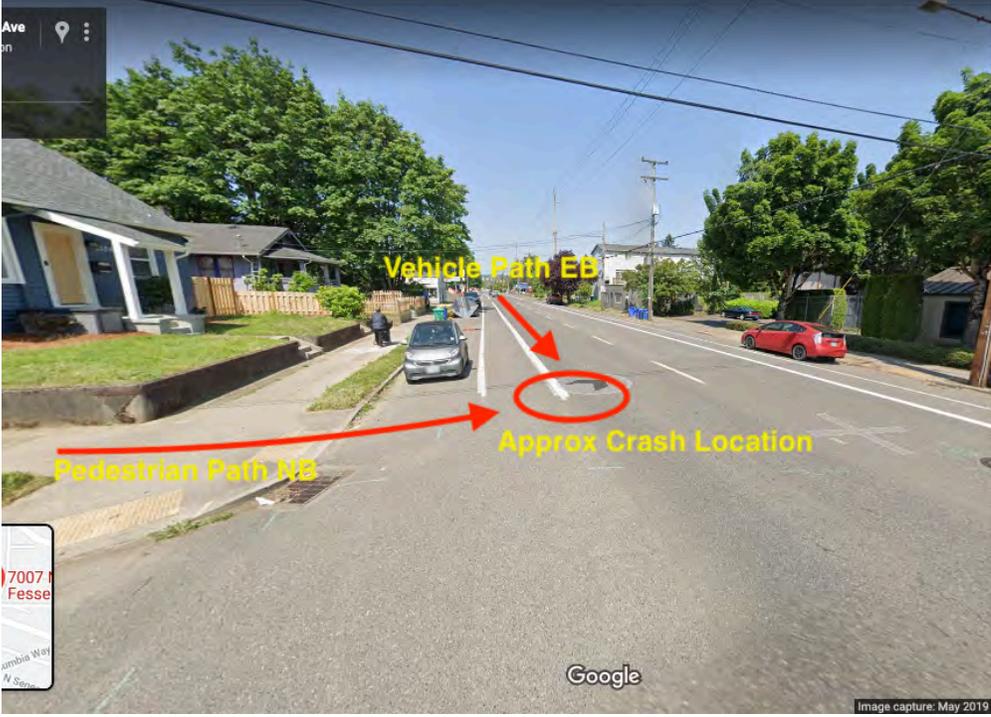
N FESSENDEN ST AND N ALMA AVE 11/26/2017

Other: Possible Inadequate Lighting

Though there was a streetlight on the direct opposite side of the road from where Mr. Ramsey was hit and killed, there are no street lights along the entire south side of Fessenden on this stretch. PBOT literature states that streets over 48' should have lights on both sides. Fessenden is 54' from curb-to-curb at the crash location. Engineering review is needed to determine whether street lights should be added to the south side of the corridor. PBOT Appendix K guidelines recommend 1.2 Average Maintained fc, 3 Uniformity Ratio at the intersection of Fessenden St. and Alma Ave.

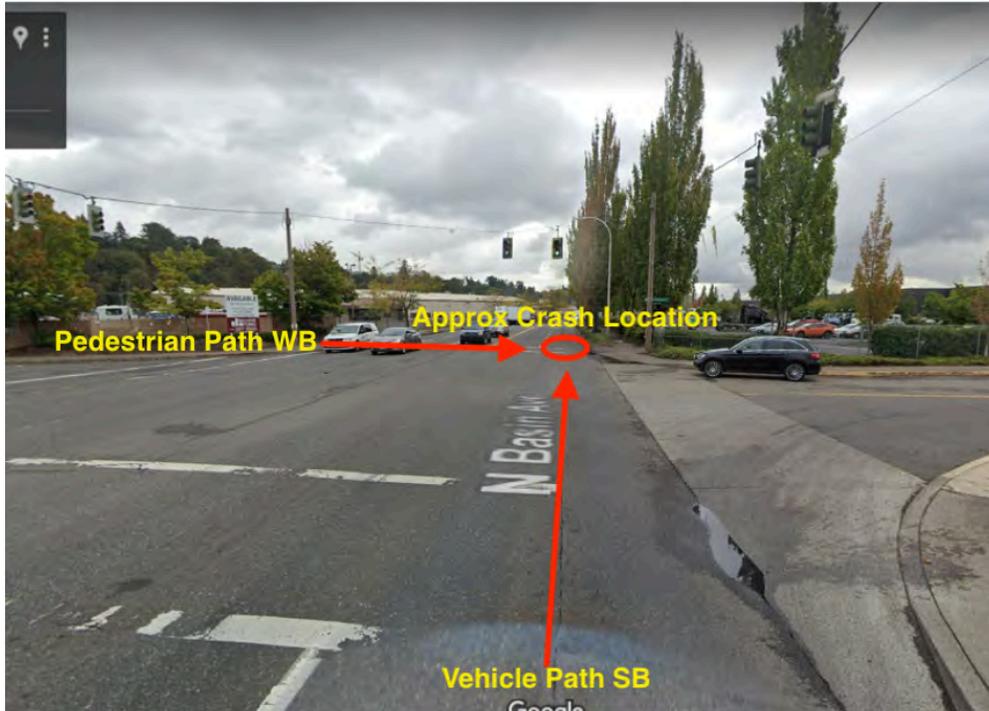
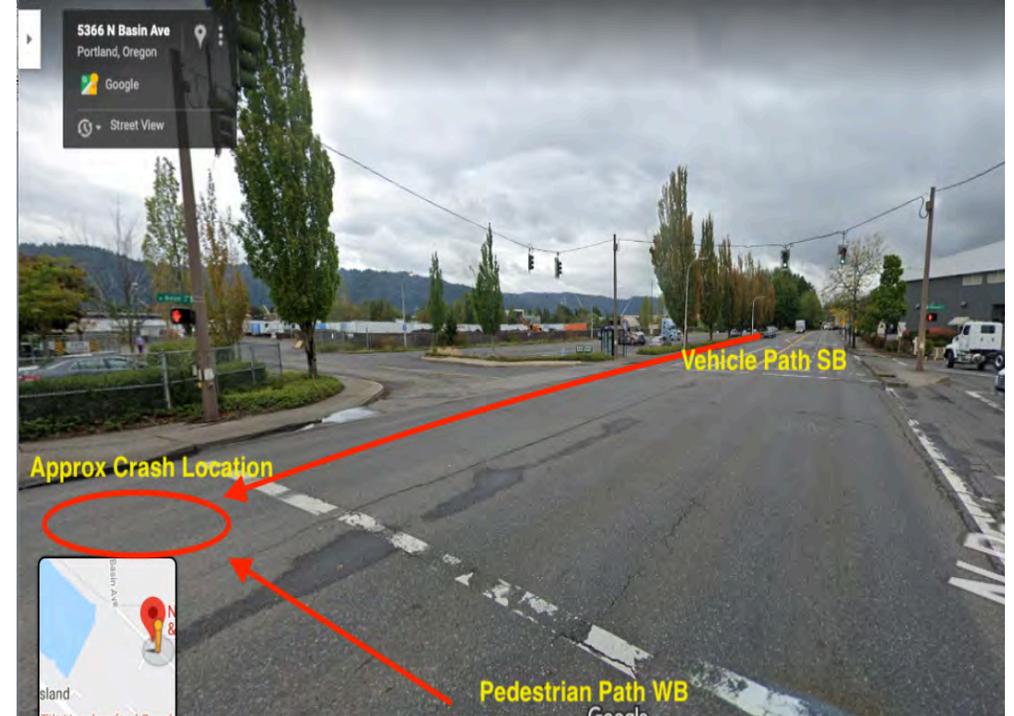
N BASIN AVE AND N EMERSON ST 03/23/2018

The person walking was an Older Adult. Confirm that signal timing is long enough to accommodate slower walking pace of Older Adults and those with mobility issues. It is unknown whether the person walking failed to use the push button walk signal and crossed against the light, or whether he failed to make it all the way across the last lane before the light turned against him.

Other: Possible Inadequate Lighting

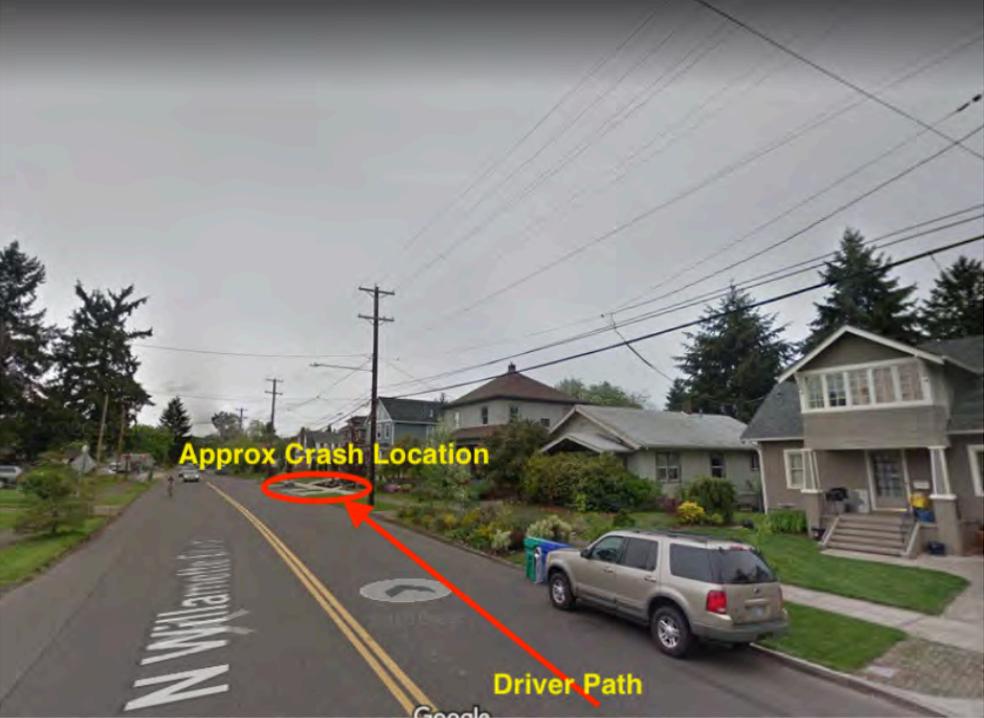
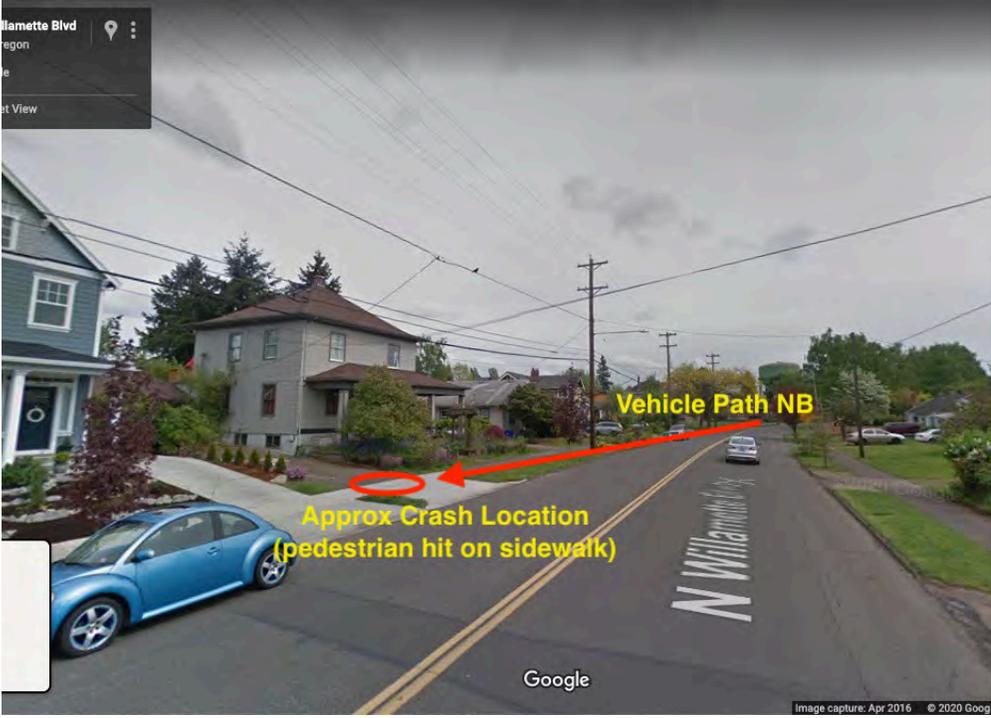
N WILLAMETTE BLVD AND N BUCHANAN AVE 11/15/2018

Willamette Blvd is a Major Collector, with many people on bicycles, and walking, running and rolling. (This is reflected in in the police report as well.) There is a long unimpeded 1.4 mile stretch from N. Portsmouth Ave. in the south to N Richmond Ave. in the north with no traffic signals, stop signs or traffic calming infrastructure to reduce vehicle speed. Extreme speed is a daily occurrence with approximately 12 drivers daily exceeding 45 MPH. Recommend installing speed bumps along N. Willamette Blvd.

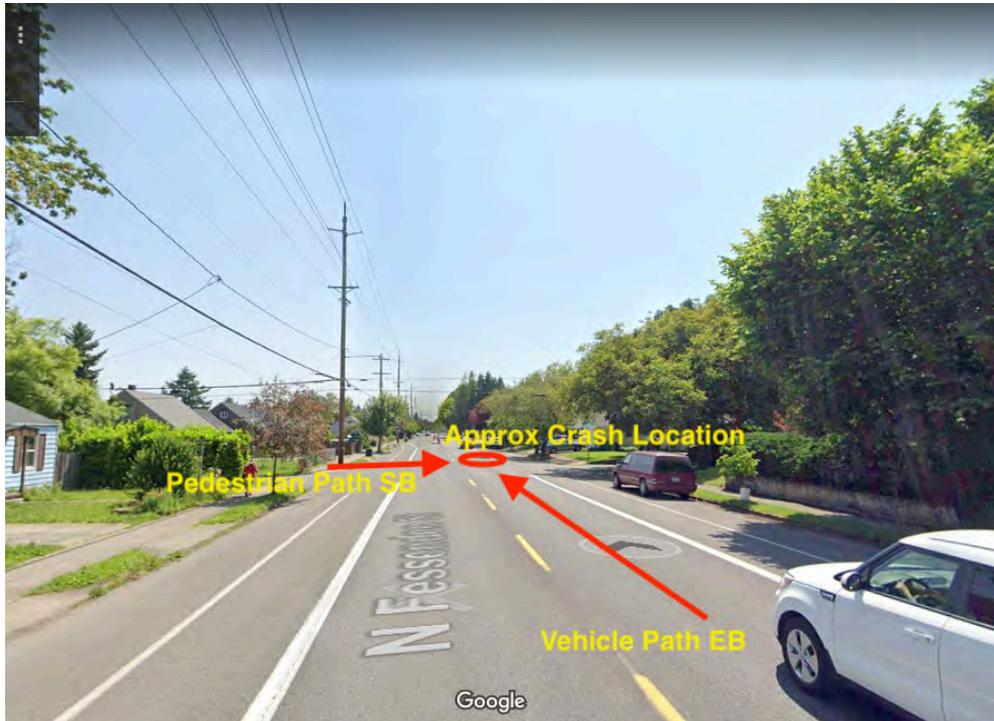
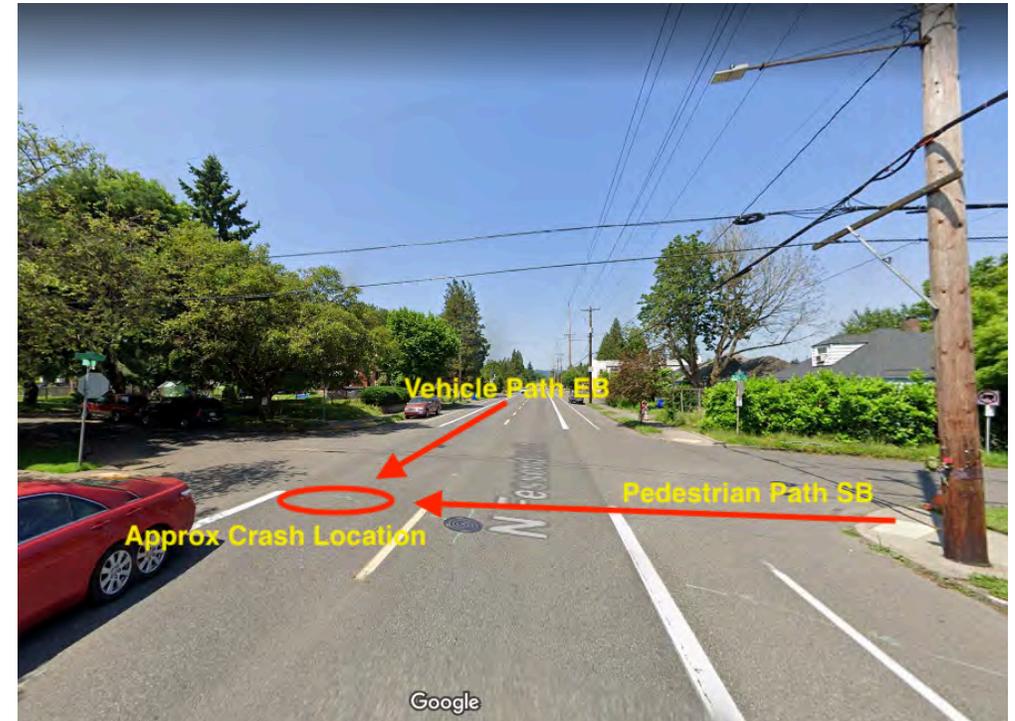
N FESSENDEN ST AND N POLK AVE 04/10/2019

This crash is remarkably similar to the 11/26/2017 crash noted above in which an (also eastbound) driver killed a person walking (also at an unmarked crossing—because they are all unmarked) just six blocks to the east of this location.

Other: Possible Inadequate Lighting

There no street lights along the entire south side of Fessenden on this stretch. PBOT literature states that streets over 48' should have lights on both sides. Fessenden is 54' from curb-to-curb at the crash location. Street lights should be added to the south side of the corridor. PBOT Appendix K guidelines recommend .8 Average Maintained fc, 4 Uniformity Ratio at the intersection of Fessenden St. and Polk Ave.

Multiple, similar pedestrian fatalities should be sufficient (and not necessary) for PBOT to comply with the speed-setting ordinance by posting N Fessenden at 20 MPH, and providing the calming and other safety improvements that needed to achieve that as the observed speed.

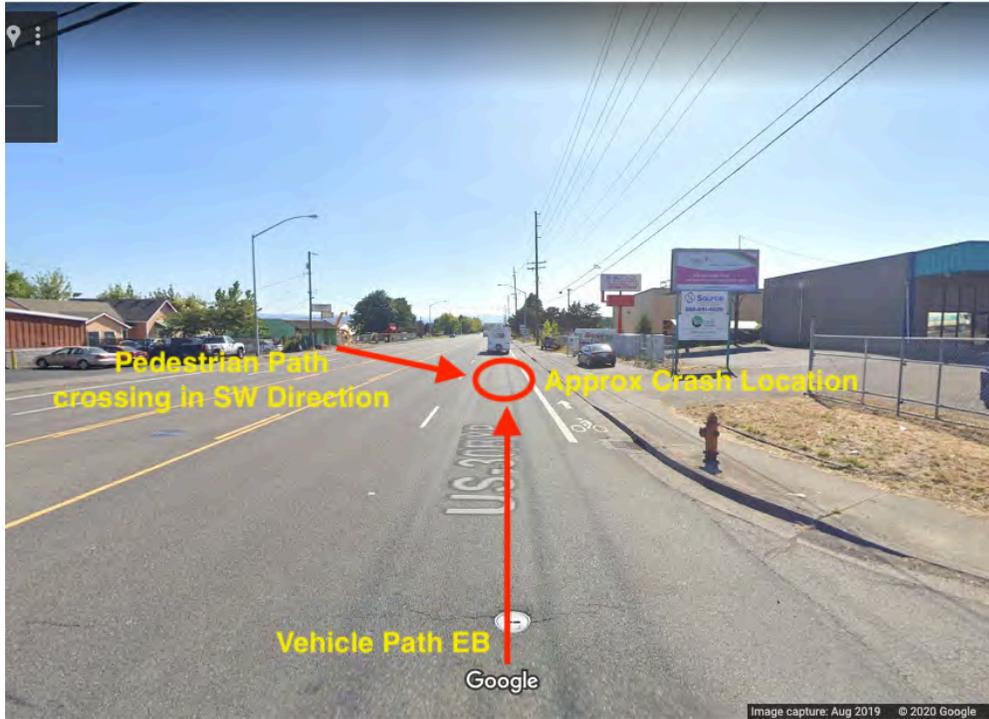
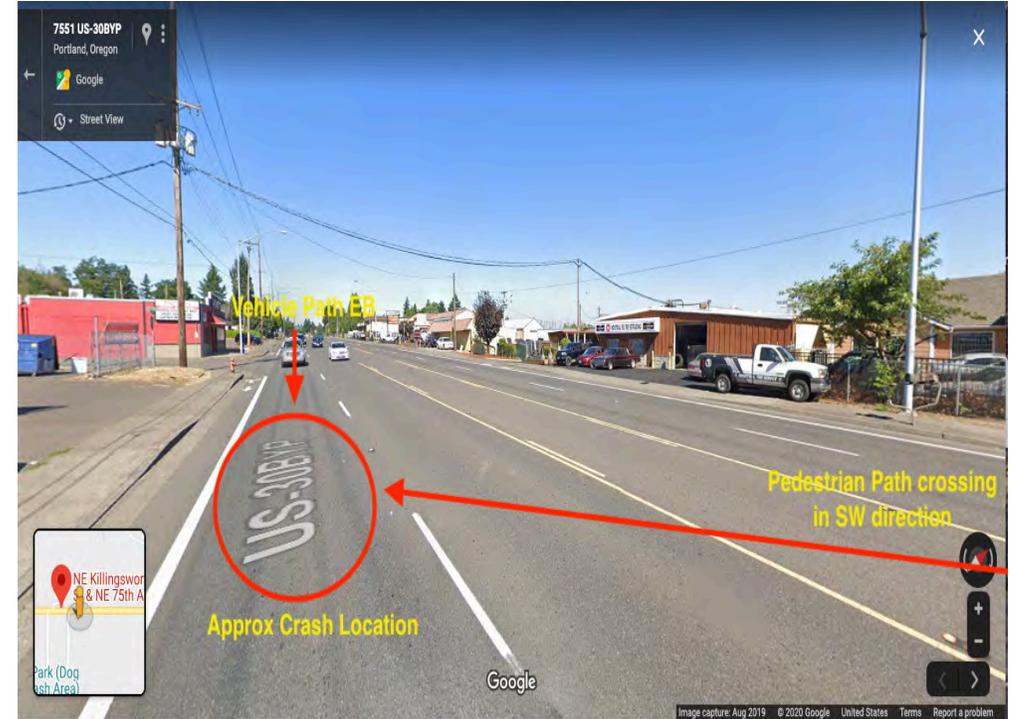
NE KILLINGSWORTH ST AND NE 75th AVE 04/30/2017

Possible Inadequate Lighting

73' curb-to-curb. Enhanced crosswalks with refuge islands recommended (if the multi-lane cross-section is preserved).

NE Killingsworth is currently posted at 35 mph. As an Arterial in a Business District, the street has a 20 mph statutory speed. Rescission of the Speed Zone Order setting a faster-than-statutory speed is recommended.

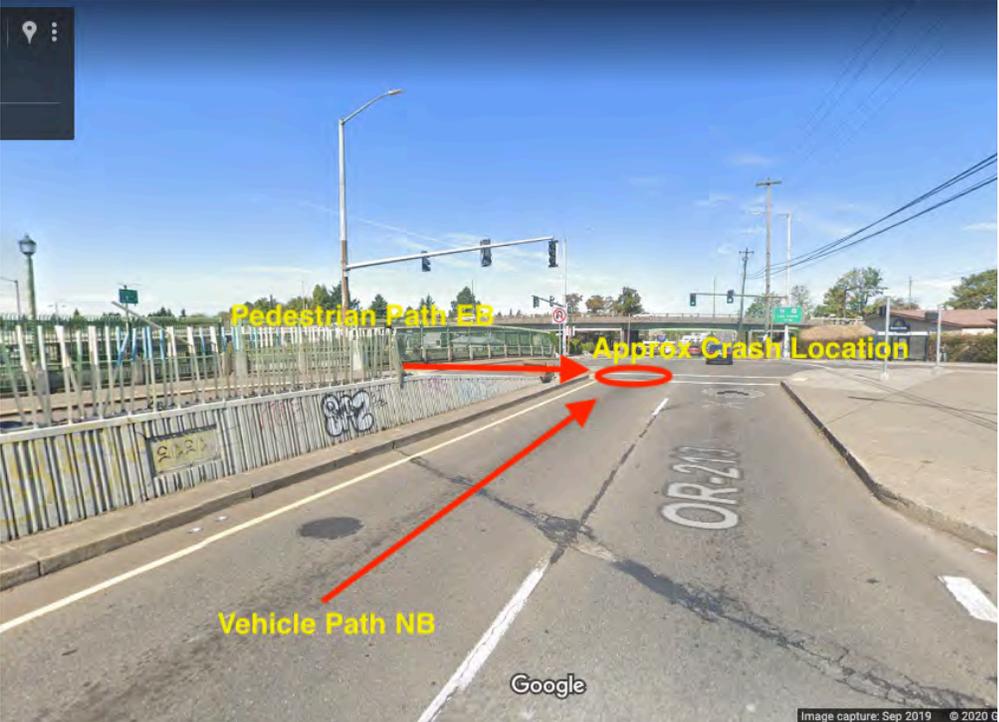
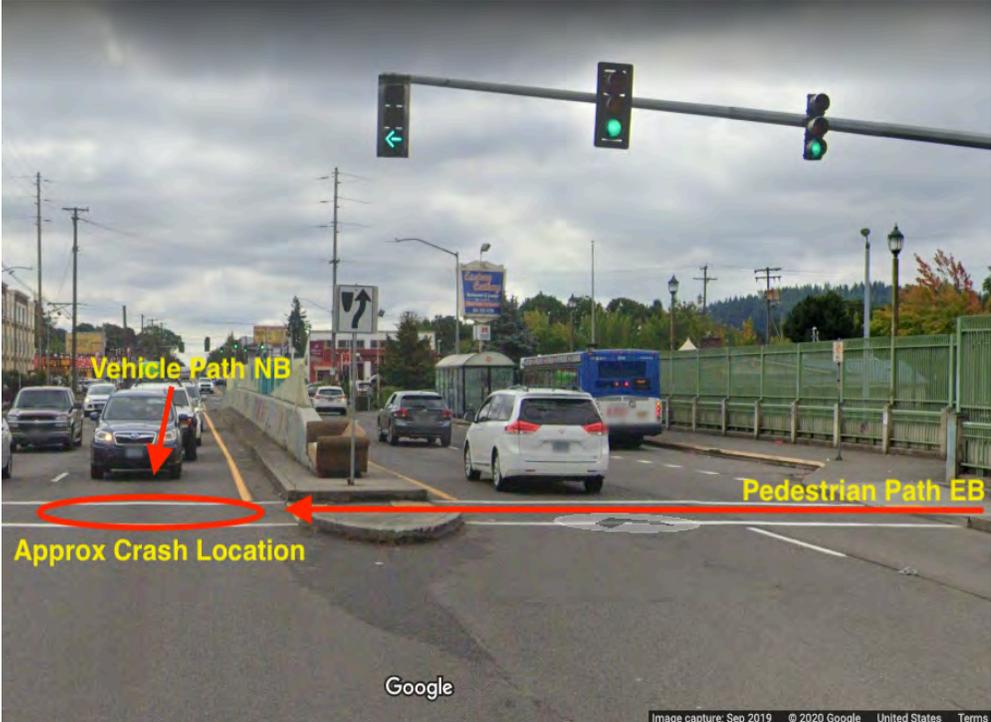
NE 82nd AVE AND NE JONESMORE ST 10/07/2017

ODOT's operation of NE 82nd Ave in this area is notoriously dangerous. There is high pedestrian traffic at the intersection due to a MAX and bus station on the east side. With speed currently set at 35 mph at this intersection there is not ample stopping time when taking into consideration the existing sightline obstruction. Recommend lowering speed to 20 mph.

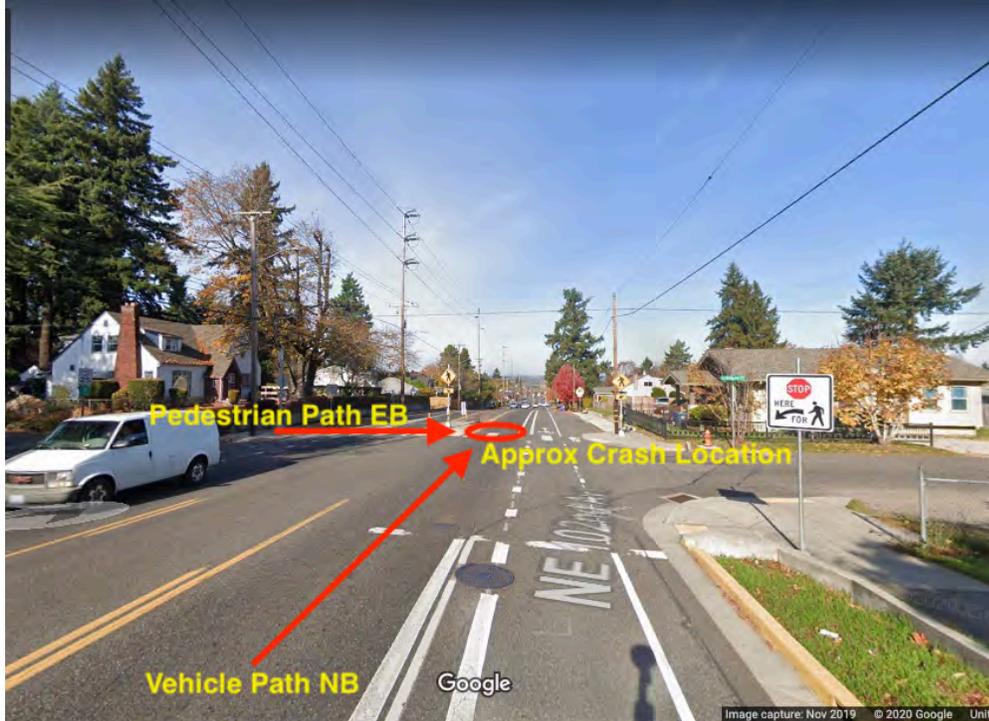
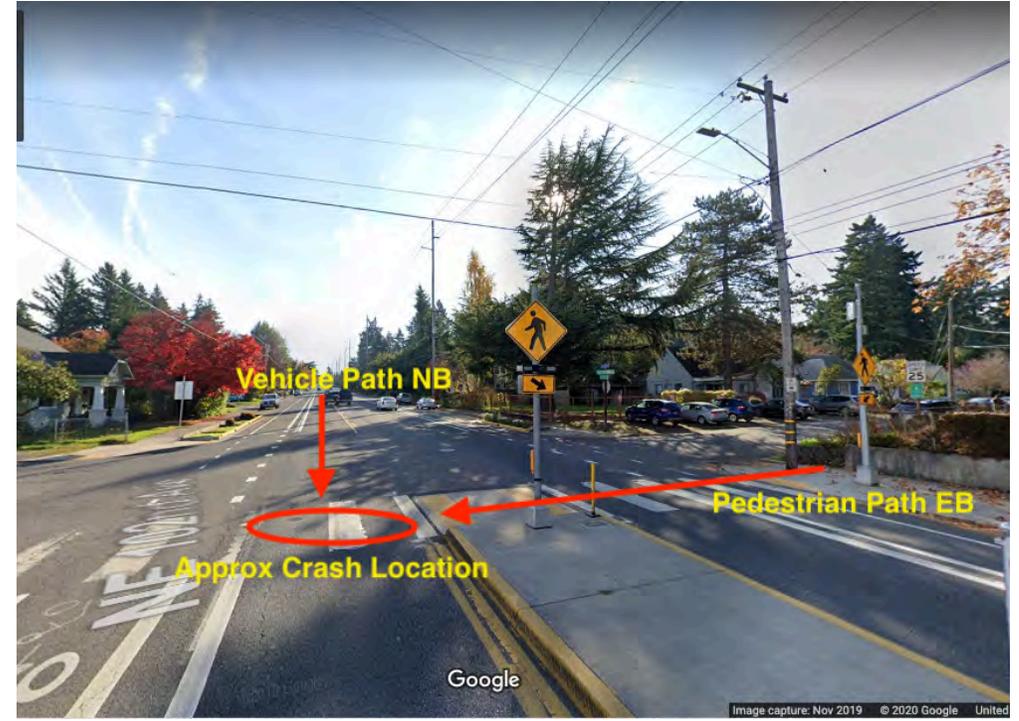
NE 102nd AVE AND NE SKIDMORE ST 11/30/2017

One overhead streetlight is on the northwest side of the crossing. The crash occurred on east side of the crosswalk. LED light spread is not very wide. Recommended that lighting levels be reviewed and streetlight be installed as needed to illuminate pedestrians from the position of approaching drivers.

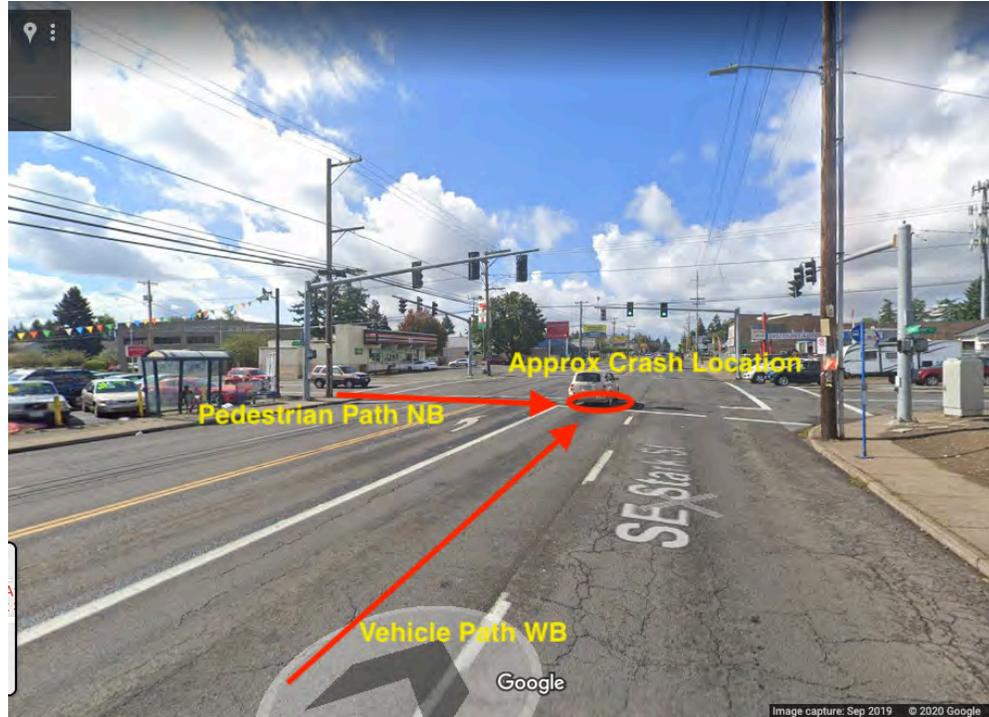
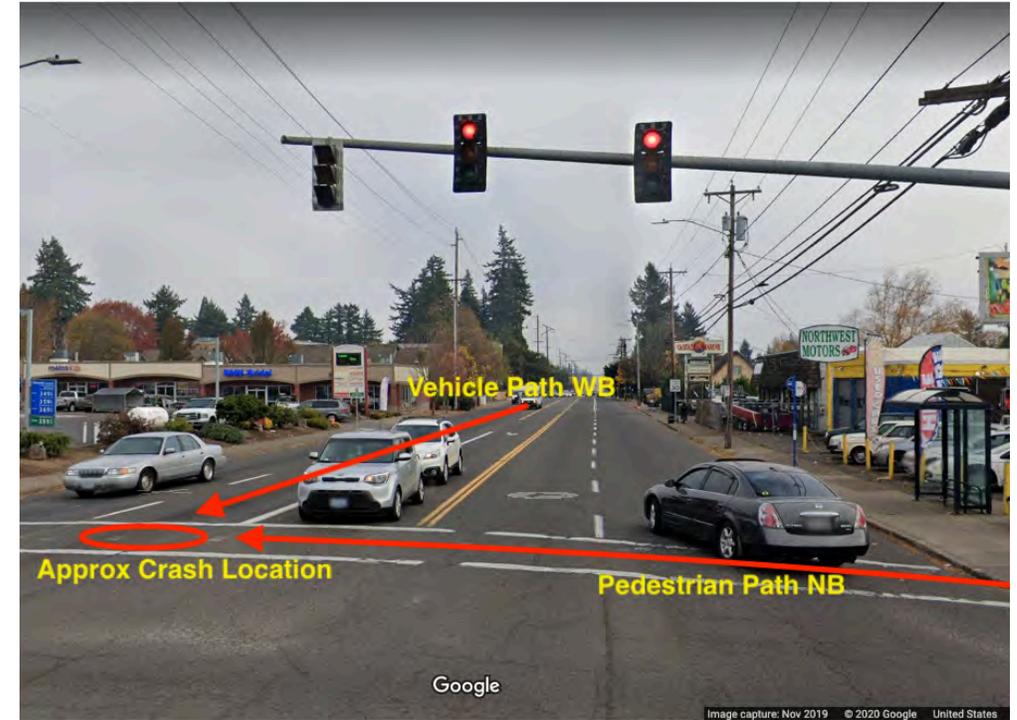
SE STARK ST AND SE 148th AVE

92.1% of drivers exceed the posted speed limit of 30 mph. 22.8% or 2791 drivers daily exceed 40 mph. Speeds are too high on this corridor. There are 3540' between the signals at 148th and 162nd Avenues with three marked crossings with refuge islands in between (one crossing has a RRFB). Though there are crossing options there is no traffic calming (speed bumps, signals, stop signs) to mediate driver speed on this long stretch. Recommend street design changes that are proven to save lives including centerline hardening, additional crosswalks, narrower travel lanes, and a potential "narrow road, wide node" street reconfiguration.

This stretch of SE Stark St. is currently at 30 mph. The crash occurred near the divider between Business District and Residence District on an Arterial, but within Business District boundaries. The speed should be statutory 20 mph. Rescission of SZO recommended.

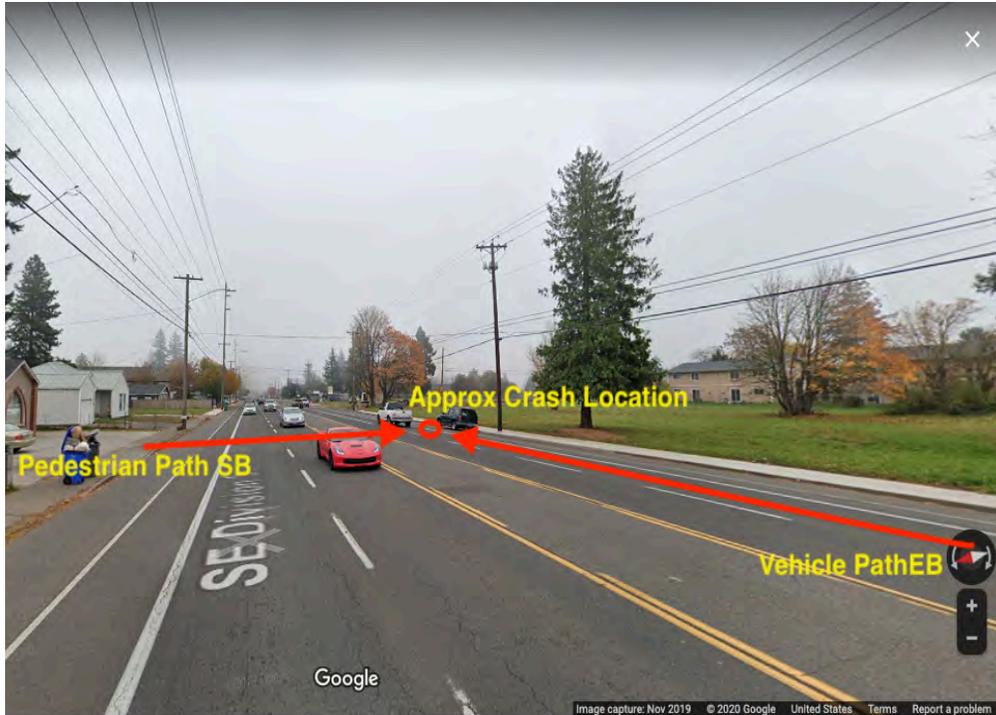
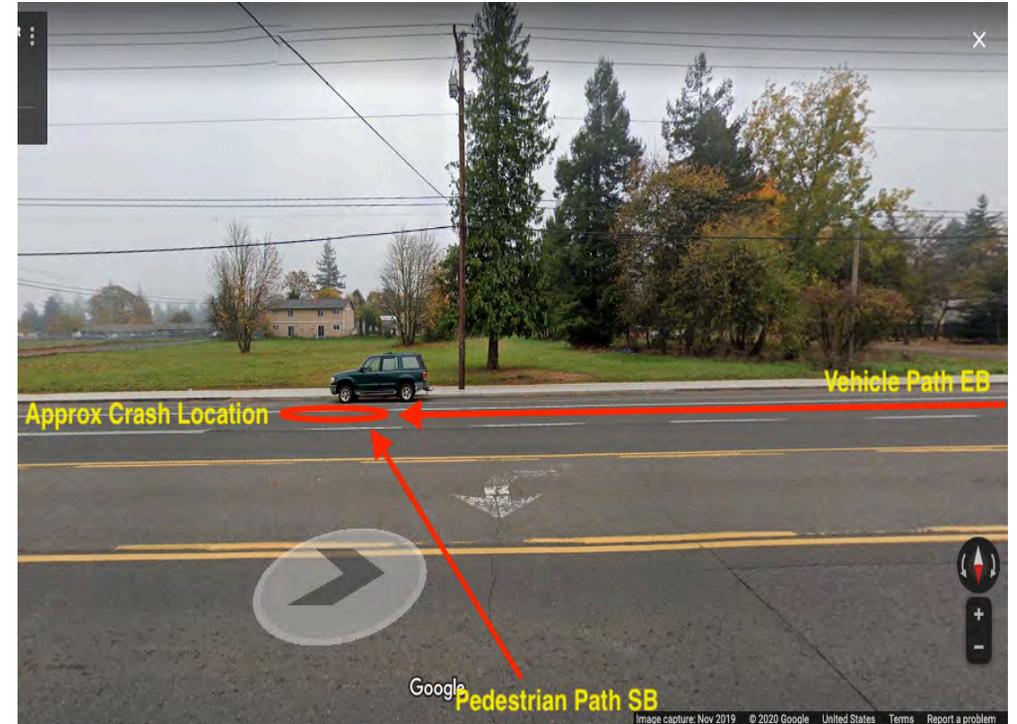
SE DIVISION ST NEAR SE 113th AVE 03/11/2018

The person driving was heading WB when he hit and killed the person walking in the northern most lane. Investigators did not believe he was speeding, impaired or distracted. Not accounting for bad weather and lighting conditions, the person walking was in the roadway and in the person driving's view for approx. 9.5 seconds.

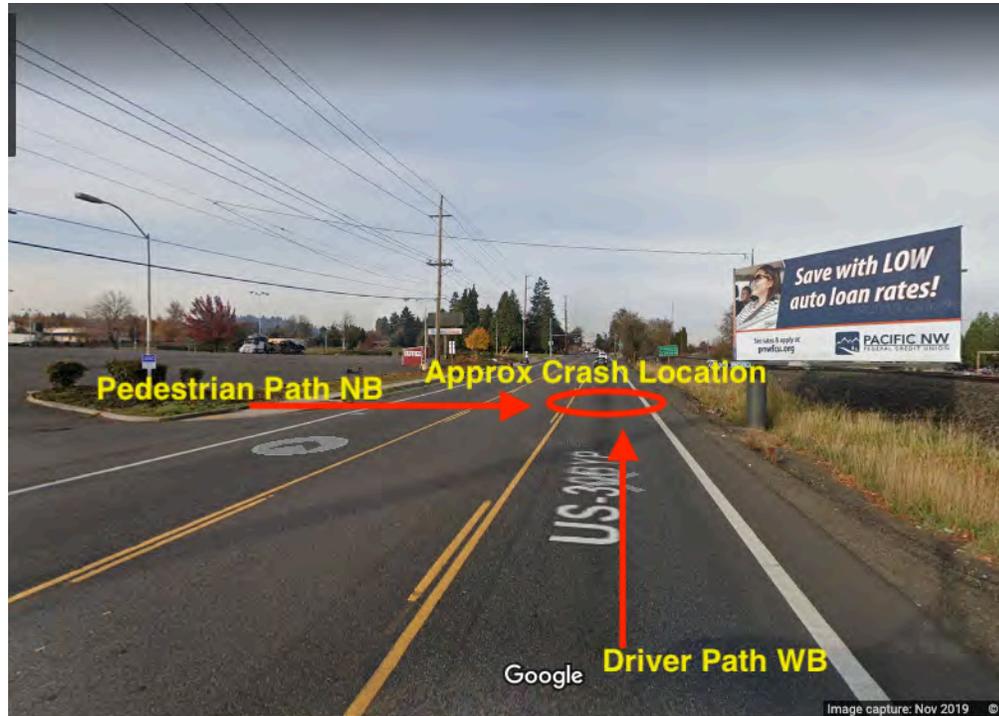
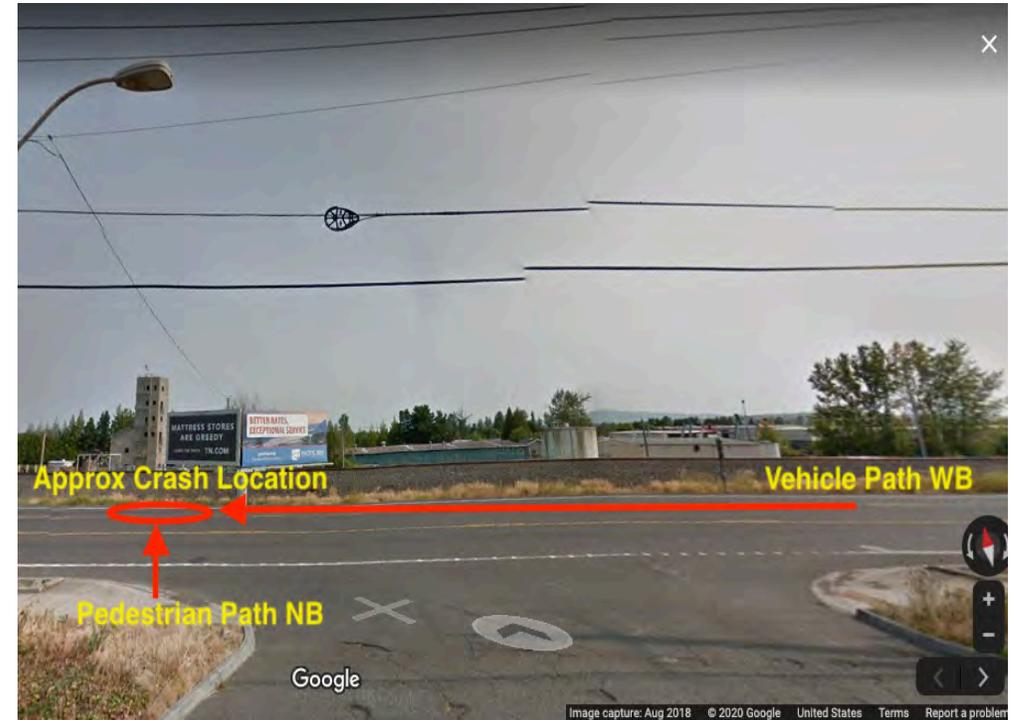
NE SANDY BLVD NEAR NE 122nd AVE 03/21/2018

Recommend exploring whether this section of road qualifies as a Business District eligible for 20mph statutory speed.

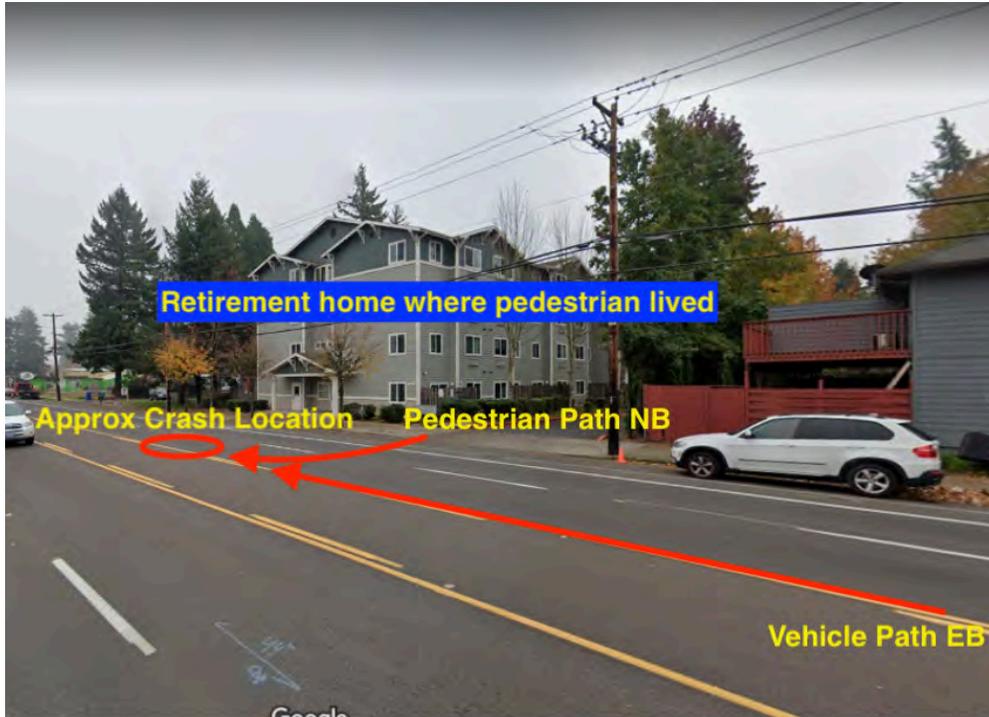
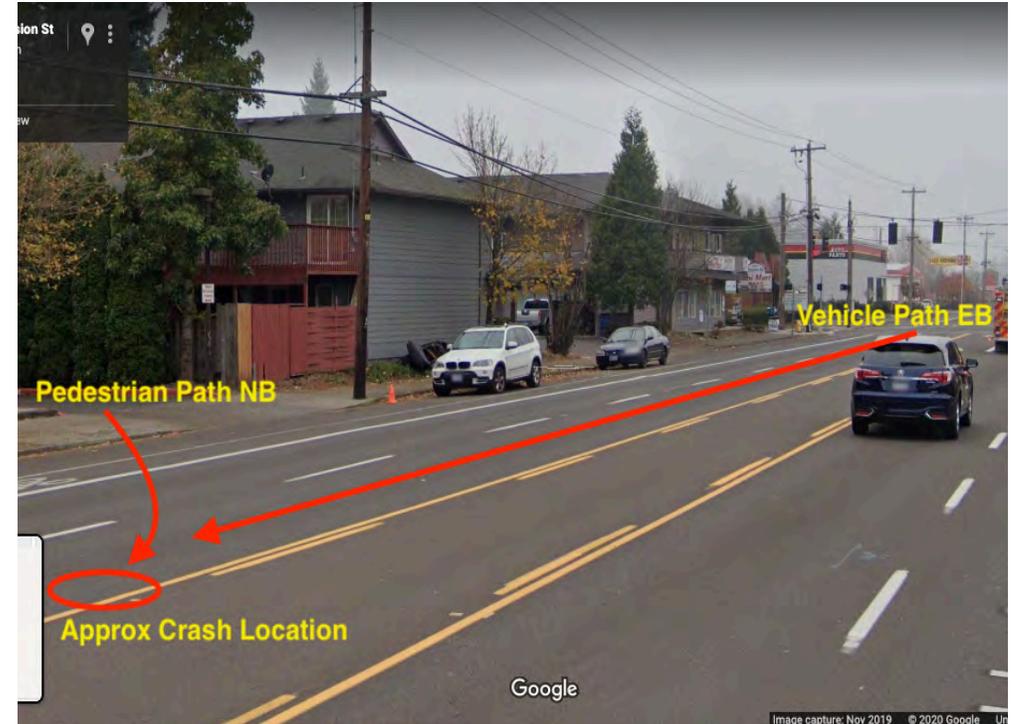
SE DIVISION ST NEAR SE 169th AVE 05/08/2018

Recommend exploring whether this section of street qualifies as Business District eligible for 20mph statutory speed.

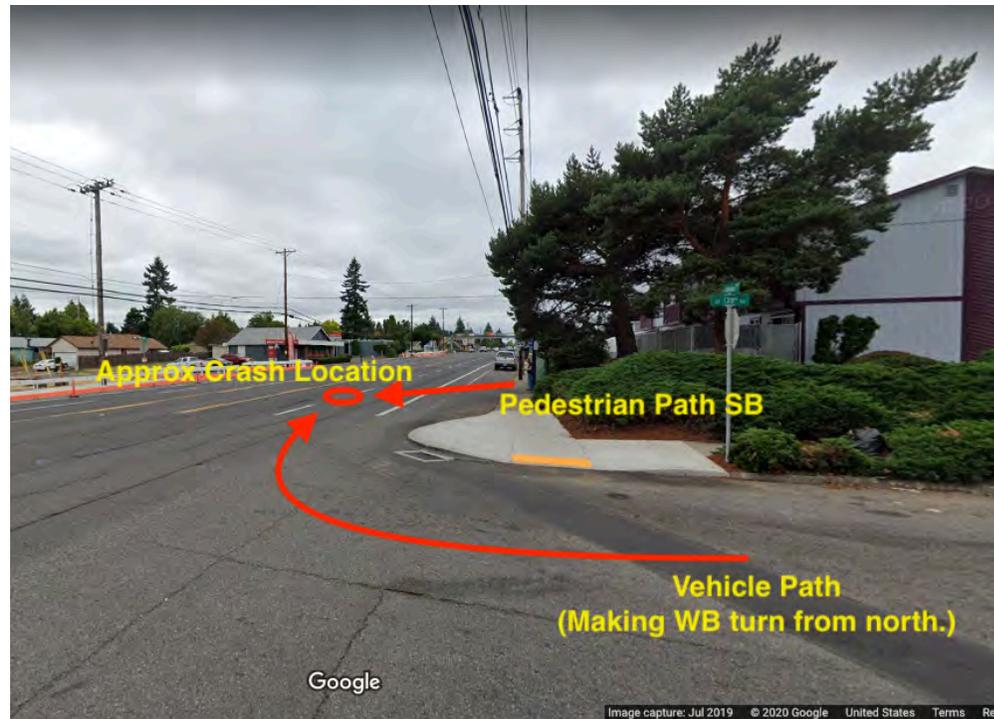
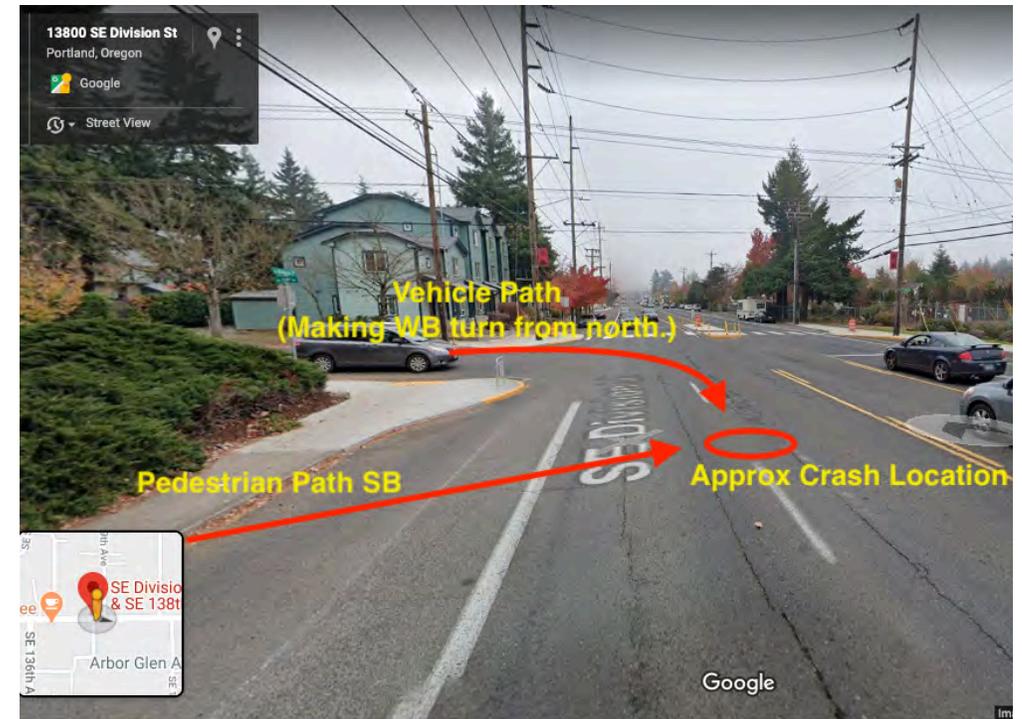
SE DIVISION ST AND SE 139th AVE 10/10/2018

The police report notes that this is a “darker stretch of roadway” and that there are trees on the NW side of the intersection where the person walking was hit and killed that may block streetlights. There are no streetlights on the south side of the road. PBOT guidelines recommend 1.0 Average Maintained fc, 3 Unity Ratio. Lighting upgrades throughout the corridor are scheduled through 2021. No information about lighting upgrades is provided at this time. Recommend checking with PBOT about specific up-to-date lighting upgrade plans.
