FATAL PEDESTRIAN CRASH REPORT
CRASH REVIEWS

PORTLAND, 2017-2019

This report provides information relating to each of the 48 fatal pedestrian crashes in Portland, Oregon from 2017-2019.

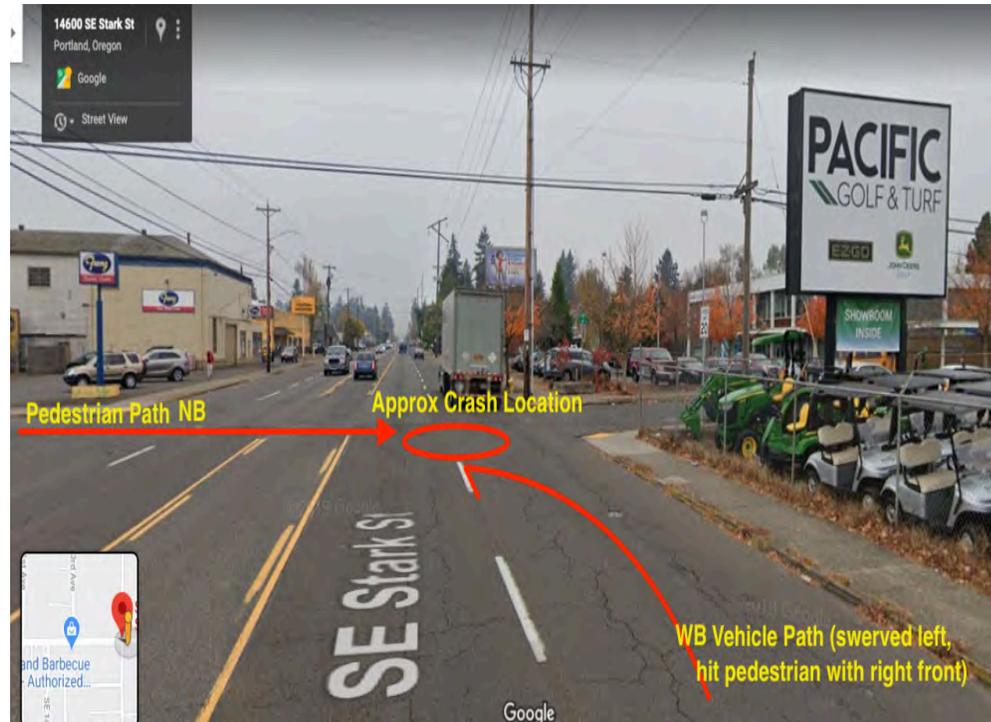
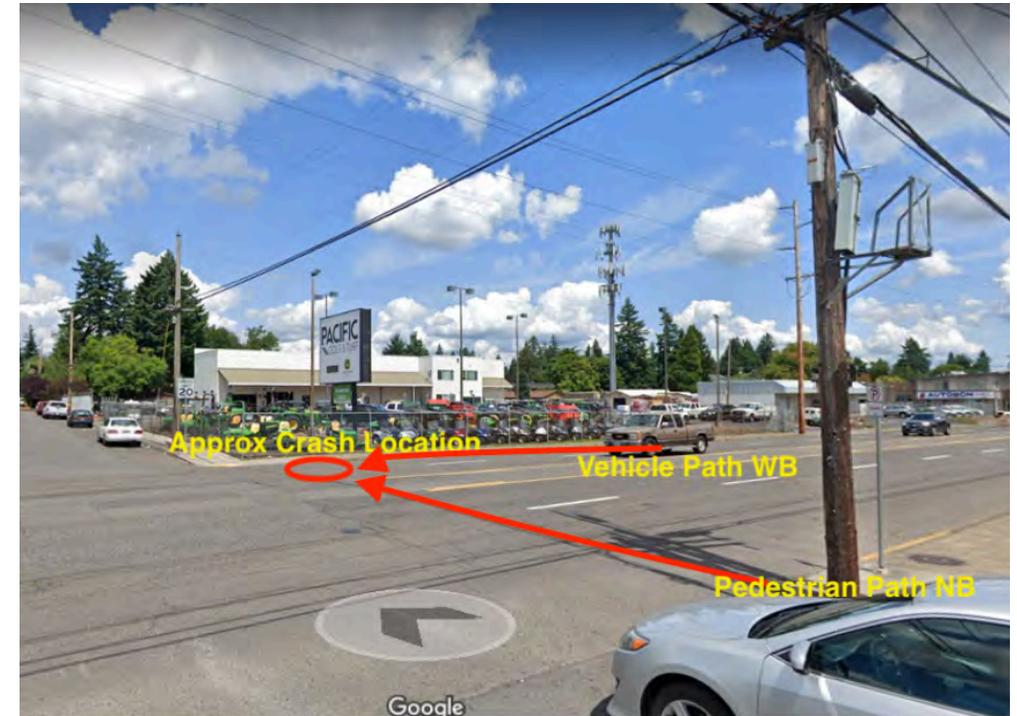
SE STARK ST AND SE 146th AVE 10/26/2018

Though speed has been lowered from 40 to 30 mph by two separate SZO's since the crash, speed remains too high at this location with 87% of drivers exceeding the posted speed limit and 16.3% or 2181 drivers daily exceeding 40 mph. There are 2648' between signals at 148th and 139th Avenues with only one midblock crosswalk with RRFB and island to act as a traffic calming feature. Recommend street design changes that are proven to save lives including centerline hardening, additional crosswalks, narrower travel lanes, and a potential "narrow road, wide node" street reconfiguration.

The speed limit is currently at 30 mph. This is a Business District on an Arterial and subject to statutory 20 mph. Rescission of SZO recommended.

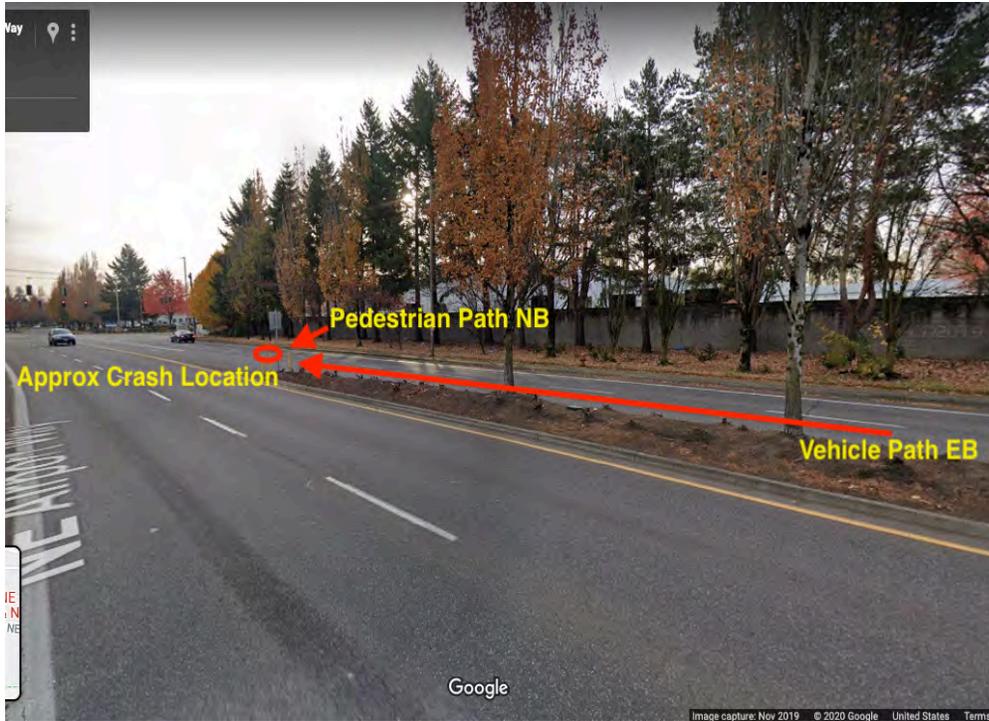
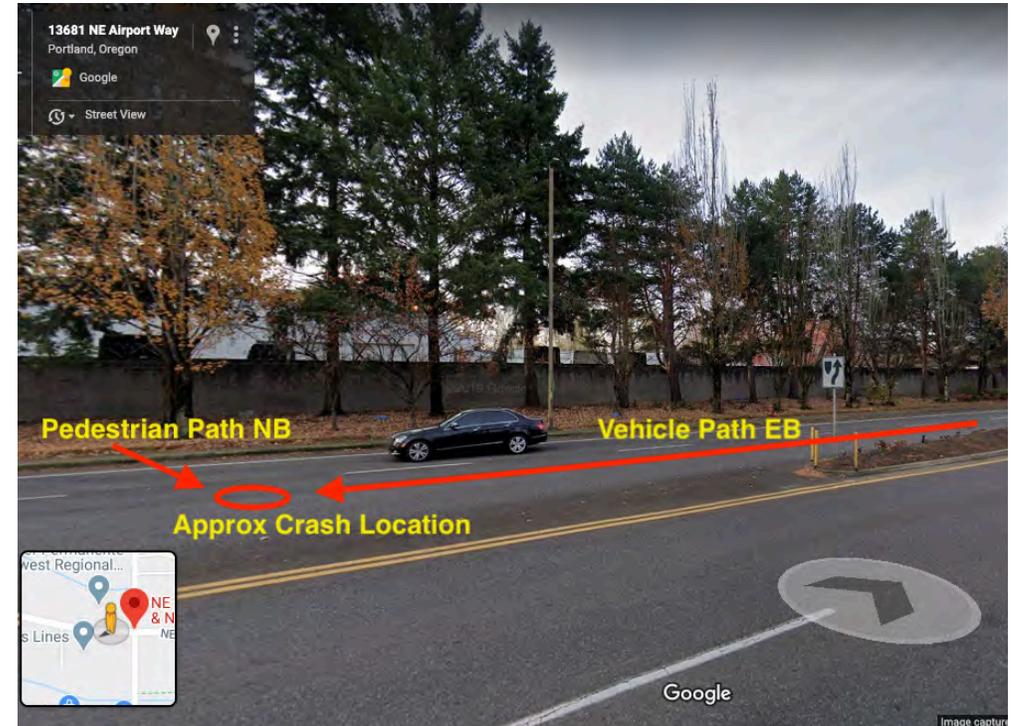
NE AIRPORT WAY NEAR NE 138th AVE 11/13/2018

43.3% of drivers exceed the posted speed limit of 45 mph with 137 drivers daily exceeding 55 mph. There are 3696' between signals at 122nd Ave and 138th Ave without any traffic calming (crosswalks, traffic islands, stop signs etc.) Recommend adding traffic calming to this road to bring speeds down.

This road is an Arterial in a Business District and subject to statutory 20 mph. Rescission of SZO recommended.

On this road there are 74' from curb-to-curb. Due to the wide crossing it is recommended that marked crosswalks with traffic islands and RRFB's be installed.

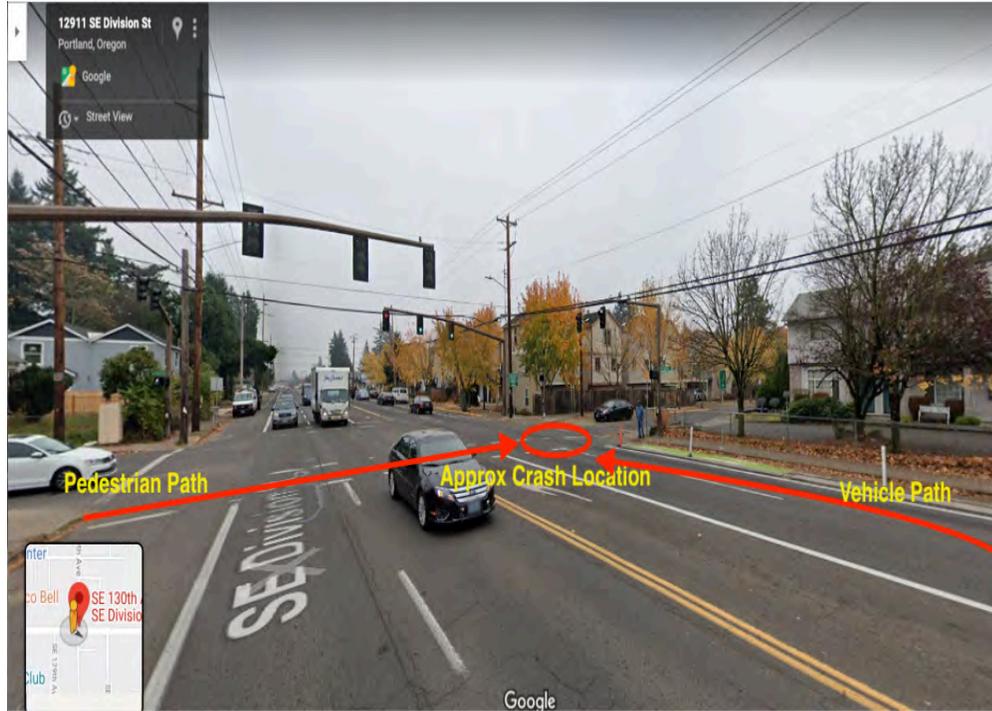
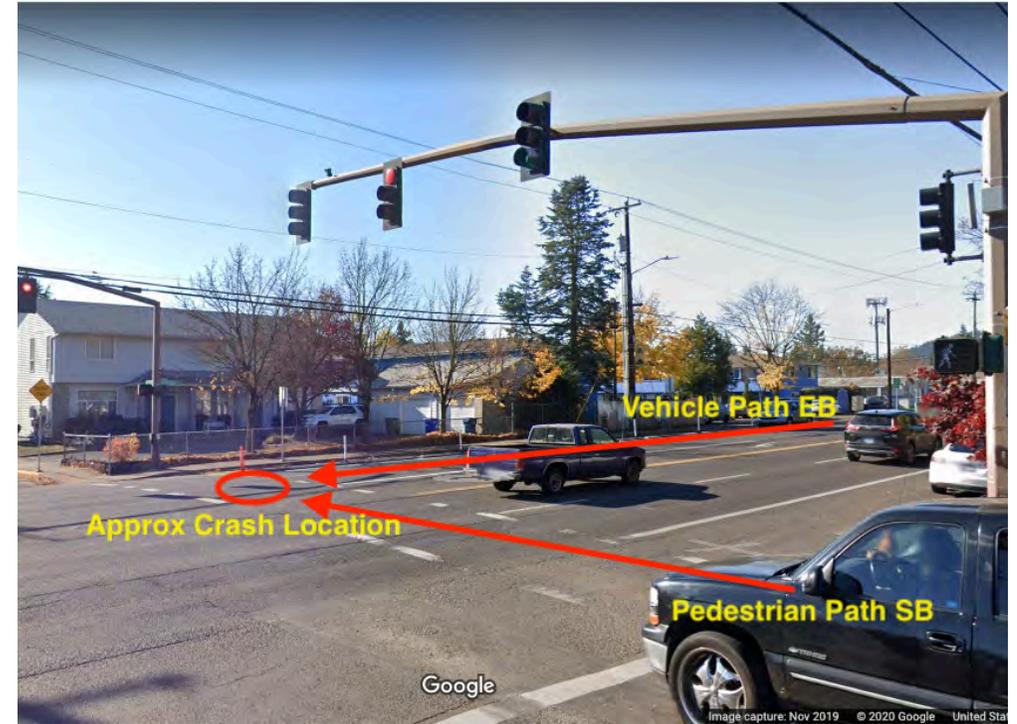
SE DIVISION ST AND SE 130th AVE 02/02/2019

Police noted that all lights on the south side of the street where the person walking was hit and killed were out on the night of the crash from 122nd to 140th Ave. The nearest north side streetlight was 174 feet east of the crash site crosswalk and 194 ft. in a direct line to the spot where the person walking was hit on the south side of the street. The recommended foot candle lighting is 1.0 Average Maintained fc, 3 Uniformity Ratio. Current lighting conditions at the location should be examined and the circumstances surrounding the lack of south side lighting on the crash date should be investigated further to assess culpability.

A Google Map street view from November of 2019 shows significant wear and missing areas of the reflective crosswalk markings due to vehicle traffic.

The person driving was travelling WB in the #2 outside lane and drove through the green light a 36.7 mph and hit and killed the person walking in the crosswalk near the dividing for the #1 and #2 WB lanes on the west side of the intersection. Conditional sightline obstruction due to stopped traffic and a large garbage truck in the turn lane was a factor for both pedestrian and driver. Police noted that “driver error” was also a factor as a driver should not proceed through an intersection with stopped traffic and sightline obstruction at such a high speed.

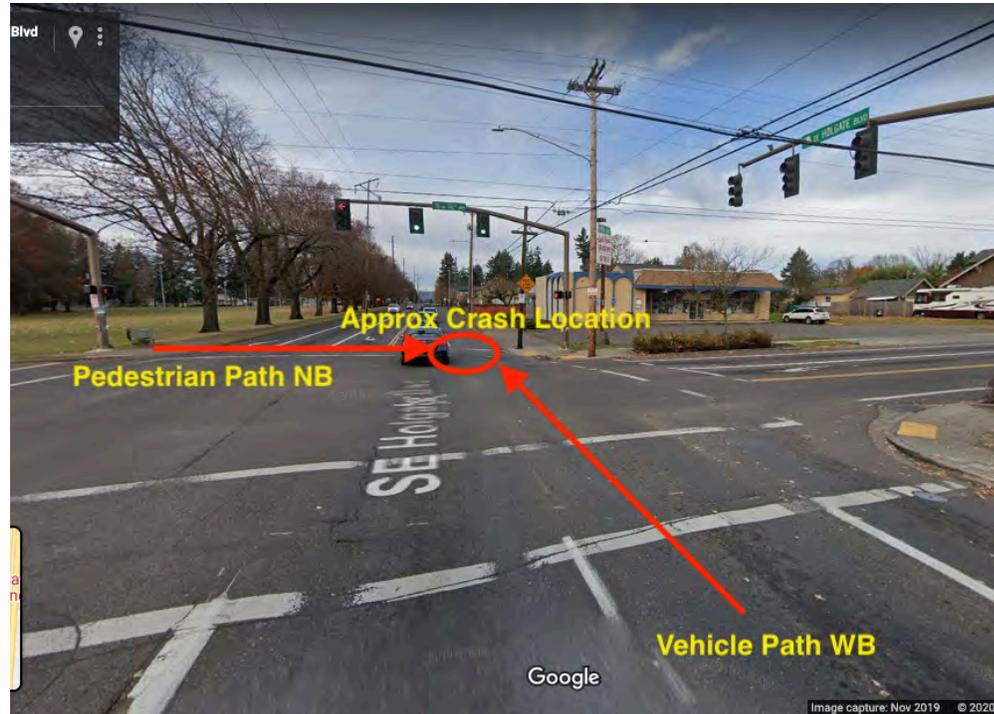
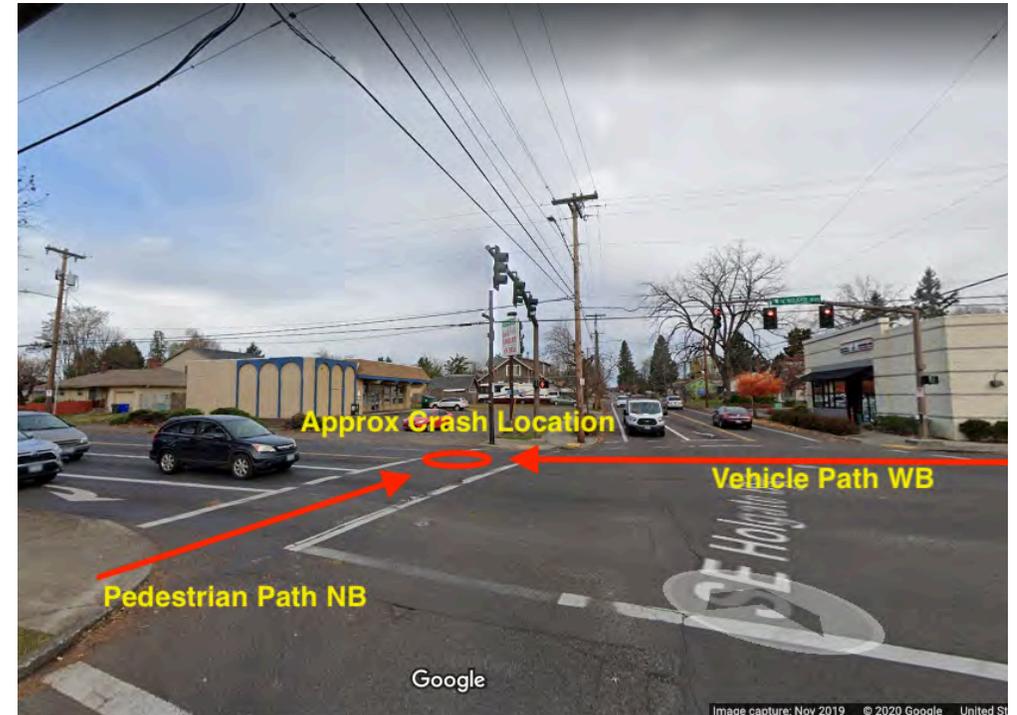
SE HOLGATE BLVD AND SE 92ND AVE 03/01/2019

The crash location is in a Business District on a Collector and subject to statutory 20 mph. Rescission of SZO recommended.

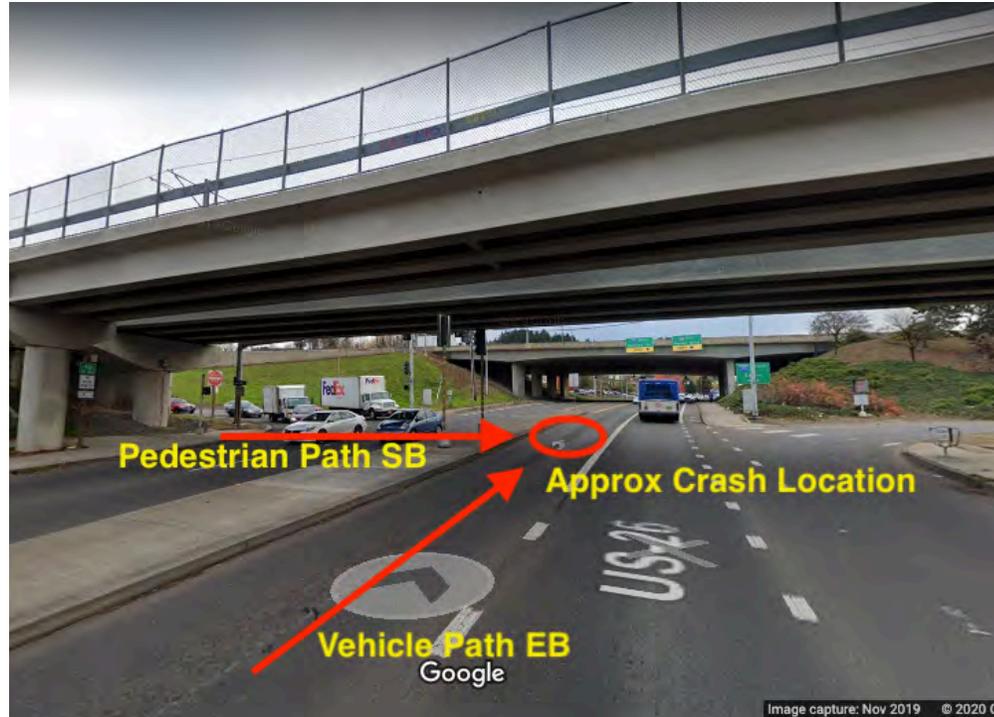
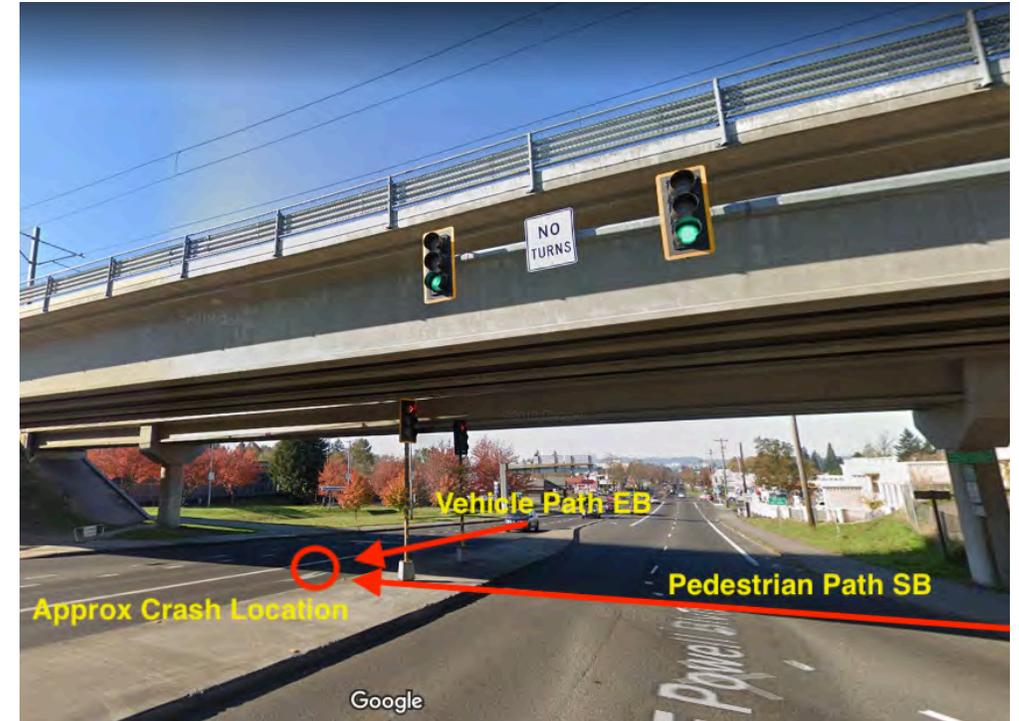
SE POWELL BLVD AT I205 04/07/2019

The police investigator note that “visibility issues from rainy weather and poor lighting were factors in this crash.” The recommended PBOT Average maintained fc is 1.2 with a Uniformity Ratio of 3 at this location. There are no lights under the I205 multi-use path/MAX overpasses where the person walking was hit and killed. The lights in the area are old style high pressure sodium and the police describe them as casting an “orange hue.”

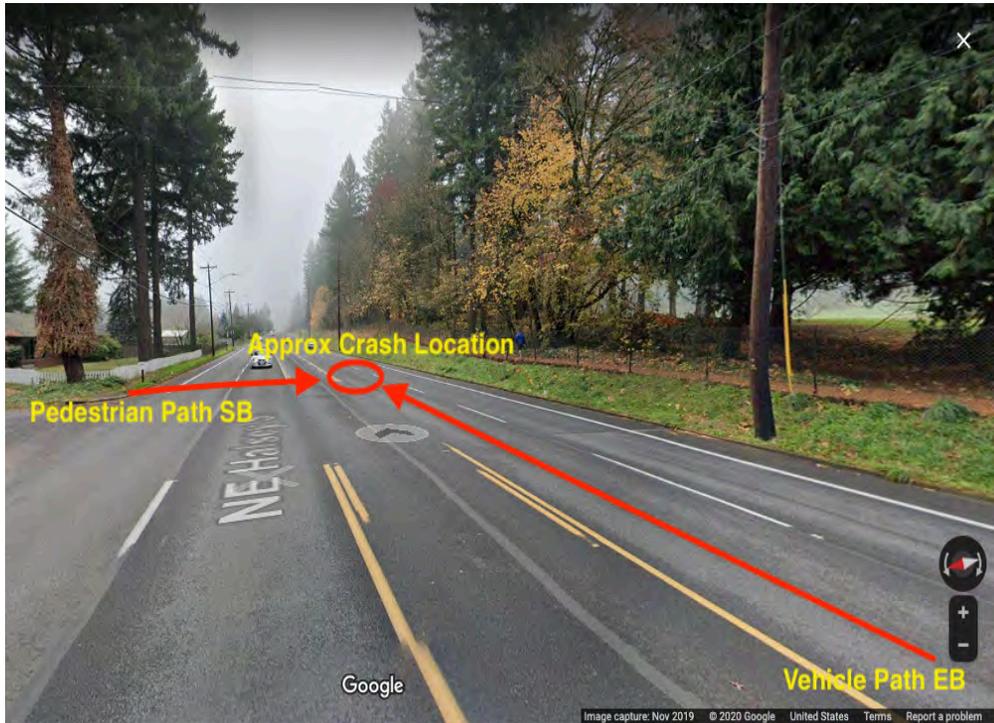
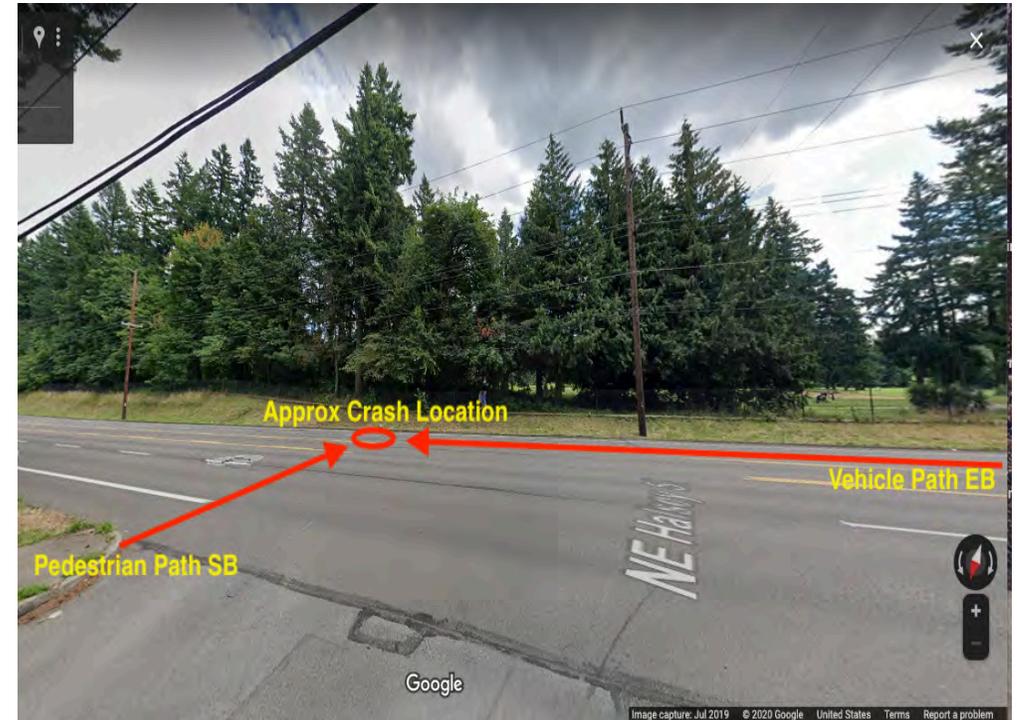
NE HALSEY ST AND NE 141st AVE 07/24/2019

There are streetlights only on north side of the road. The person walking was hit and killed on south side. 1.2 Average Maintained fc, 3 Uniformity Ratio per PBOT Appendix K guidelines is recommended.

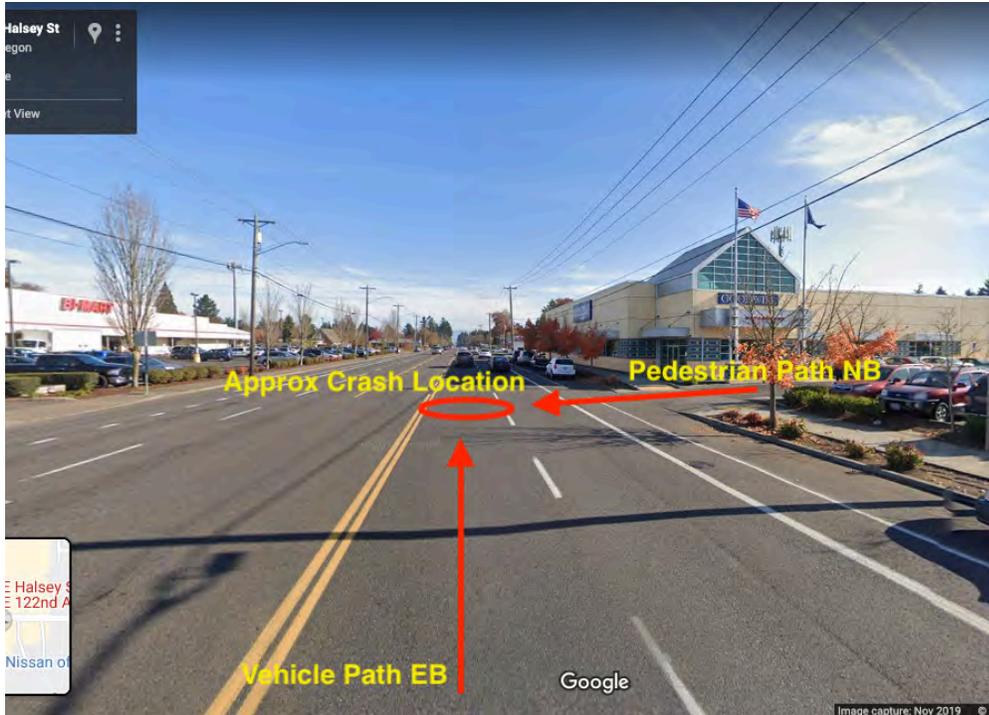
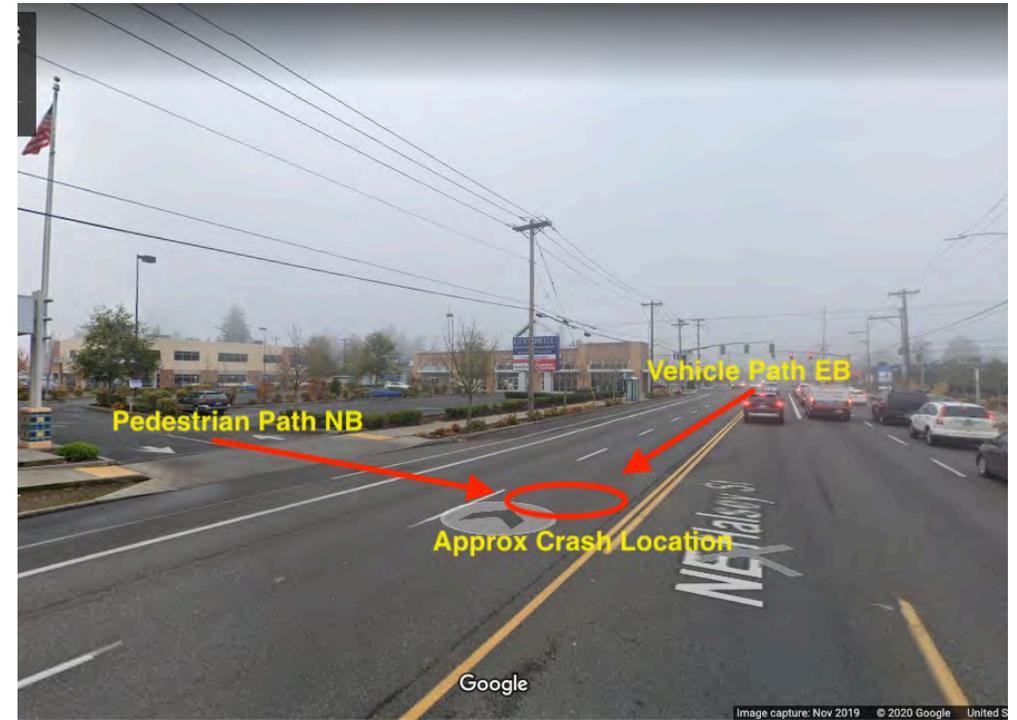
NE HALSEY ST NEAR NE 122nd AVE 12/27/2019

The location is a Business District on an Arterial and subject to statutory 20 mph. Rescission of SZO recommended.

The officer noted that there was "some illumination" from the Goodwill on the south side of the road but that there are streetlights only on the north side of the road. NE Halsey is designated a Major City Traffic Street, Major City Bikeway and Major City Walkway. PBOT Appendix K recommends 1.2 Average Maintained fc, 3 Unity Ratio.

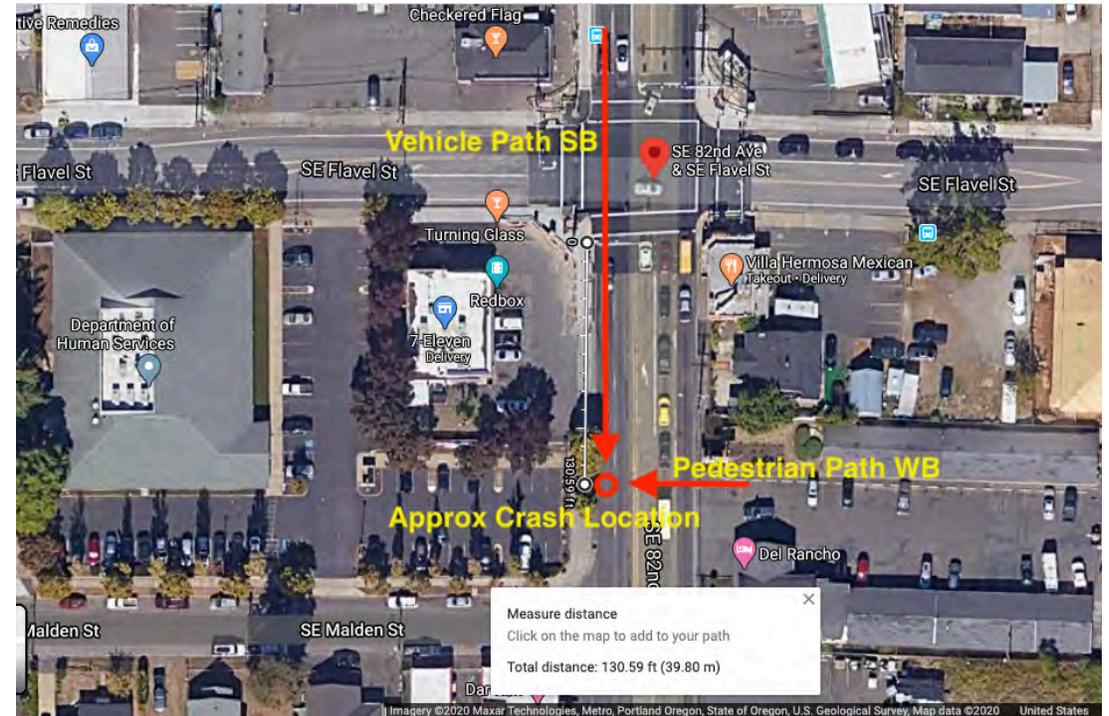
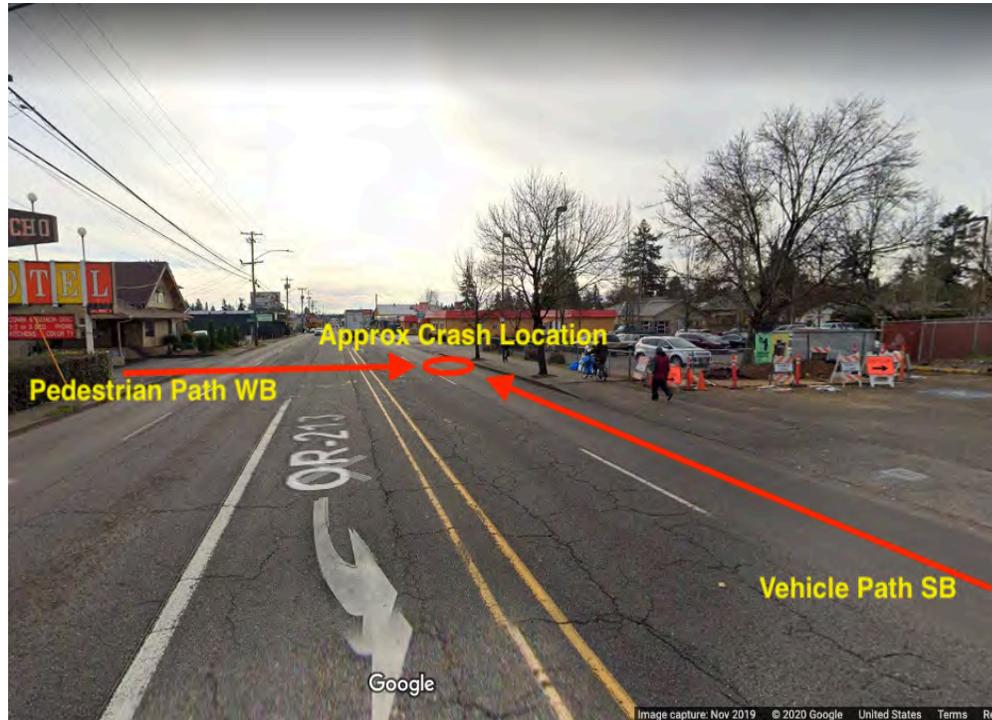
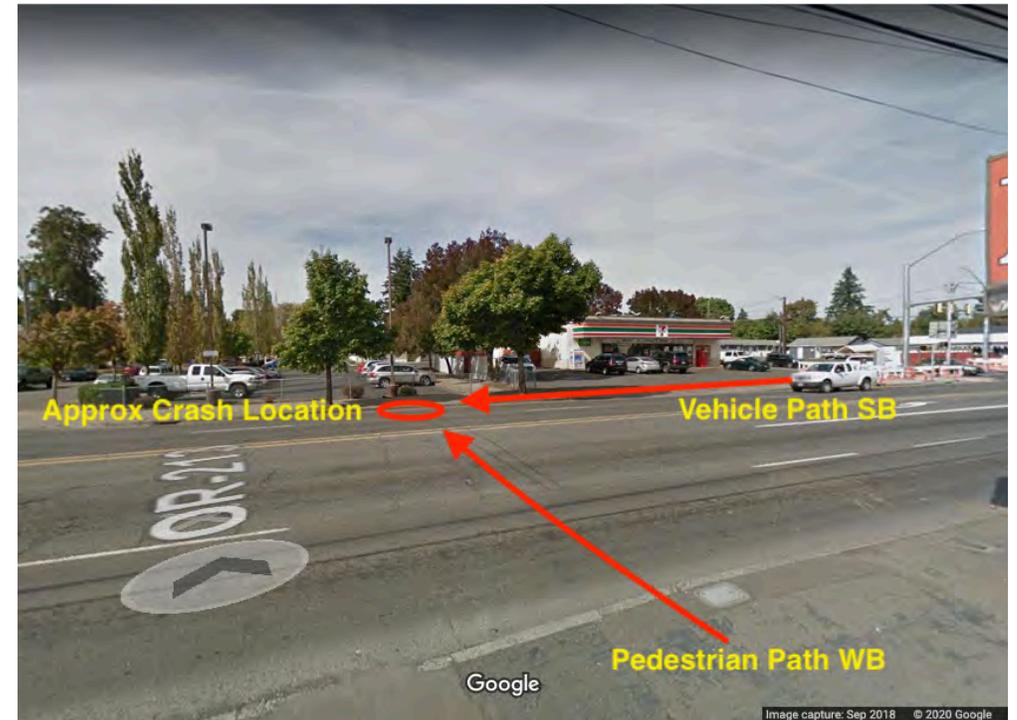
SE 82nd AVE NEAR SE FLAVEL ST
05/05/2017

The person walking was staying at the Del Rancho Motel after visiting friends. He left the north end of the parking lot, crossing the street WB to go to the 7-11 on the SW corner of the intersection. He was crossing outside of a legal crosswalk as the nearest crosswalk was 130' north at Flavel St.

This was a hit-and-run. The person driving (unidentified) was travelling SB in the #2 outside lane. They were travelling above the speed limit, possibly as fast as 50 mph. The person walking saw the vehicle coming from his right as he was crossing, tried to outrun it to safety on the west side of the road, but was hit and killed in the #2 EB lane. The person driving continued SB.

The current speed limit at this location is 35 mph. 82nd Ave is an Arterial in a Business District and subject to statutory 20 mph. Rescission of SZO recommended.

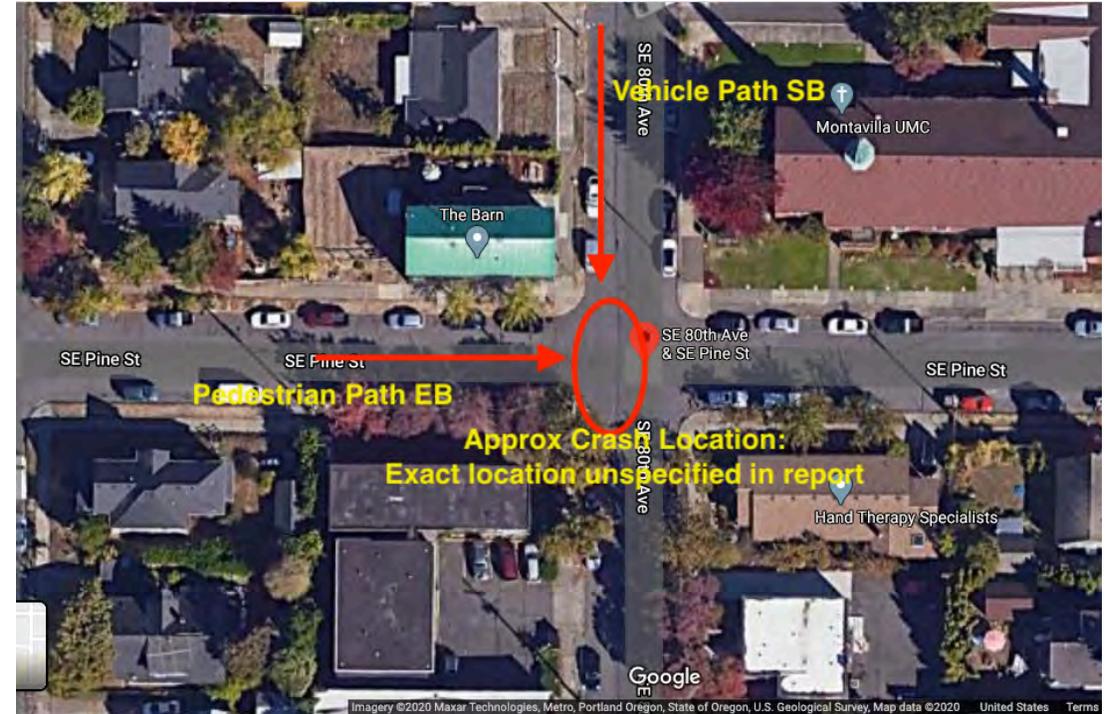
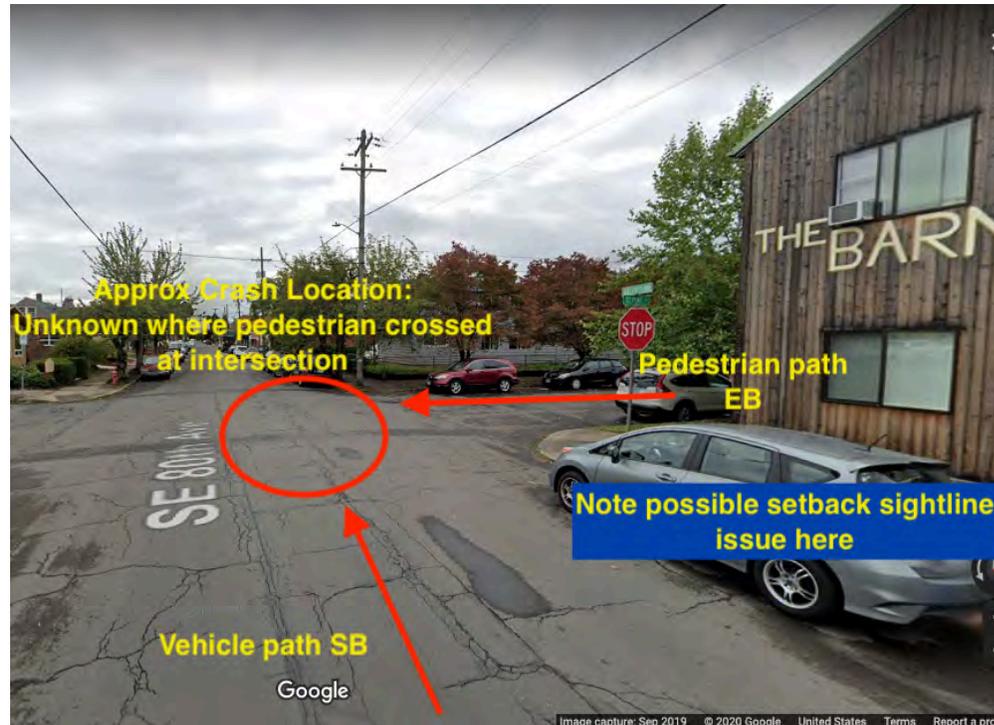
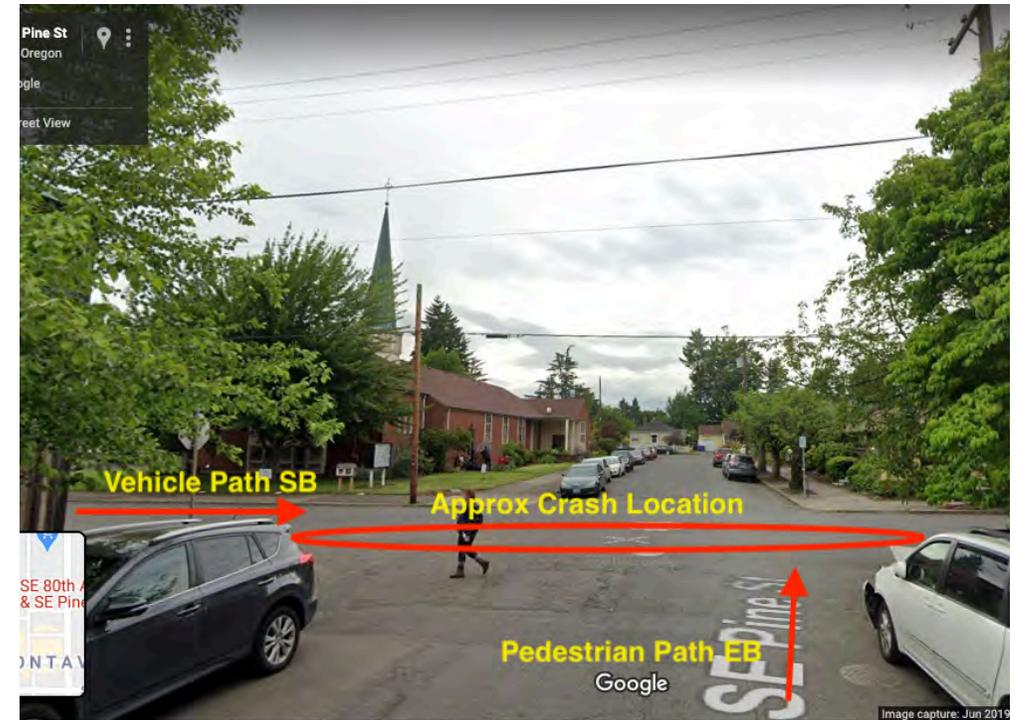
SE 80th AVE AND SE PINE ST 06/22/2017

The person walking was returning to work at the nearby Sacred Heart Bakery after taking a walk during her lunch break. It is unknown where she was crossing, but evidence suggests she was heading EB in or near the north intersection unmarked crosswalk.

This was a hit-and-run. The person driving (unidentified) was heading SB on SE 80th Ave. when they hit and killed the person walking. The person driving was in a large truck and sped off WB on SE Pine St.

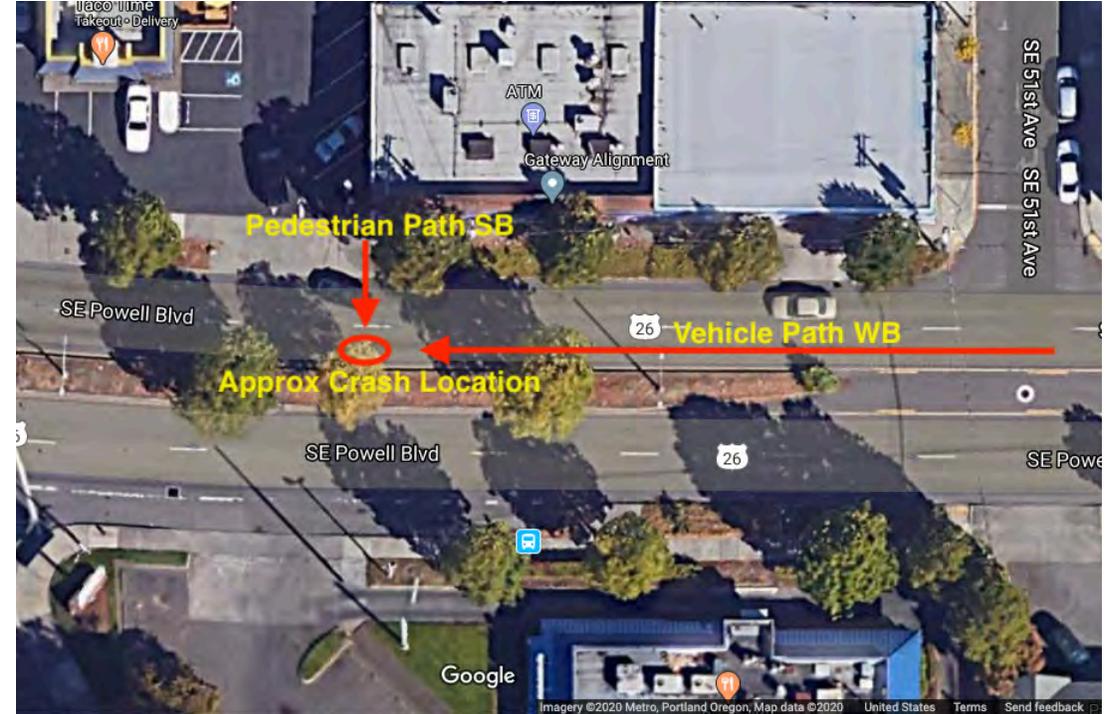
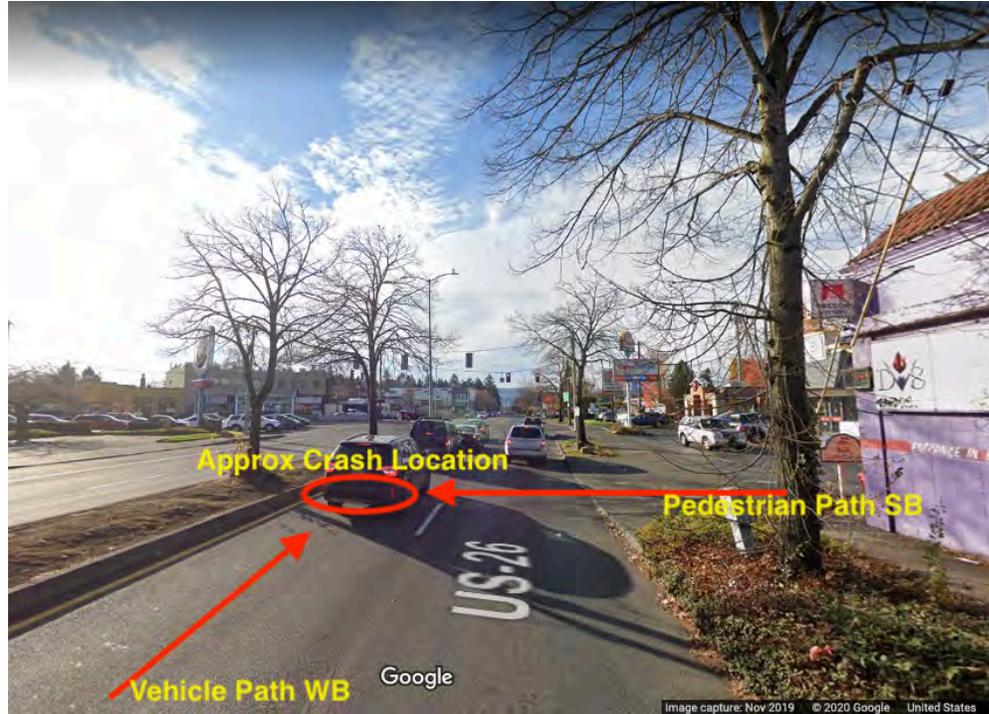
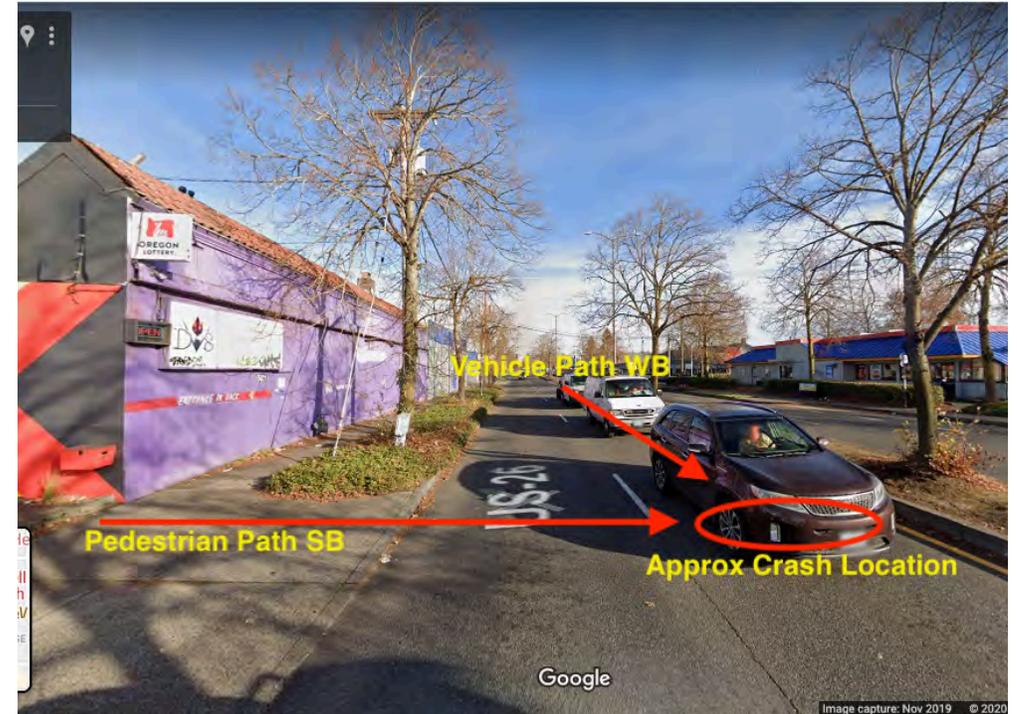
SE POWELL BLVD NEAR SE 50th AVE 07/14/2017

The person walking entered the roadway from the driveway of the DV8 Club (since out-of-business) driveway on the north side of the road 170' east of the intersection with SE 50th Ave. He was heading SB across Powell Blvd when he dropped his phone in the WB #1 inside lane and bent over back into the lane to retrieve it.

The person driving had departed from the Plaid Pantry on 52nd and Powell and was heading WB in the #1 inside lane. He hit and killed the person walking as he backtracked into the #1 lane to retrieve his cell phone. Driver toxicology later indicated a concentration of 190 ng/ml of Benzoylcegonine which is associated with cocaine use. According to police the person driving "showed no signs of impairment" at the crash scene.

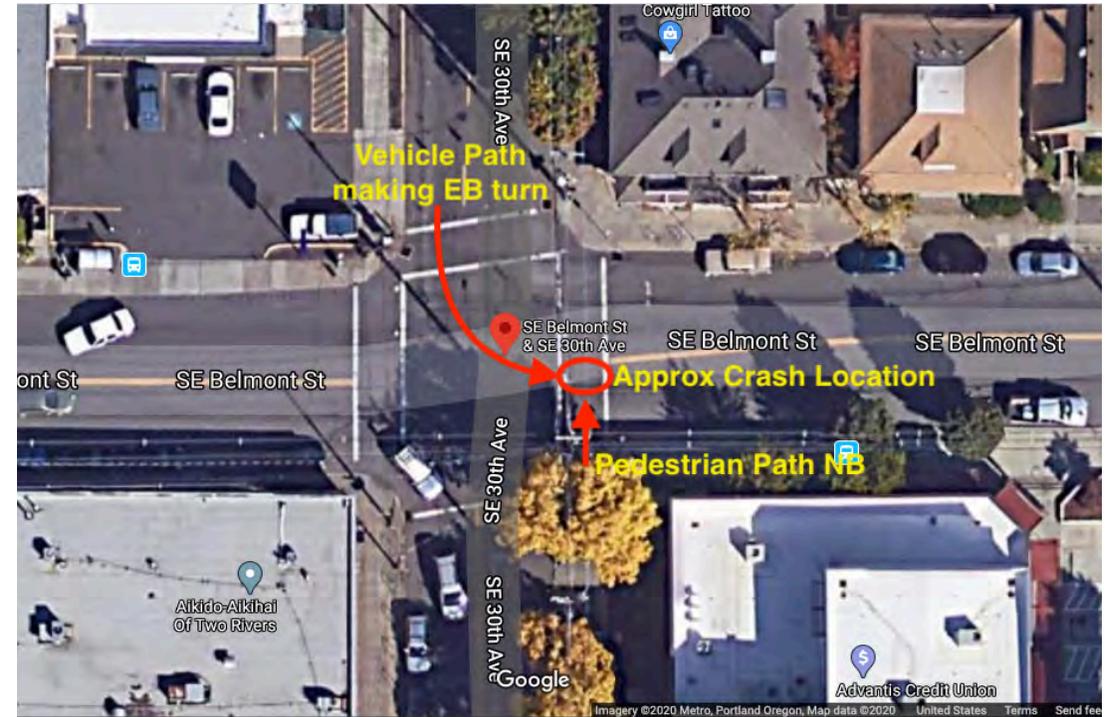
SE BELMONT ST AND SE 30th AVE

The person walking was crossing on a “walk” signal from the SE corner heading NB along the easternmost edge of the crosswalk just inside the painted line. He had cataracts in his left eye which impaired vision but was not legally blind.

The person driving was proceeding from a stop at the north intersection signal on a green light, making a left turn from SE 20th Ave onto NE Belmont St. He “cut the corner” and hit and killed the person walking near the painted yellow double lines in the crosswalk leading into the #1 EB lane of SE Belmont St.

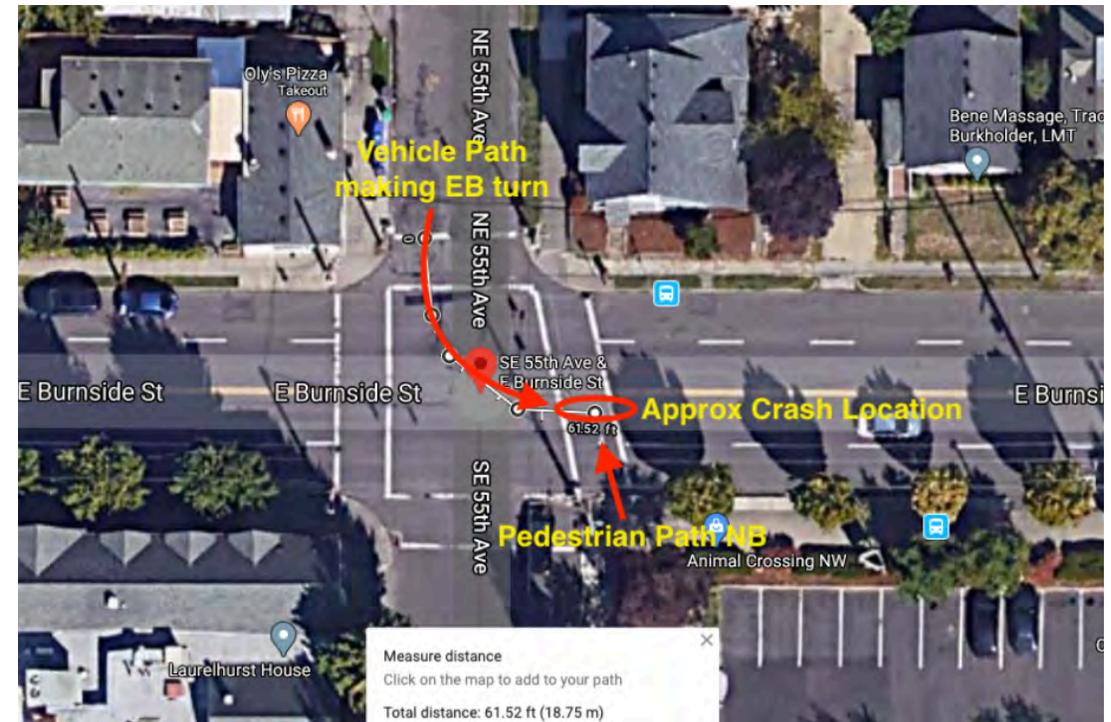
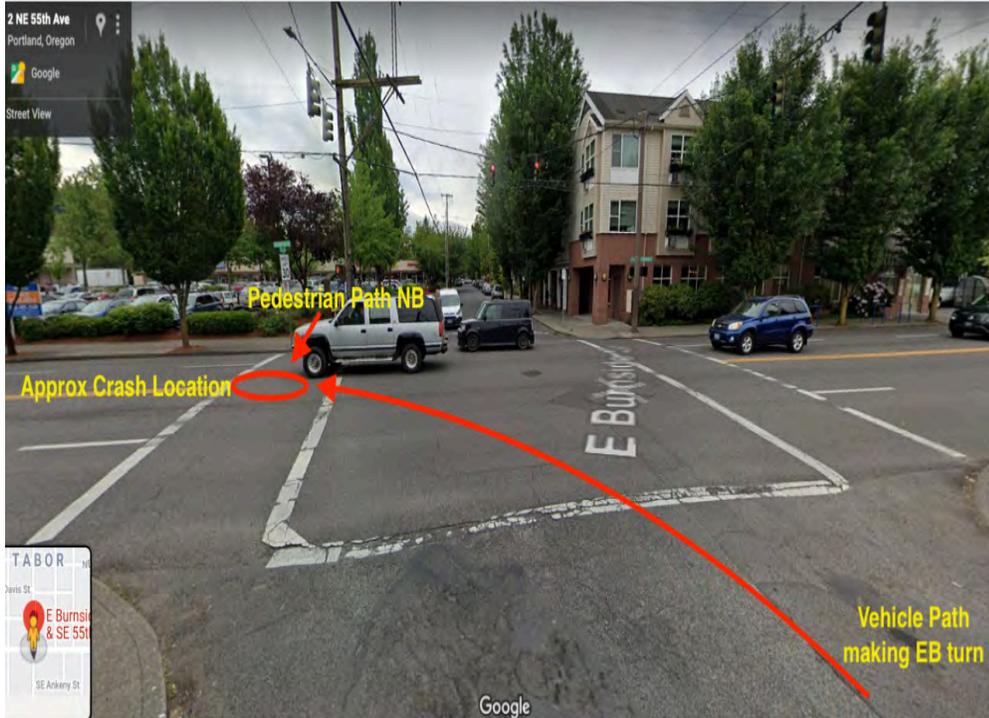
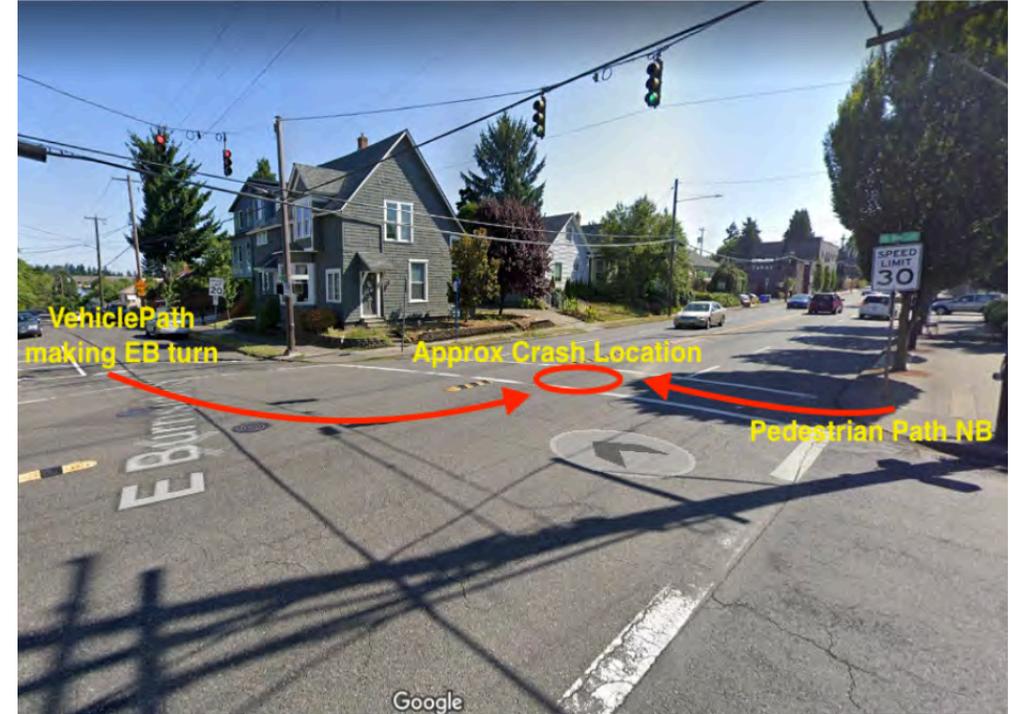
E BURNSIDE ST AND SE 55th AVE 10/11/2018

The crash location is a 4-way intersection with marked/signalized crosswalks on all sides. E Burnside is a Minor Arterial with 4 lanes (2 EB, 2 WB) and a speed limit of 30 mph. 55th Ave is a Local Road with 2 lanes (1 SB, 1 NB) and a speed limit of 20 mph. The crash occurred in full daylight.

The person walking was crossing from the SE corner heading NB in the east crosswalk. The walk signal status is unknown but the report states that if the person walking activated the signal with the button it would have been a “walk” signal.

The person driving was returning home from work. He proceeded to make a left turn onto Burnside from a full stop at the north signal with 55th Ave. He hit and killed the person walking in the marked crosswalk in the #1 inside lane path for EB traffic on Burnside.

There are a mix of businesses and residences at this location. Recommend exploring whether this section of road qualifies as Business District eligible for 20mph statutory speed.
