FATAL PEDESTRIAN CRASH REPORT
CRASH REVIEWS

PORTLAND, 2017-2019

This report provides information relating to each of the 48 fatal pedestrian crashes in Portland, Oregon from 2017-2019.

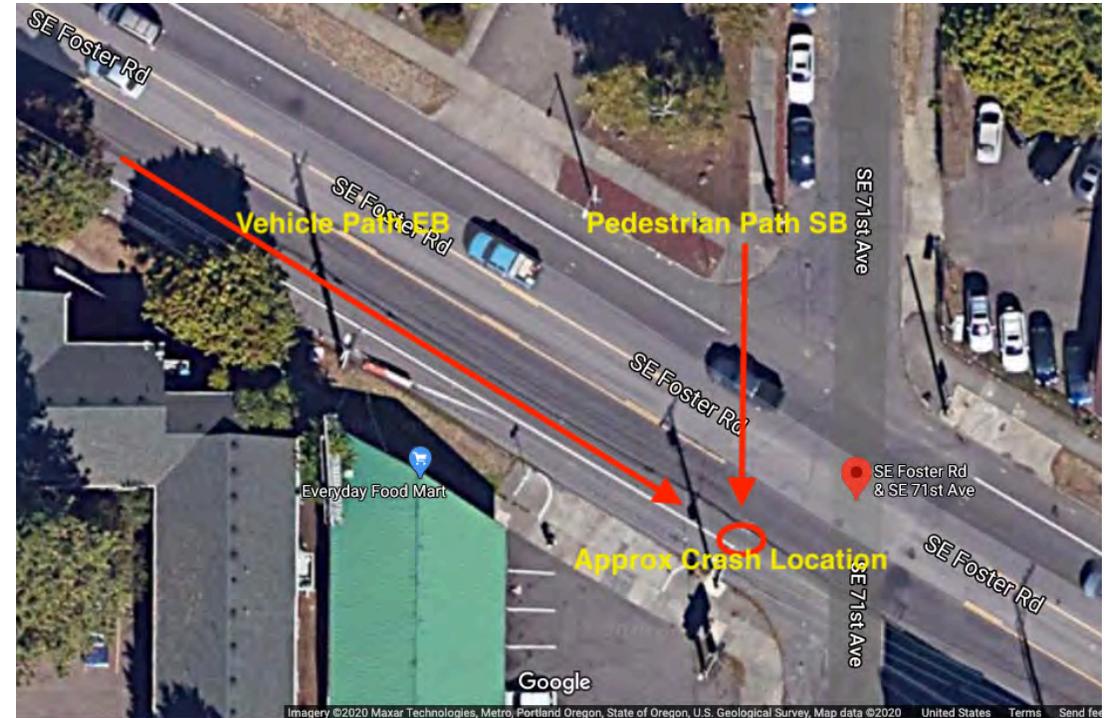
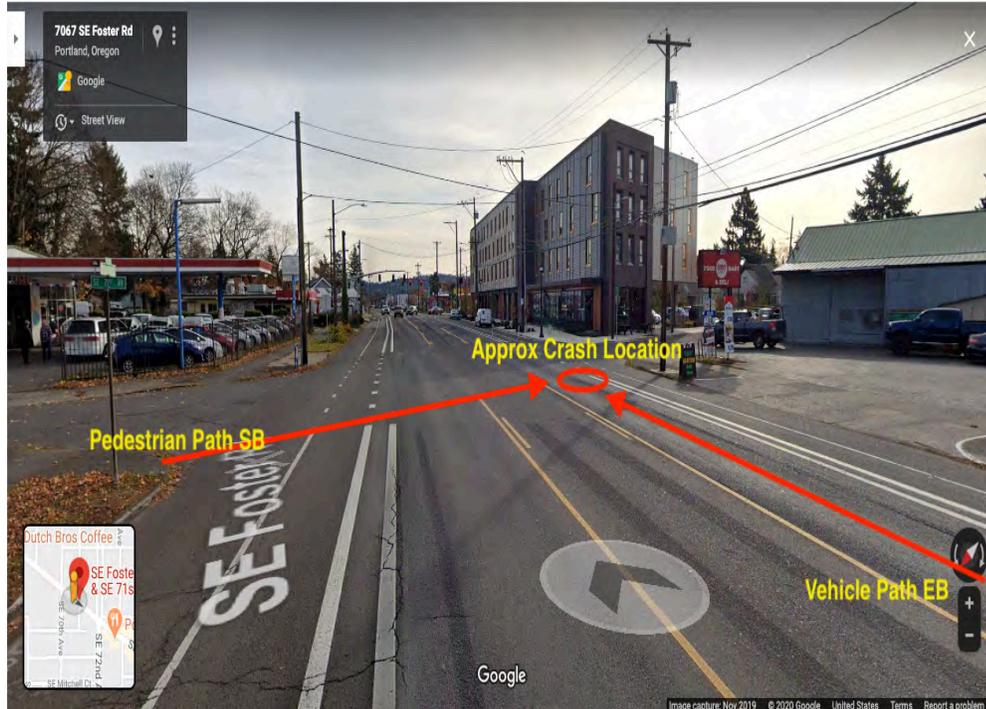
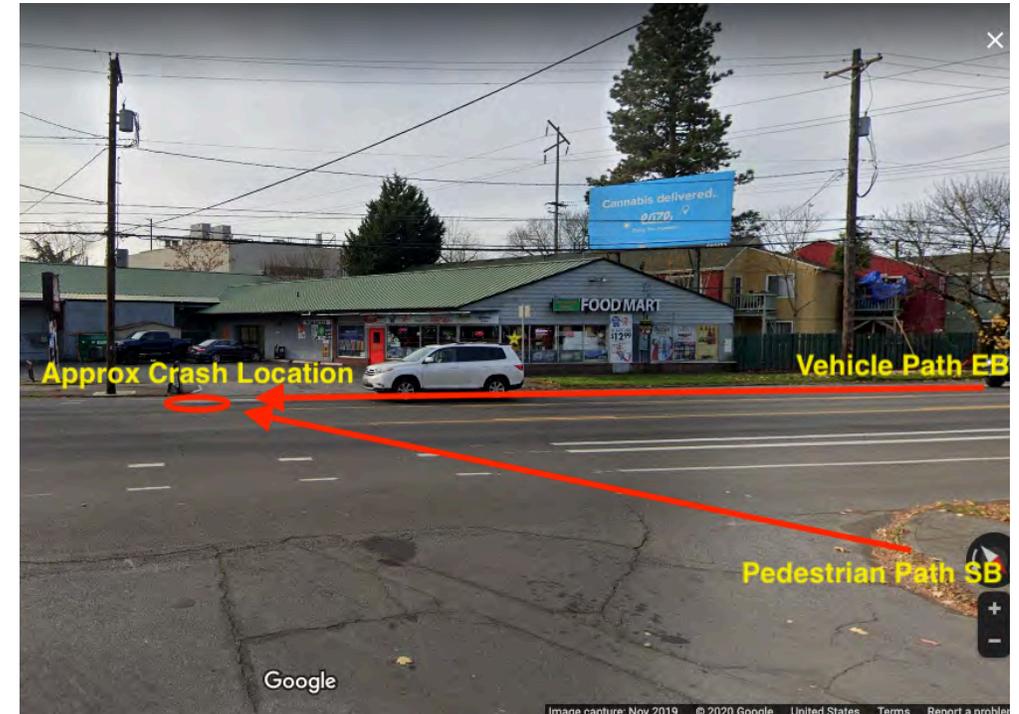
SE FOSTER RD AND SE 71st AVE 06/13/2019

The person walking was crossing from the NW side of the intersection heading SB in the unmarked crosswalk. She was an Older Adult and had a mobility disability. The person walked very slowly without the use of a cane or walker.

The person driving entered Foster Rd. 926' west from the Dollar Store Parking lot heading SEB. She hit and killed the person walking within the crosswalk just north of the painted bicycle lane in the #2 outside lane. The person driving did not have a license and was operating the vehicle with only a permit. The person walking was in the roadway and visible to the person driving for at least 18 seconds before the collision.

The speed limit is currently set at 25 mph. This location is an Arterial in a Business District and subject to statutory 20 mph. Rescission of SZO recommended.

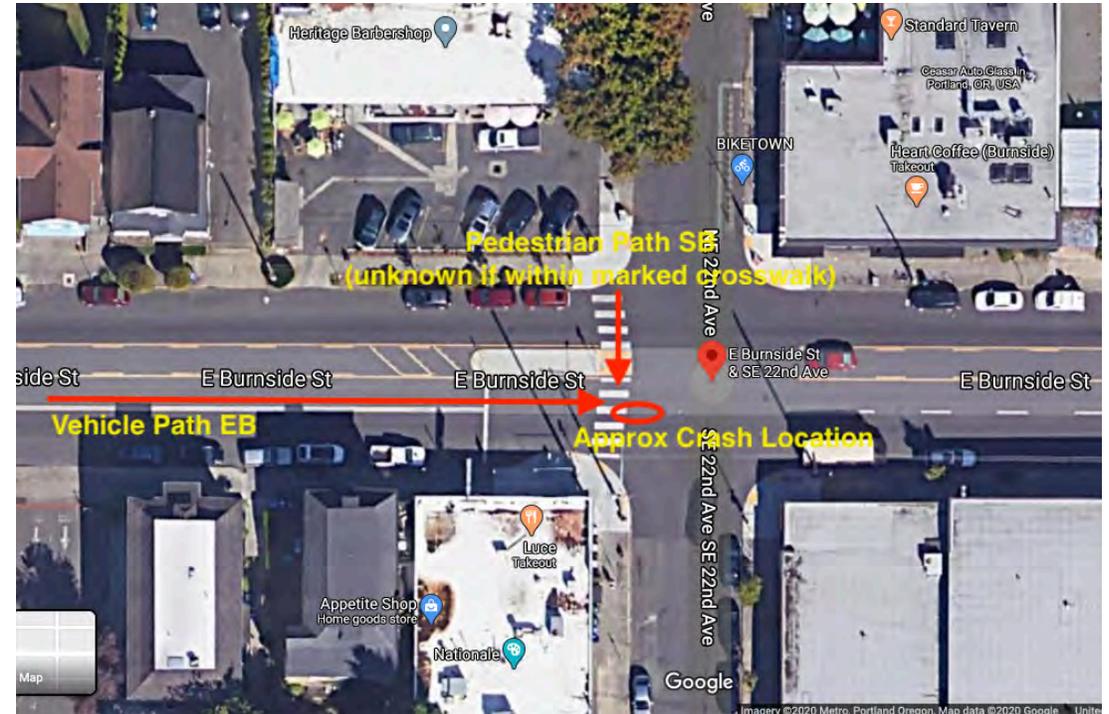
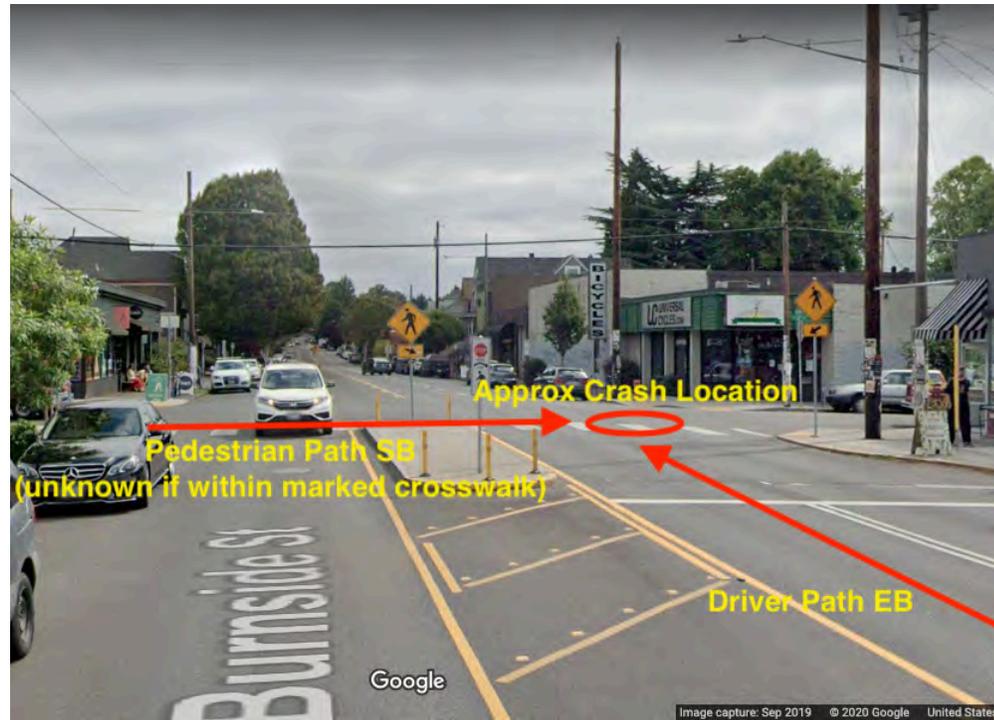
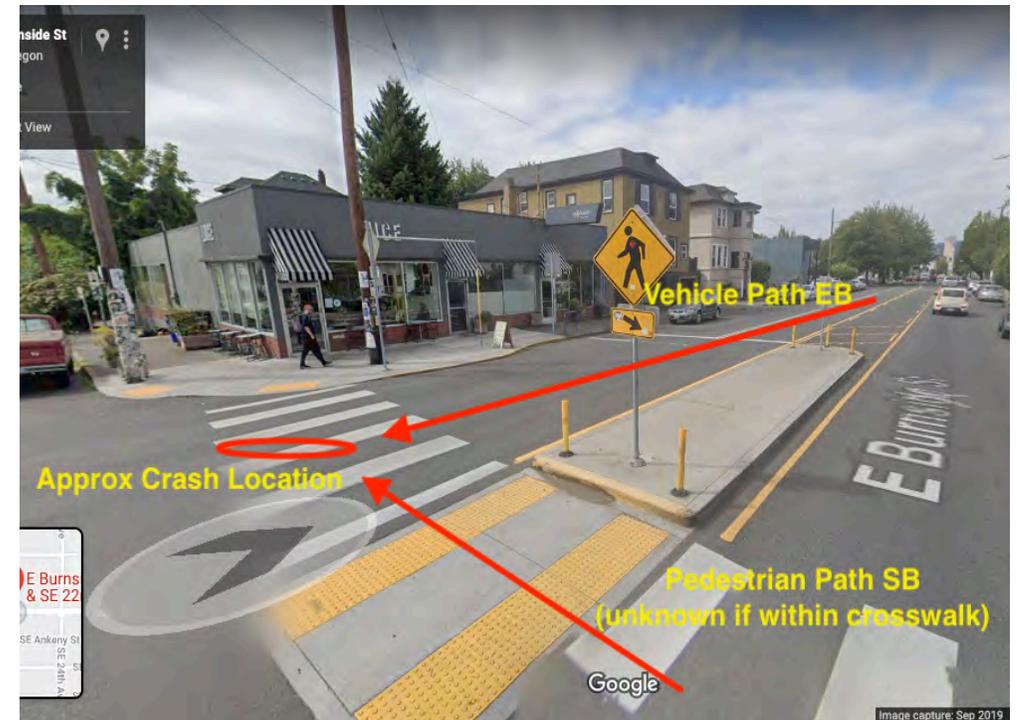
E BURNSIDE ST AND SE 22nd AVE 11/18/2019

The crash location is a 4-way intersection with a marked crosswalk with signage and a traffic island on the west side. All other intersection crosswalks are unmarked. E Burnside St. is a Minor Arterial with 4 lanes (2 EB, 1 WB, center turn median), parking and sidewalks on both sides. The speed limit is 30 mph. The crash occurred at night.

The person walking departed from The Standard tavern on 22nd Ave just north of Burnside heading to her nearby home. She was crossing Burnside heading SB. It is unknown if she was within the marked crossing area but the police investigator notes she was most likely in or near the crosswalk. Toxicology revealed she was heavily intoxicated (alcohol BAC .37).

The person driving was heading home from work travelling EB on Burnside in the #1 inside lane where she hit and killed the person walking as she was proceeding SB from the traffic island into the path of the #1 lane. The person driving was estimated (using the Searle Equation) to have been travelling 33.6-40.26 mph and the investigator noted that if she had been traveling the speed limit (30 mph) the crash could have been prevented as she would have had ample perception and stopping time.

The police investigator noted that signs and the reflective pillars on the traffic island may block the view of pedestrians for EB drivers as they provide high contrast light that obscures darker objects behind them. Though this crossing was updated as part of a 2016 PBOT safety plan, review of traffic island infrastructure is needed to ensure safety.

E Burnside St. at this location is a Business District on an Arterial and subject to statutory 20 mph. Rescission of SZO recommended.

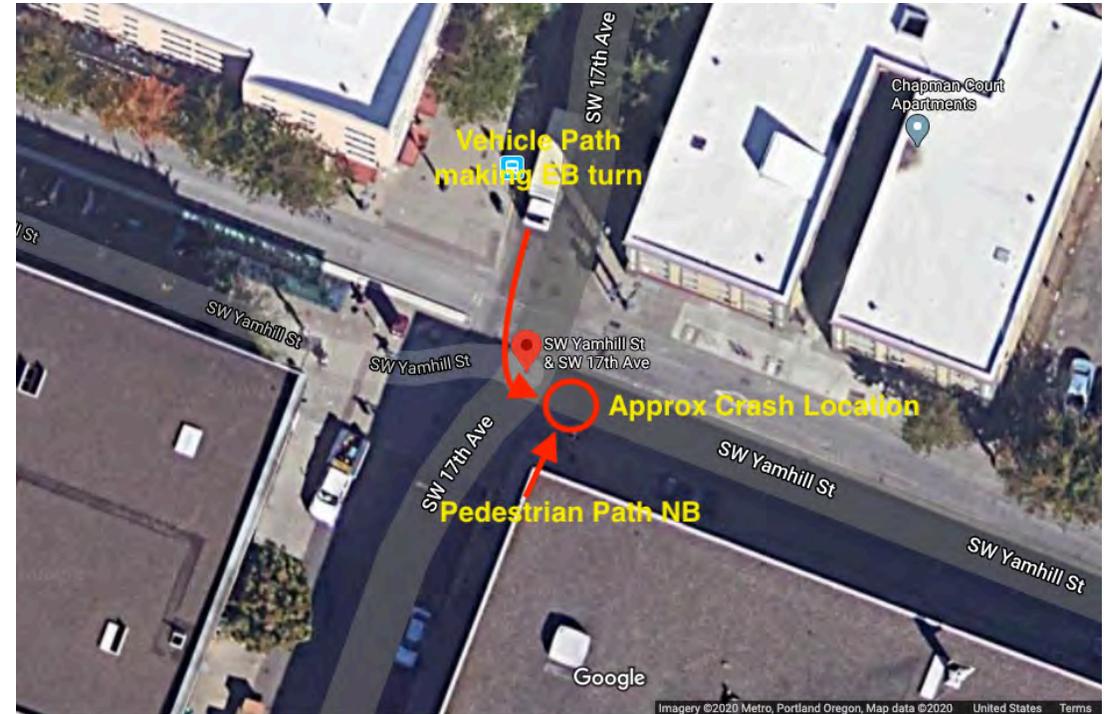
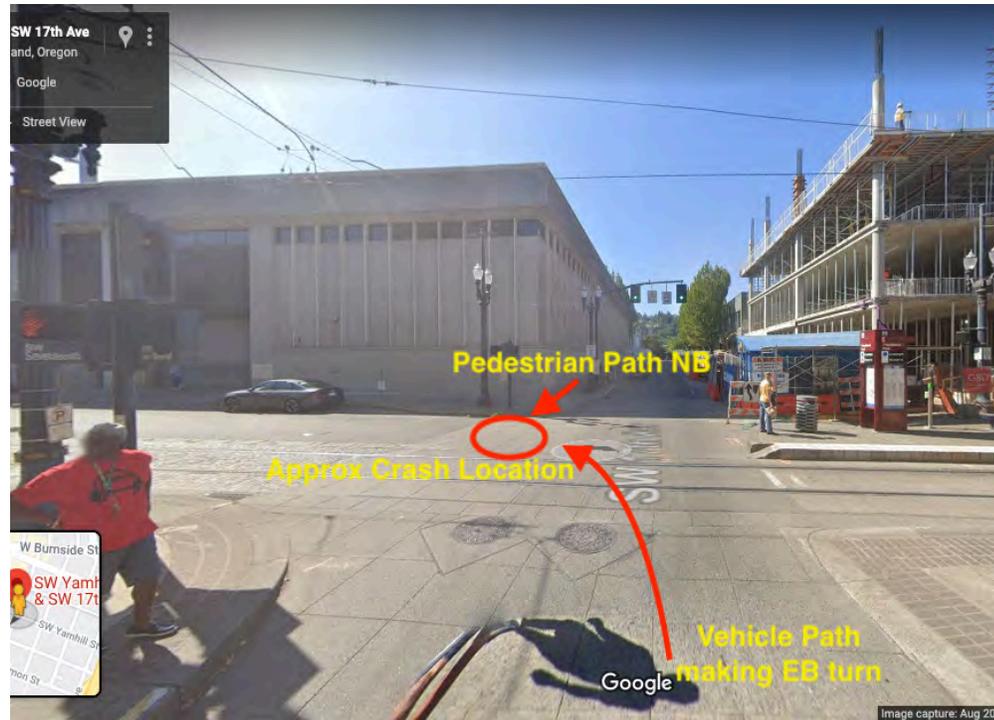
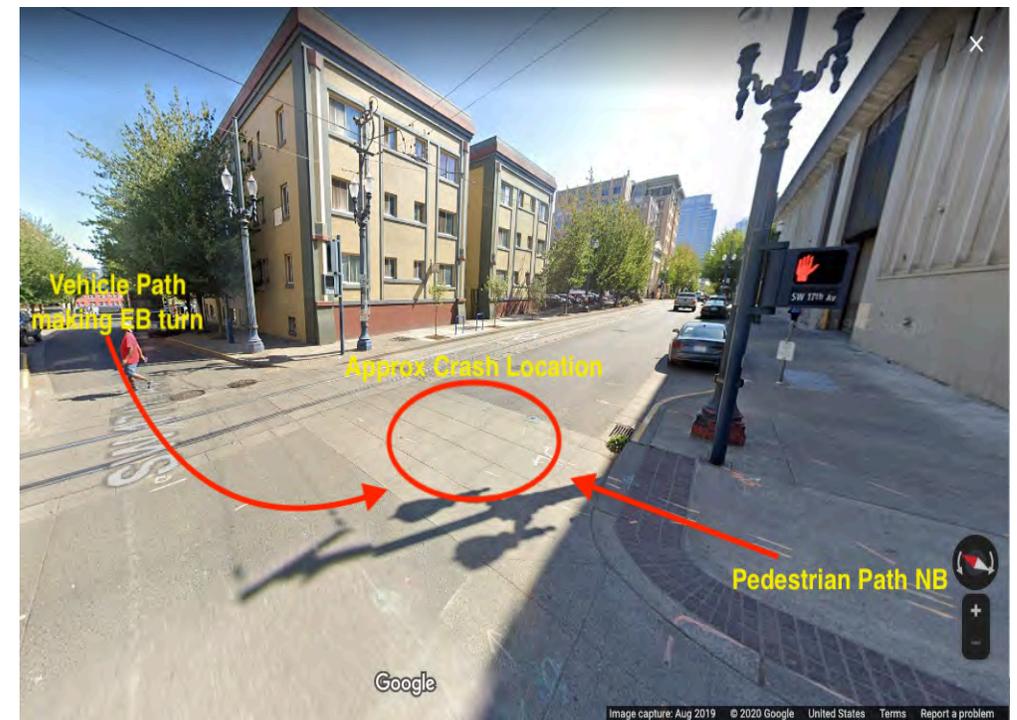
SW YAMHILL ST AND SW 17th AVE 02/07/2018

The person walking was an Older Adult crossing from the SE corner heading NB in the east crosswalk on a “walk” signal.

The person driving proceeded on a green light through the north intersection, making a left hand turn onto Yamhill street. She was driving a large rented U-Haul pickup truck because she was moving. She travelled approx. 280’ unimpeded from the signal at SW Morrison before hitting the person walking in the crosswalk at the EB lane of Yamhill Street. The person walking died later in the hospital. Driver A-pillar obstruction may have been a factor.

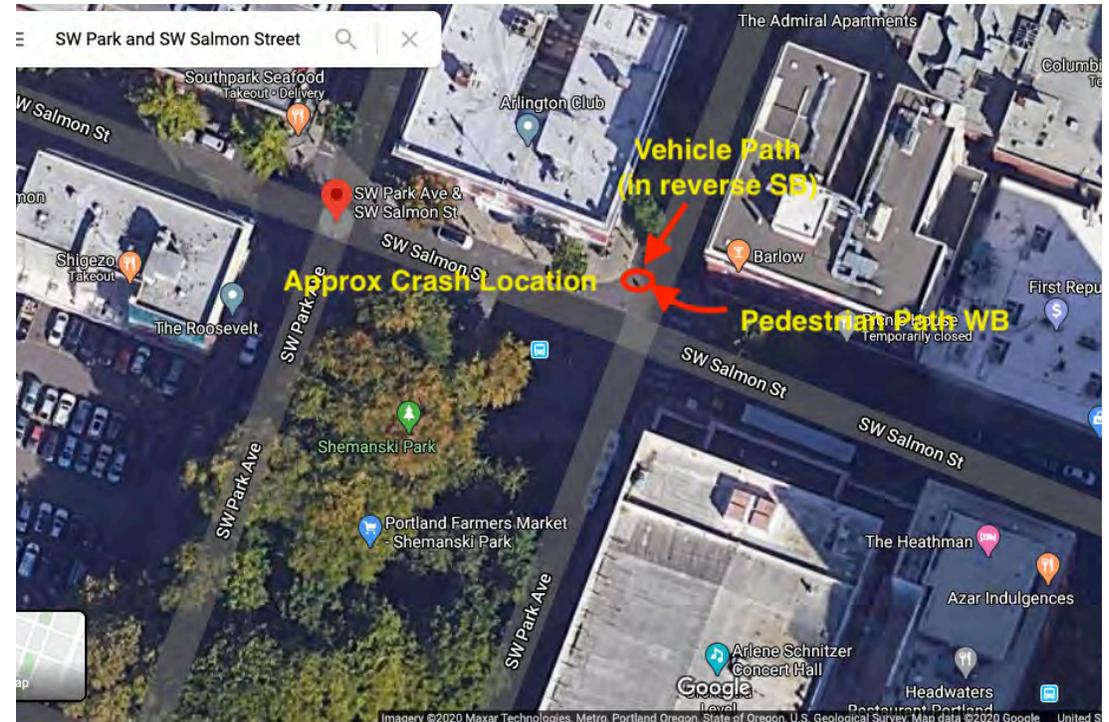
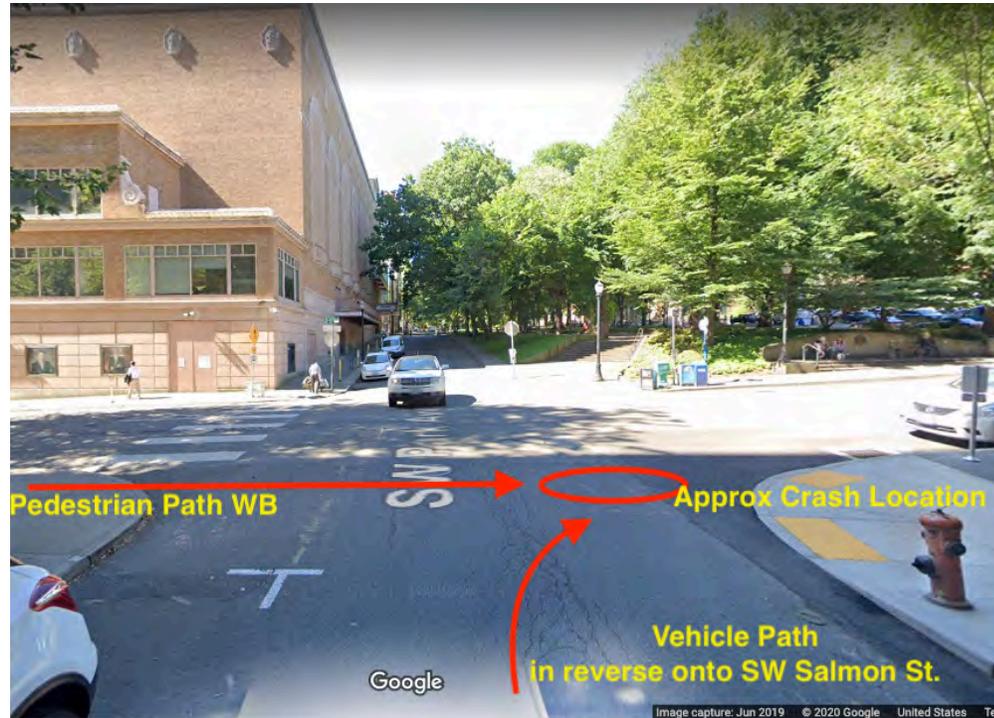
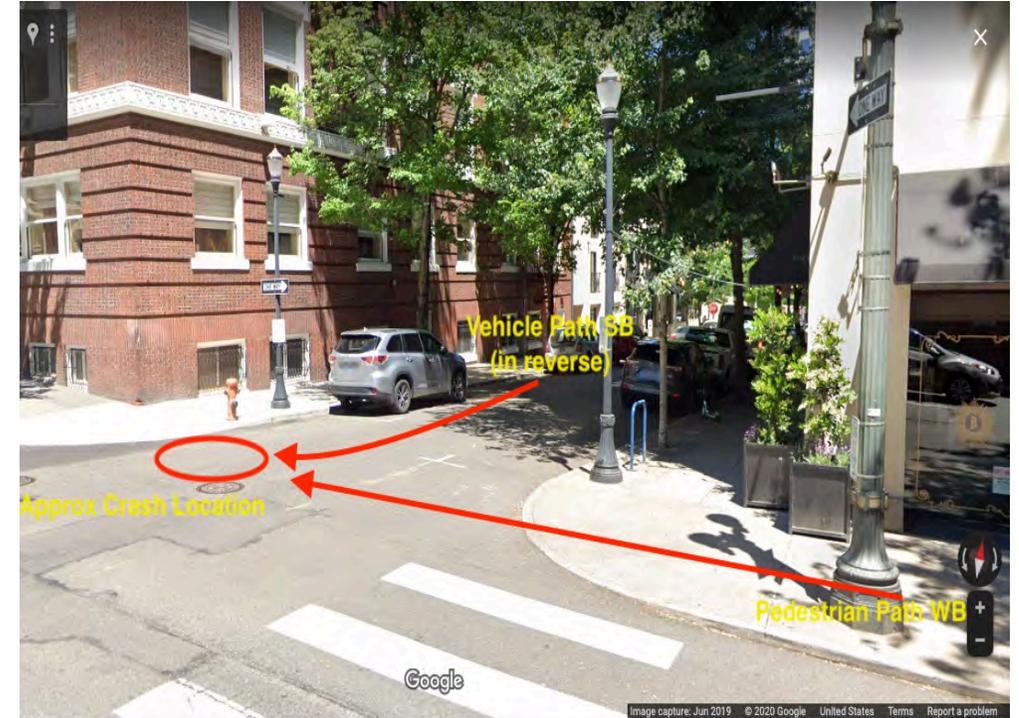
SW SALMON ST AND SW PARK AVE 01/04/2019

The person walking had left his home at the apartment building on the NE corner and was crossing WB in the north unmarked crosswalk. He was an Older Adult with mobility issues and used a walker.

The person driving had made a NB turn from Salmon onto Park Ave. and the road was blocked by a stopped garbage truck. He put his vehicle into reverse and hit and killed the person walking in the crosswalk as he was backing up.

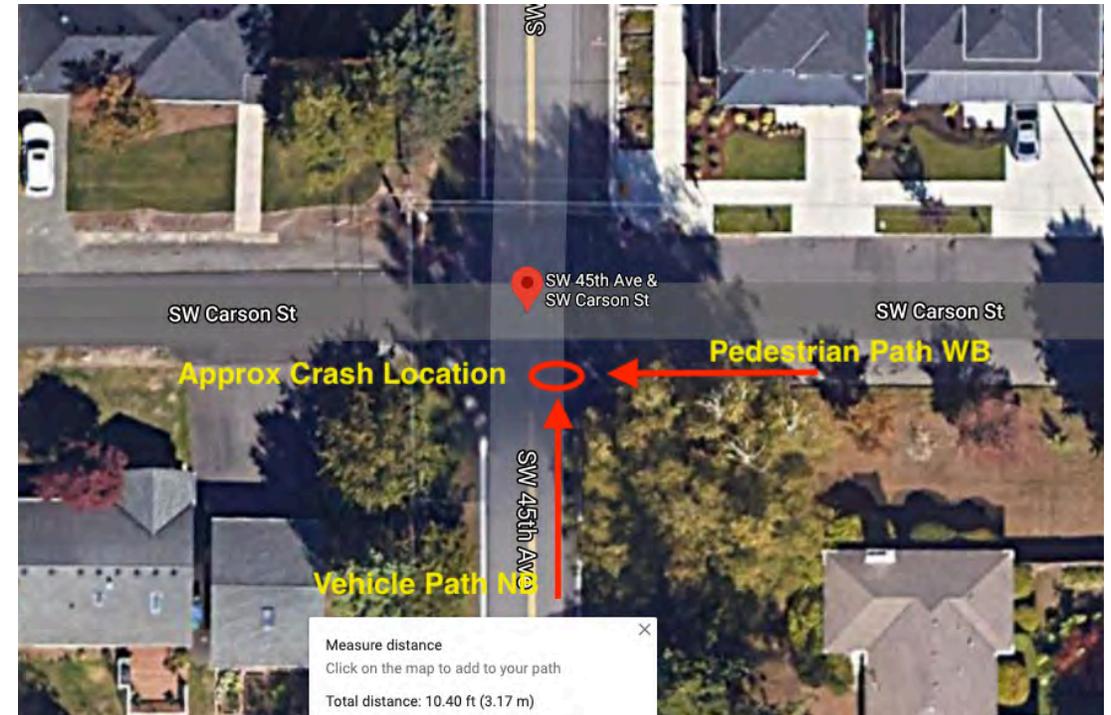
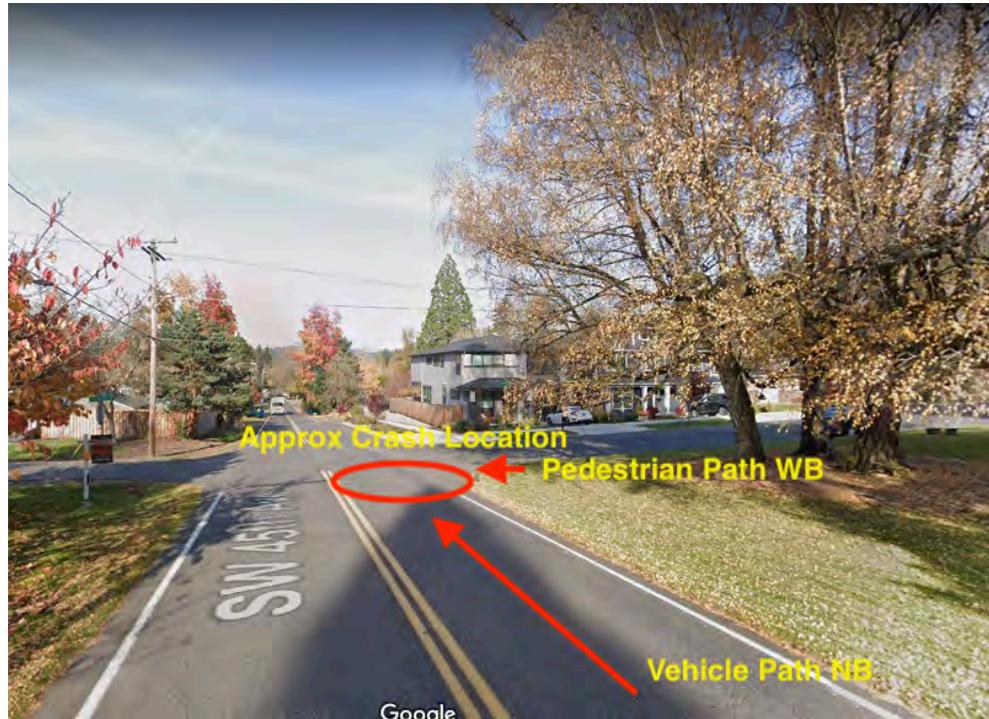
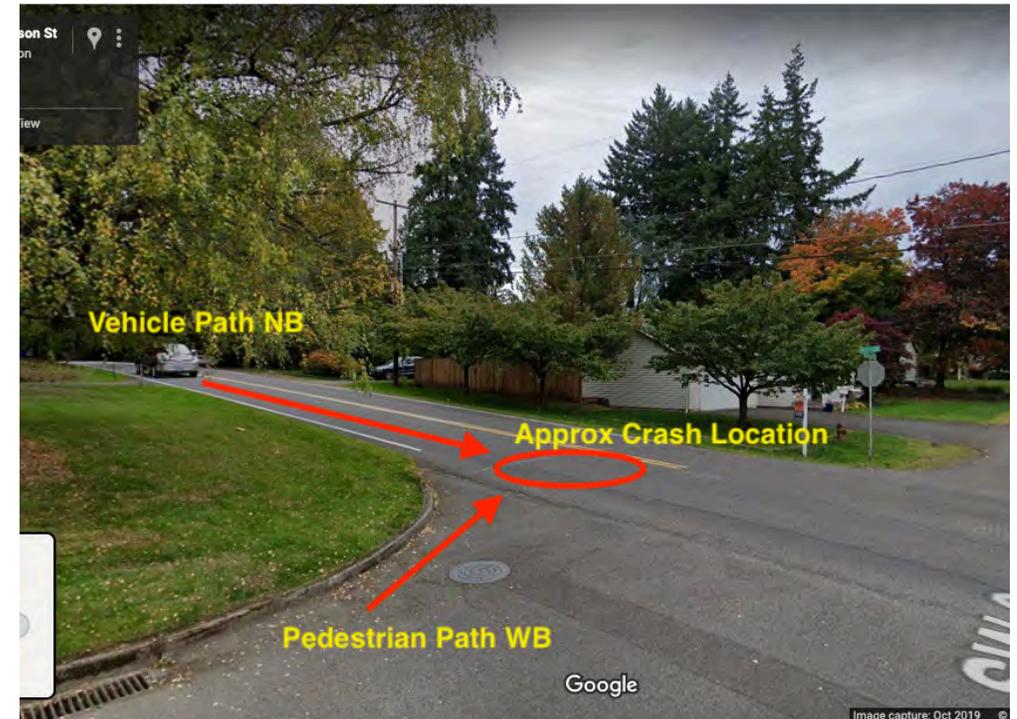
SW 45th AVE AND SW CARSON ST 03/19/2019

The person walking was an Older Adult on her morning walk through her neighborhood. She was crossing from the SE corner of the intersection heading WB in the south unmarked crosswalk.

This was a hit-and-run. The person driving was travelling NB on SW 45th Ave when he hit and killed person walking in the south crosswalk and sped away. The person driving was later arrested on unrelated charges and tied to the hit-and-run.

There is a .8 mile stretch on 45th Ave. from SW Garden Home Rd. to the north and SW Taylors Ferry Rd. to the south. Most of the distance is through a wooded area with few residences. But there is a neighborhood where the pedestrian was hit with no traffic calming infrastructure or signs to alert drivers of pedestrians before they enter this more densely populated zone. Speed bumps and signage are recommended to slow traffic before it enters the neighborhood.

There are no marked or signaled crossings in the area of the crash. Recommend installing marked crosswalks and providing "Ped X-ing" signs to alert drivers.
